UXBRIDGE DOWNTOWN FLOOD REDUCTION CLASS ENVIRONMENT ASSESSMENT STUDY

EXISTING ENVIRONMENTAL CONDITIONS REPORT

Uxbridge Brook Watershed

Our Project No. 10257.450
March 2012

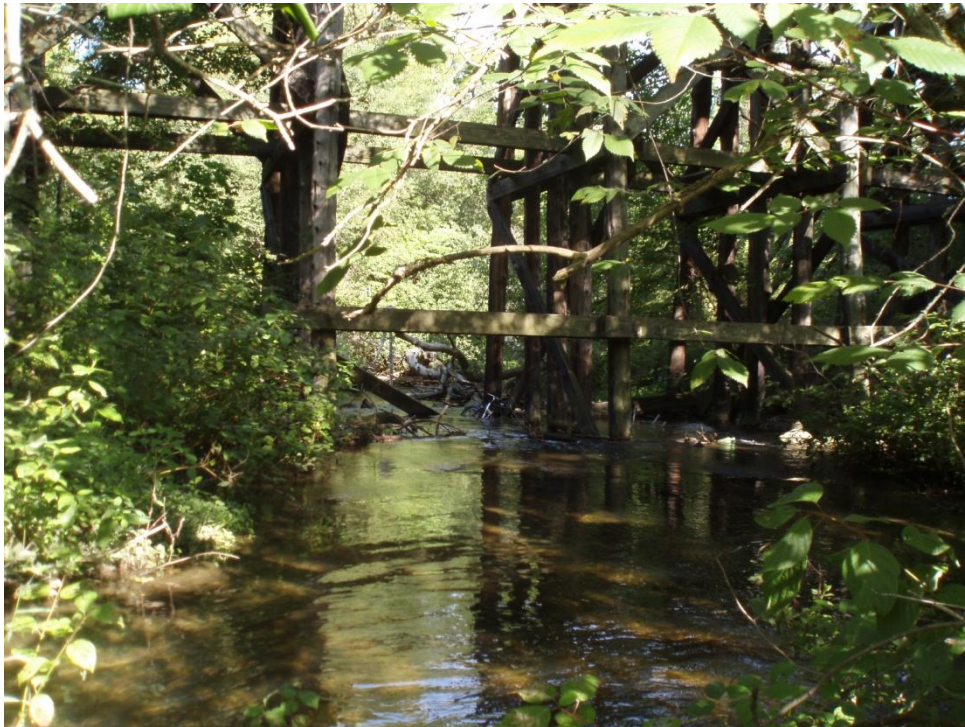
Photo 1.

Downstream view of wooden footbridge & decommissioned CN railway. Wetted width was 7 m and wetted depth was 0.6 m. Note: minor vegetation encroachment, woody debris jam and garbage debris.

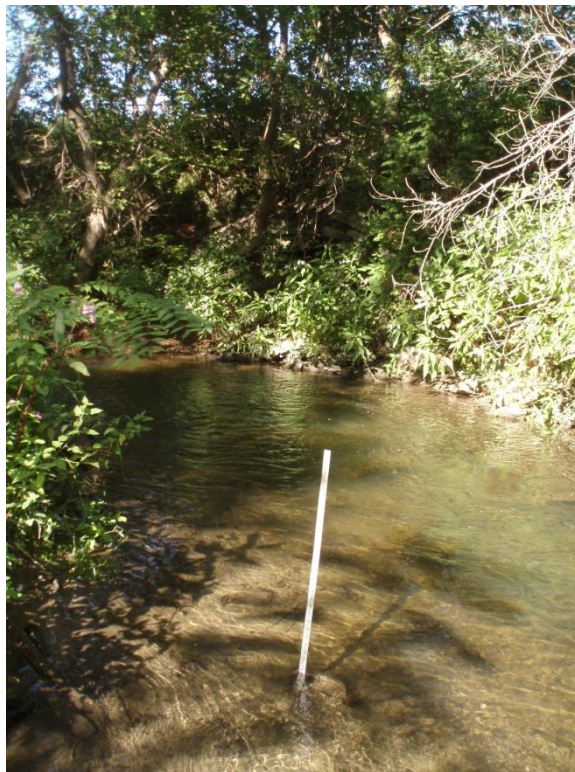
Photo 2.

Photograph of valley wall contact (centre). Valley wall toe was protected by concrete rubble.

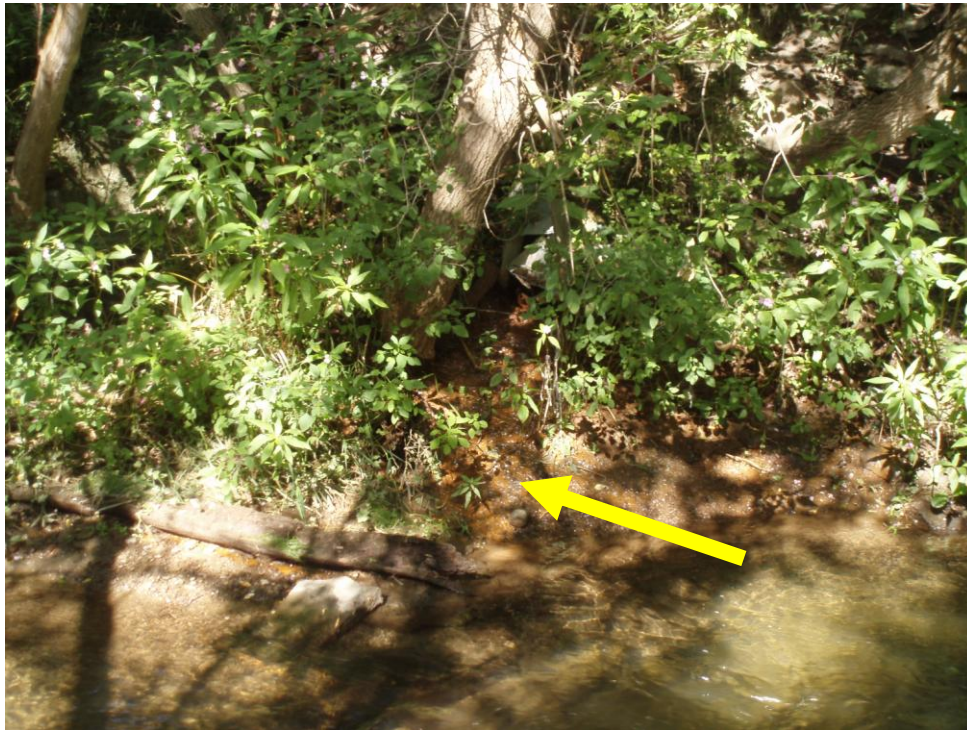
Photo 3.

Iron staining on the channel bank (yellow arrow) was indicative of groundwater discharge.

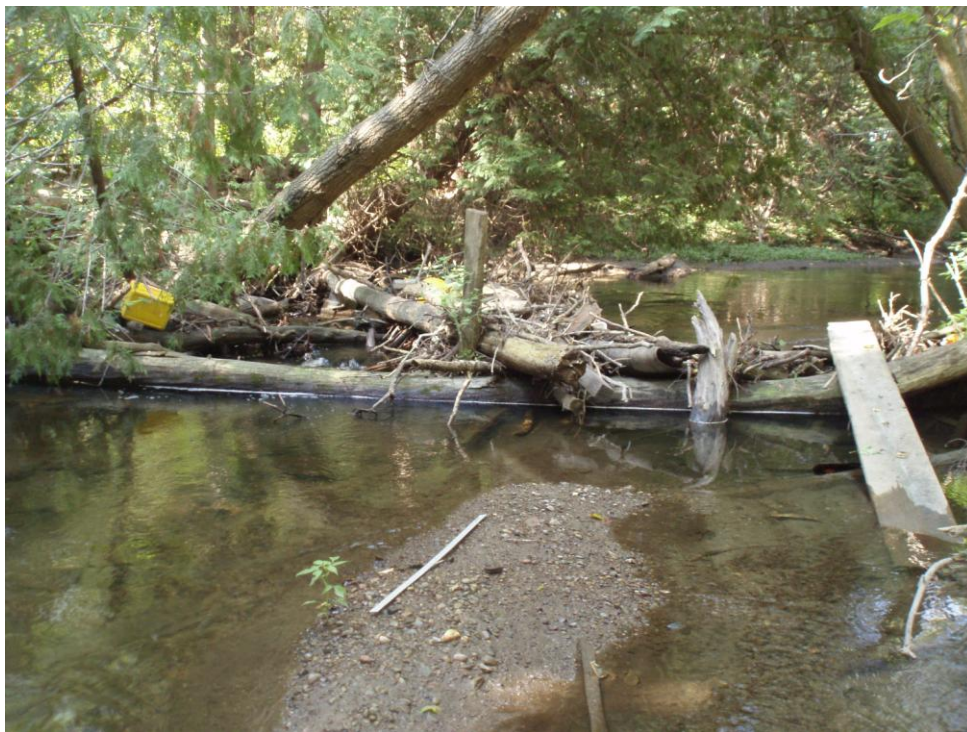
Photo 4.

Example of a medial bar and woody debris jam.

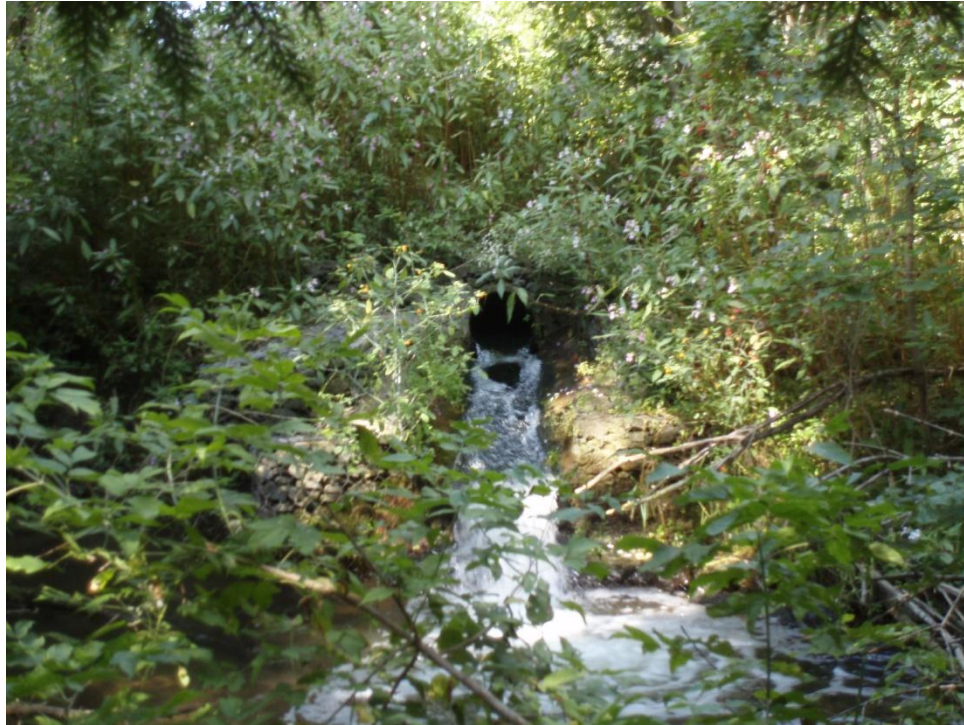
Photo 5.

Reach UX1 extended approximately 300 m upstream from the decommissioned CN railway to the treatment plant on Main Street North, as shown in **Appendix A**. The surrounding land use consisted of residential homes, a public park and forest. The upstream channel was partially confined whereas the downstream channel, closer to Main Street North, was confined. The extent of riparian vegetation was continuous and consisted of trees and grasses. The channel sinuosity and gradient were low. Bankfull widths and depths ranged from 7 to 12 m and 0.5 to 1 m, respectively. Garbage and woody debris jams were frequent and occurred on average approximately every 15 m to 25 m. Erosion and bank undercutting occurred along the outer bends of the channel, exposing tree and grass roots. A valley wall contact and evidence of seepage, iron staining and exposed till were also noted downstream of the stormwater outfall outletting from the treatment plant mid-reach. The base and sides of the stormwater outfall were protected by concrete slabs and gabions, which were outflanked.

Photograph of storm sewer outfall from treatment plant. Undermined concrete slab at base and outflanked gabion baskets (centre).

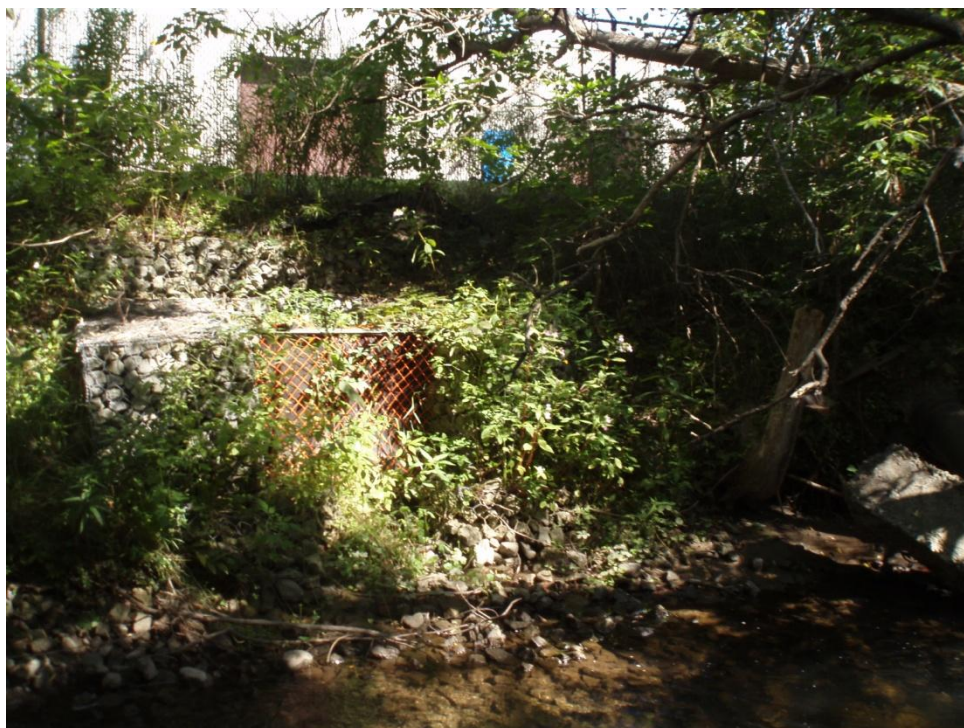
Photo 6.

Outflanked gabion baskets (centre-left), concrete rubble and exposed steel pipe along channel bank. Note proximity of building to channel.

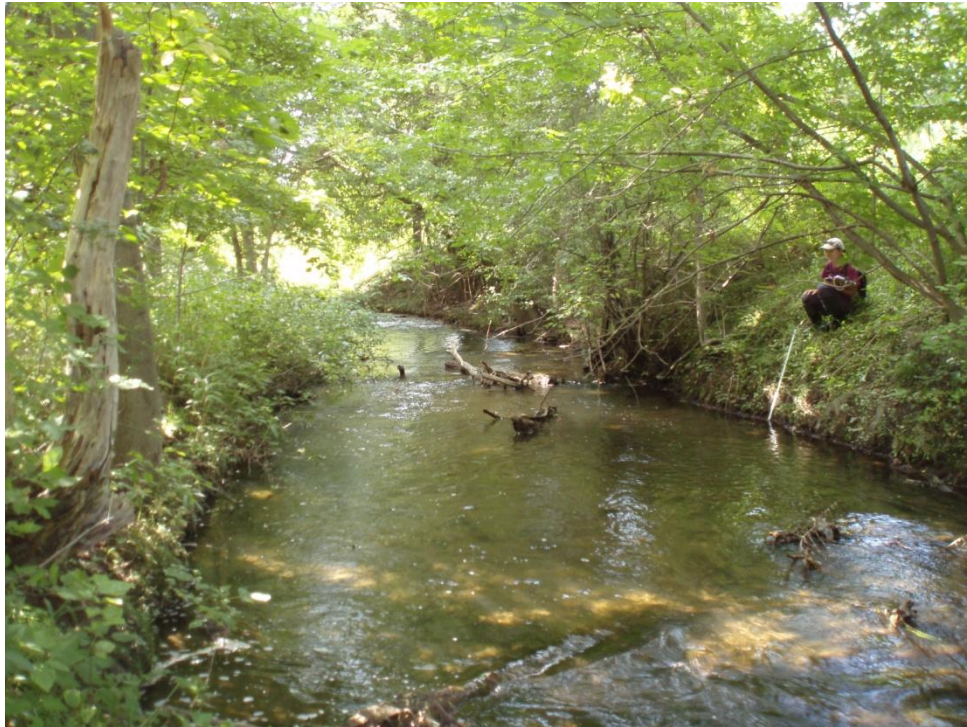
Photo 7.

Upstream view of straight (and typical) channel section. Low to moderate input of woody debris. Bankfull width was 7 m and bankfull height ranged between 0.5 to 0.75 m.

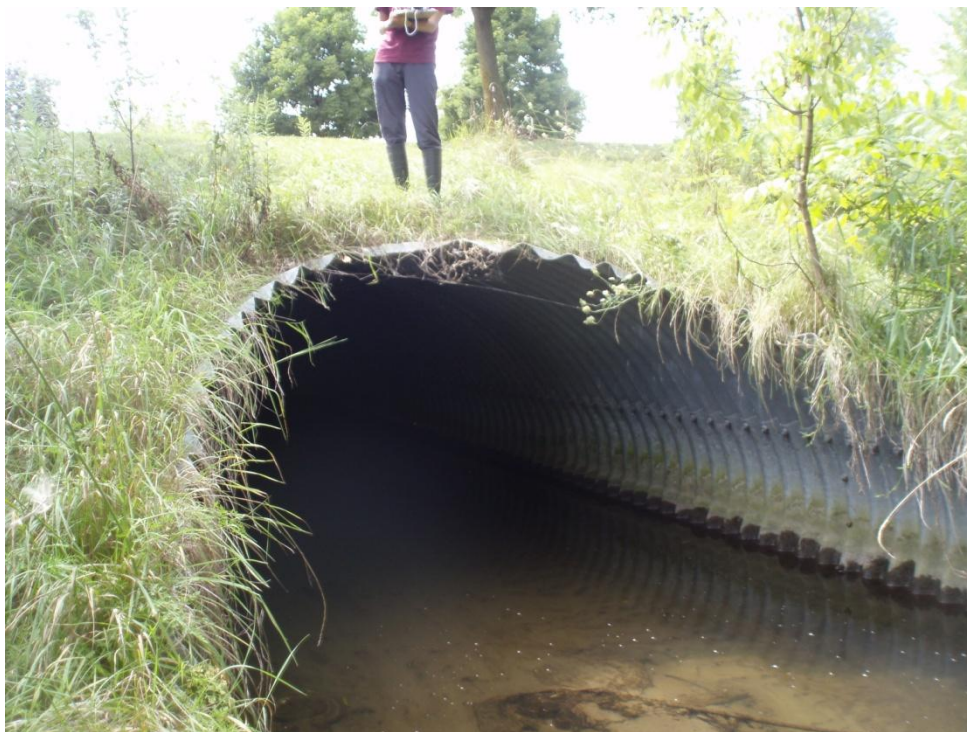
Photo 8.

Upstream end of CSP culvert at Main Street North.

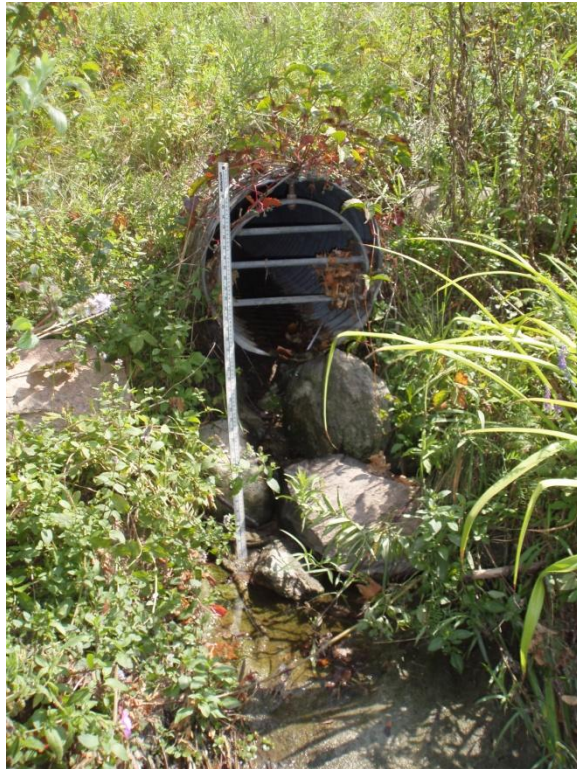
Photo 9.

Elevated stormwater outfall (500 mm diameter) at Dominion Street West and Toronto Street North. Concrete rubble and boulders at base.

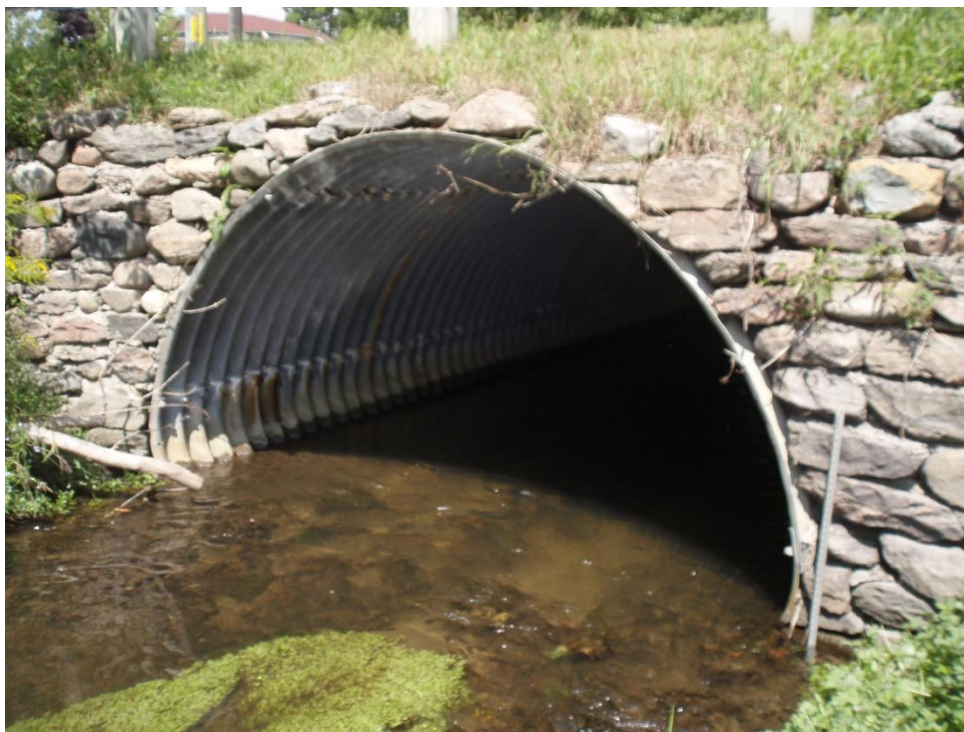
Photo 10.

Upstream end of CSP culvert at Dominion Street West. Note rooted algae, and cobble and silt substrate. No erosion or scour was observed.

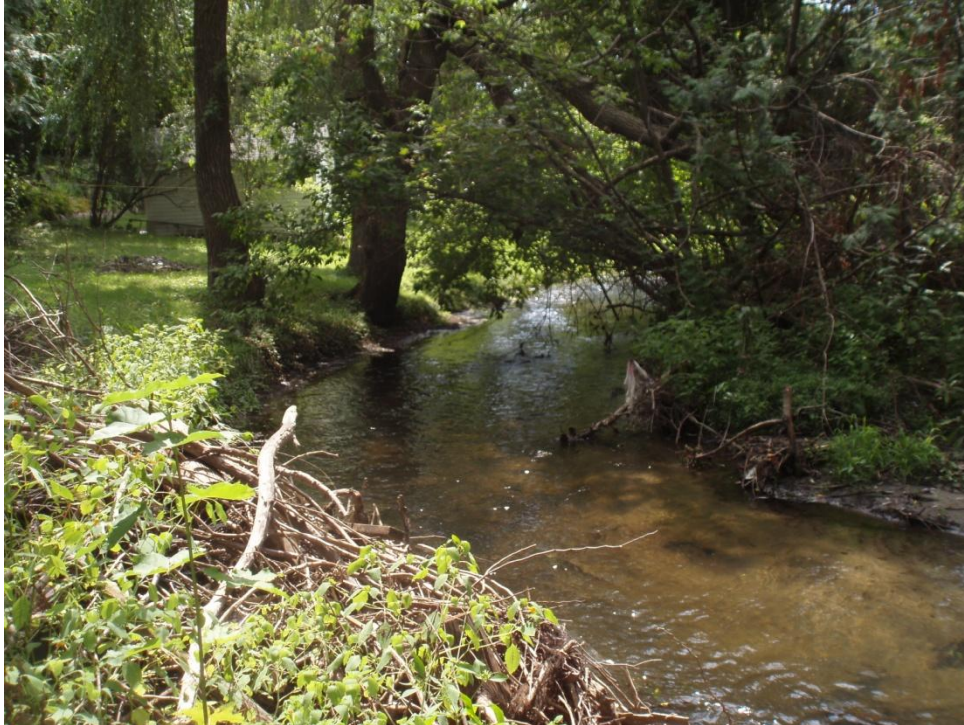
Photo 11.

Upstream view of channel at 38 Main Street North. Erosion along outer bends, and deposition of woody debris was observed. Note the manicured lawn and proximity of property to channel.

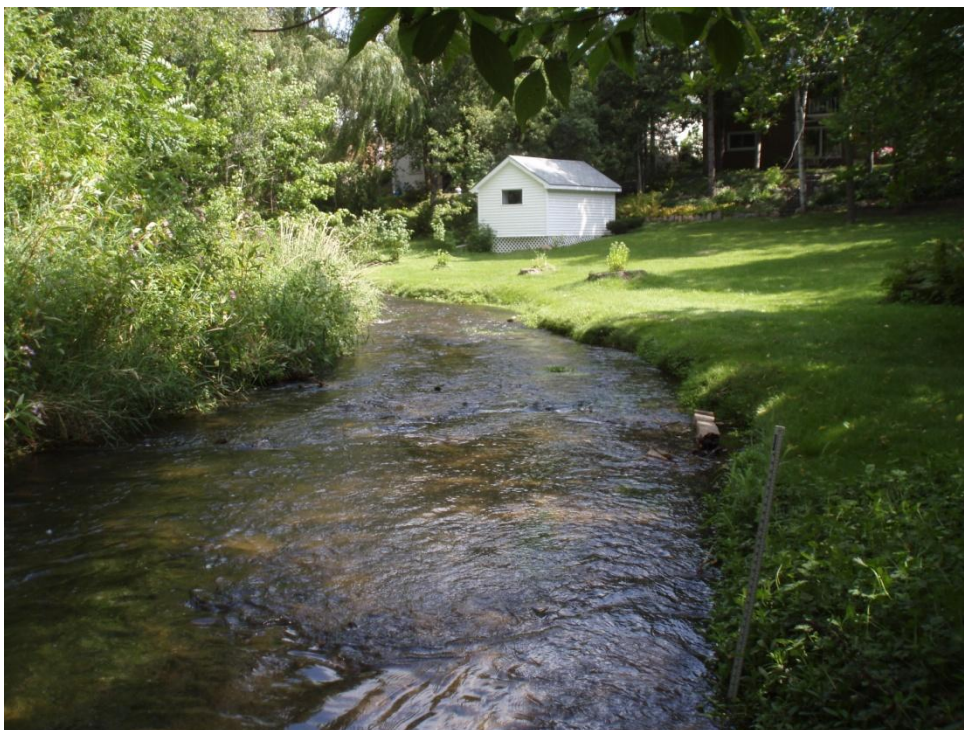
Photo 12.

Downstream view from CSP culvert at parking lot. Defined right bank, poorly defined left bank. Note the manicured lawn and lack of riparian cover (centre).

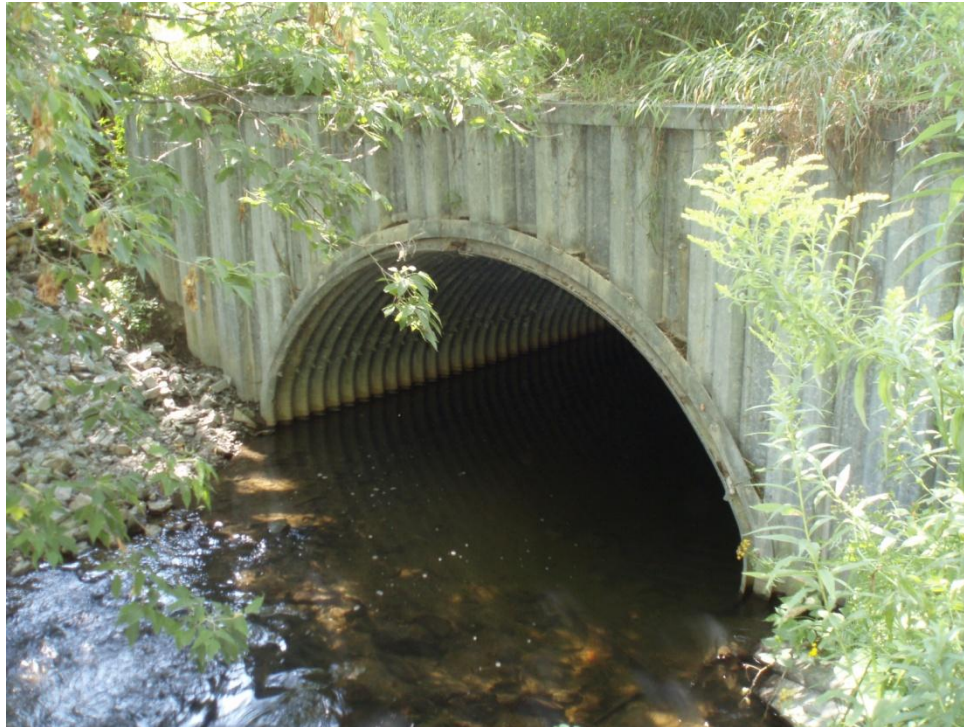
Photo 13.

Downstream end of CSP culvert at Brock Street West and Main Street North parking lot. Rip rap armouring on right bank.

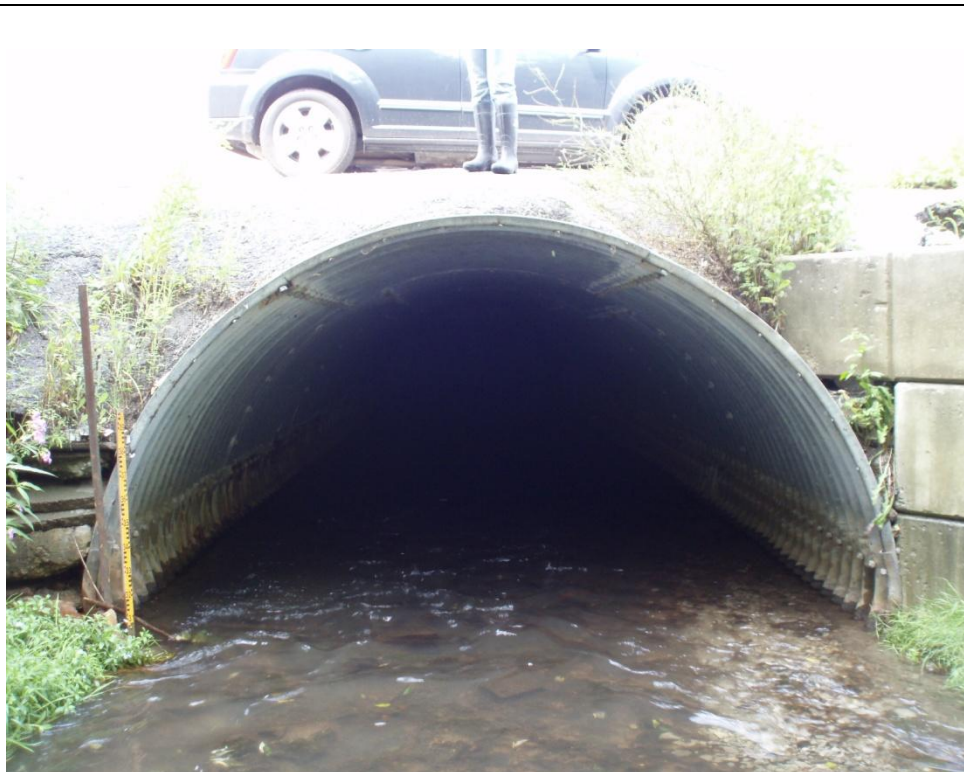
Photo 14.

Upstream end of CSP culvert at Centennial Drive. Failed pavement was observed behind armour stone blocks. Cobble and gravel substrate within channel.

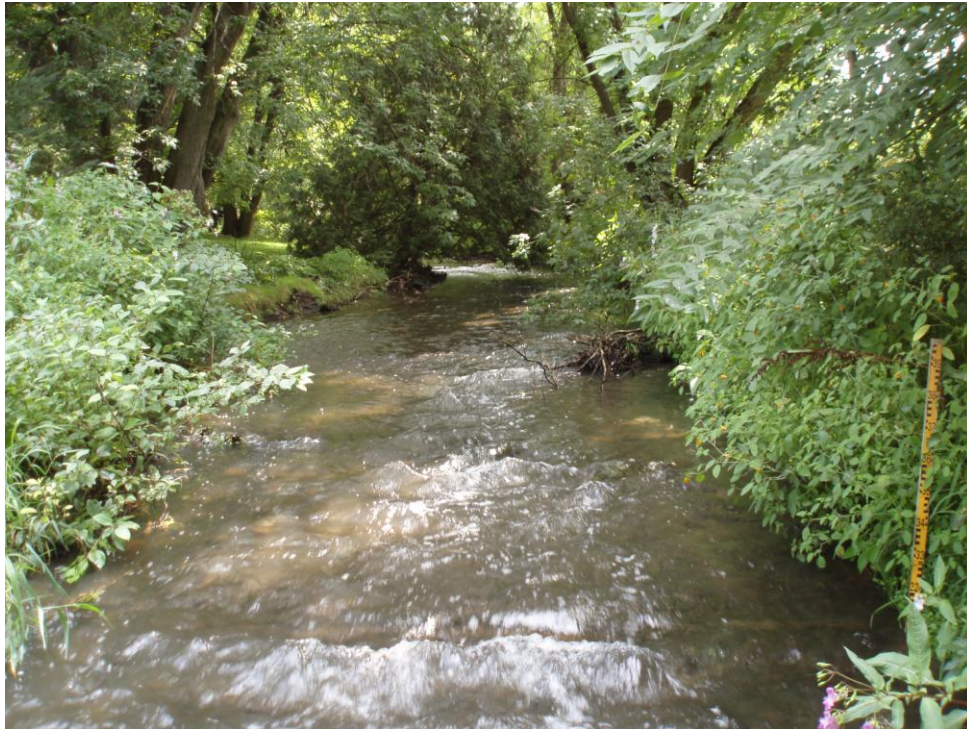
Photo 15.

View upstream from the Brock Street East. Note the riffle, and steeper channel gradient observed in the foreground of the photo.

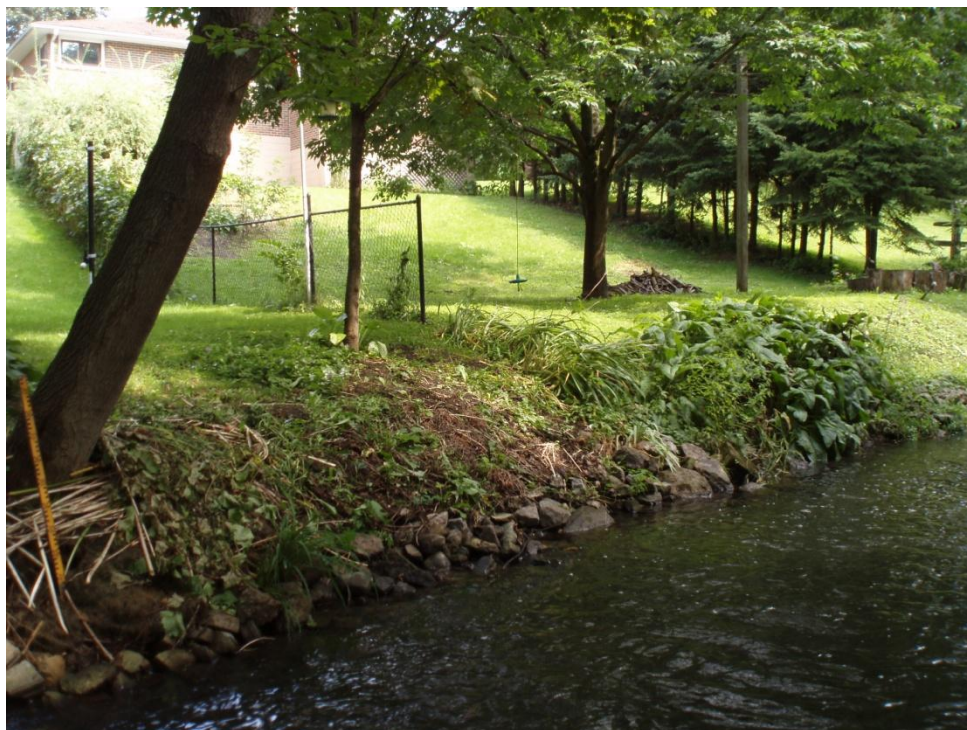
Photo 16.

Concrete rubble protection on right bank. Overbank sand and organic debris deposits. Note the manicured lawns.

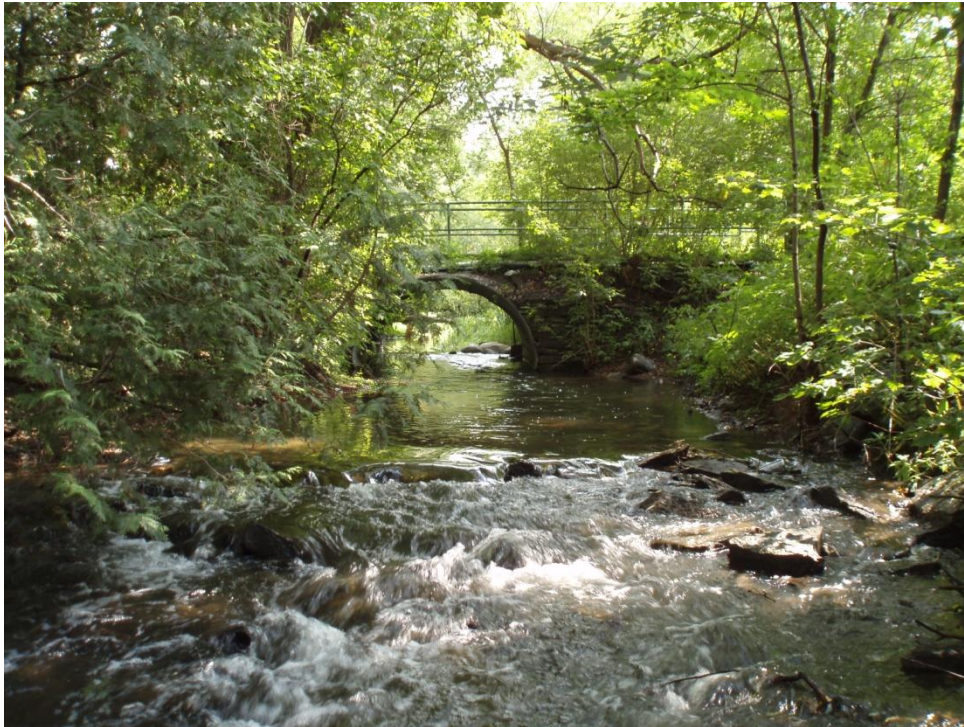
Photo 17.

Upstream view of pedestrian bridge with CSP culvert. An approximate 0.6 m deep scour pool was observed downstream of the crossing structure.

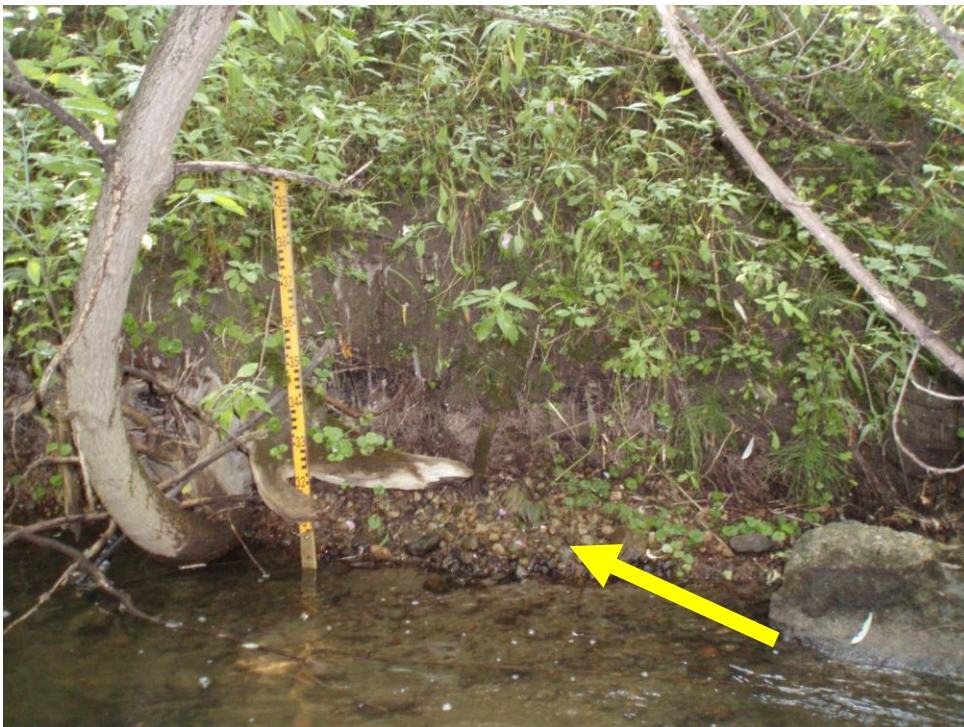
Photo 18.

Suspended armour layer in channel bank (yellow arrow), upstream of photo location 10, is indicative of channel downcutting.
