## CONSERVATION PLAN

### **Gould Estate**

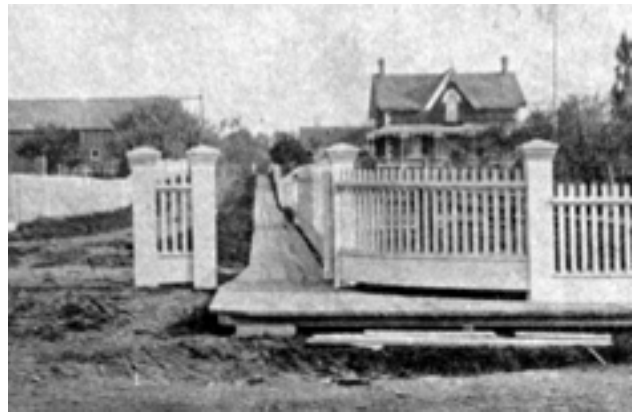
Figure. 1.3. Archival photo of 62 Mill St.

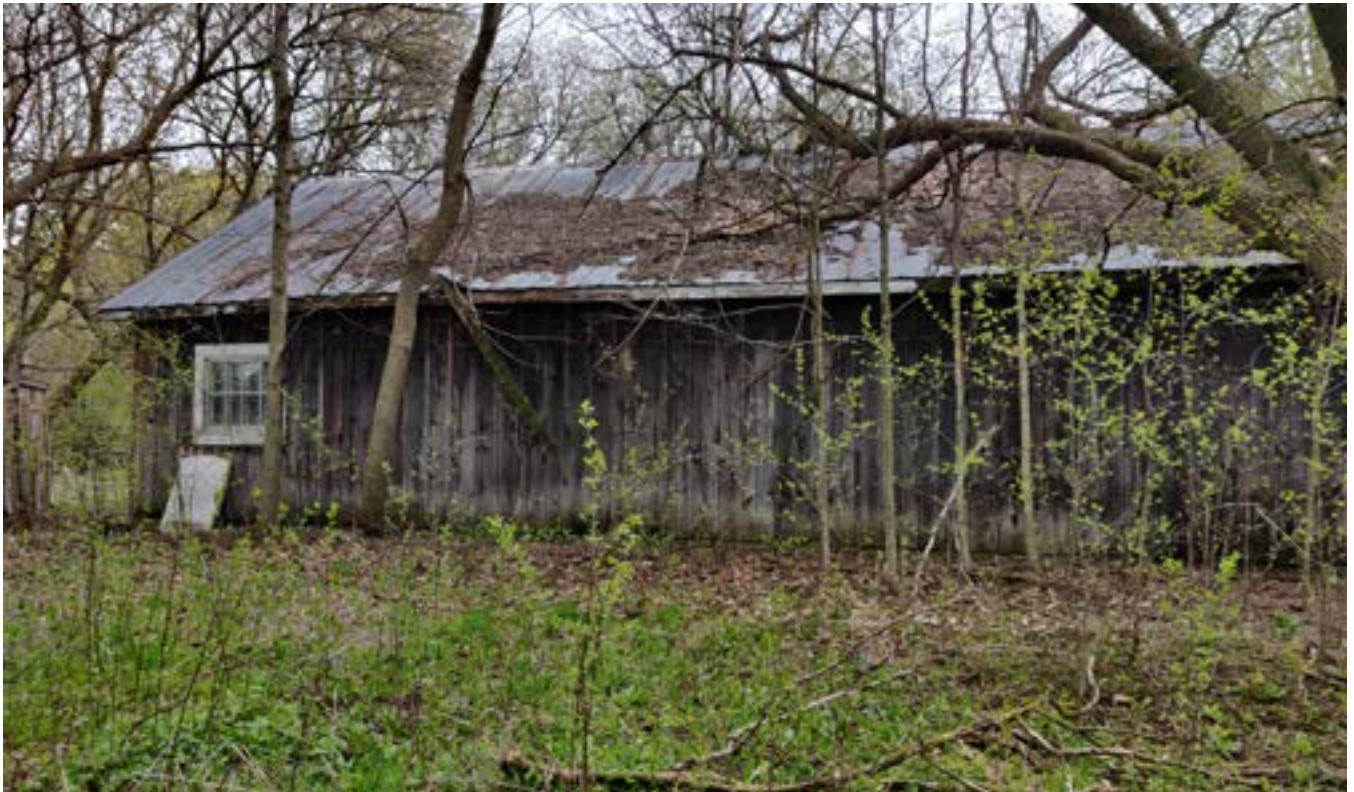
Figure. 1.12. Driveshed existing west facade

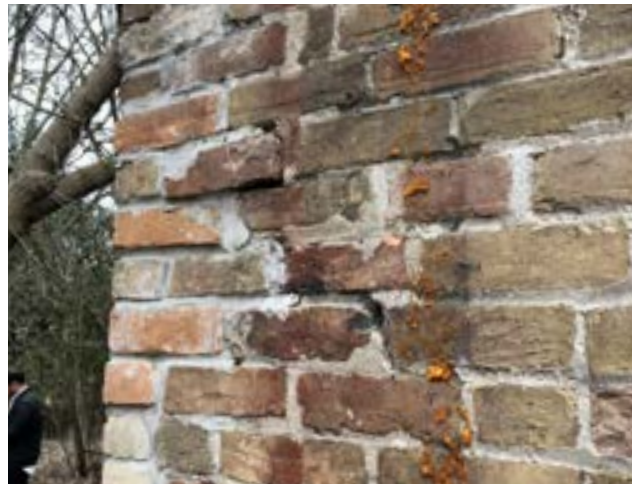
Figure. 2.1. Loose and open mortar joints

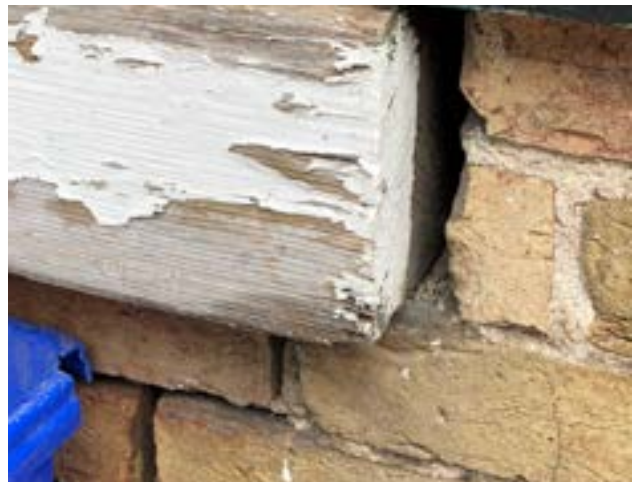
Figure. 2.2. Loose and open mortar joints

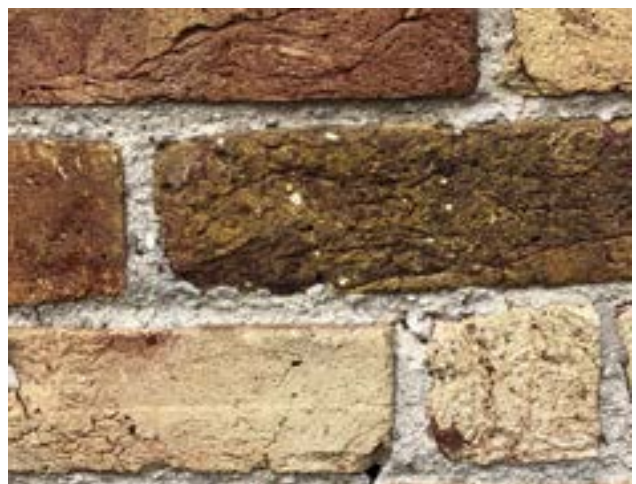
Figure. 2.3. Cracked brick

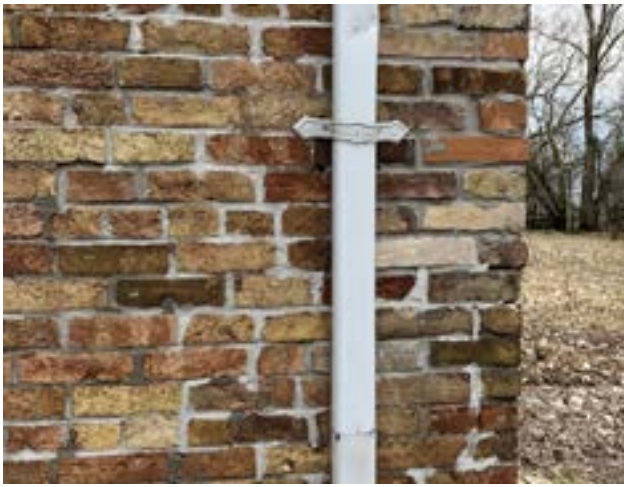
Figure. 2.4. Incompatible mortar

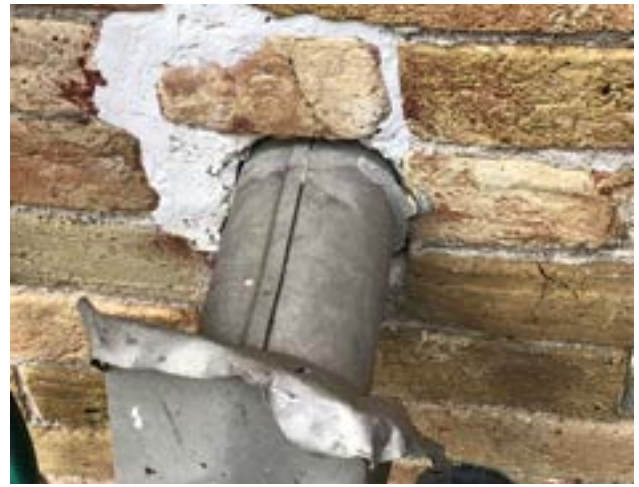
Figure. 2.7. Partially missing bricks and incompatible sealant

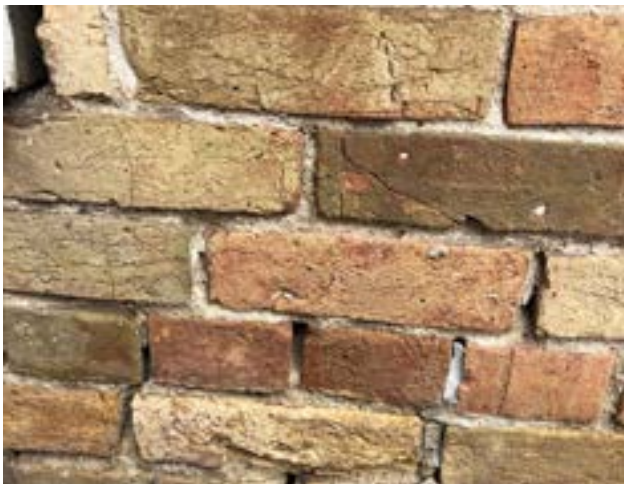
Figure. 2.5. Open mortar joints & spalled brick

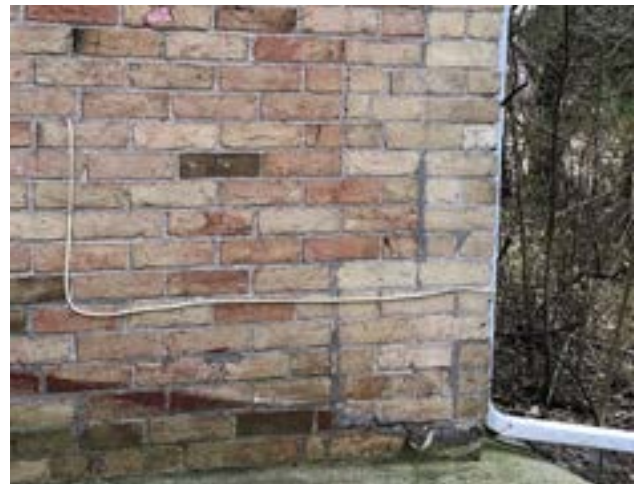
Figure. 2.8. Staining & soiling

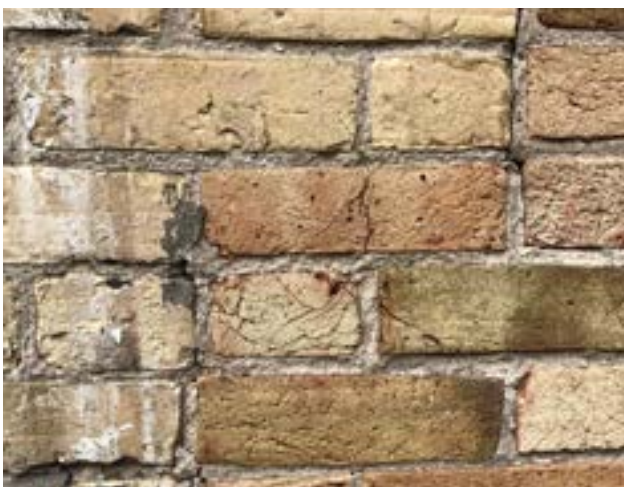
Figure. 2.6. Incompatible mortar & cracked brick

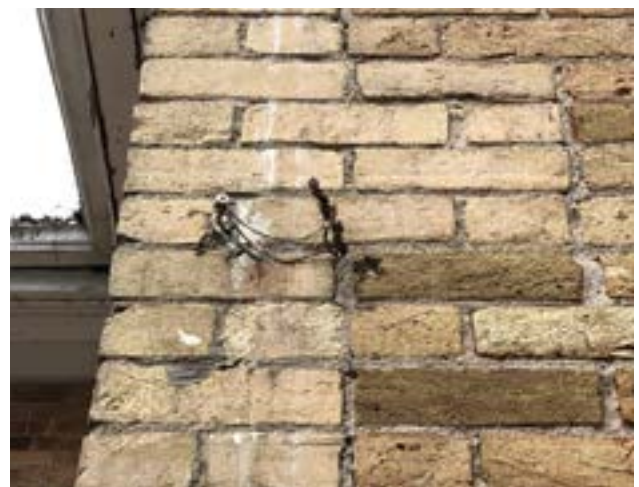
Figure. 2.9. Residual fasteners & penetrations, chipped bricks at the corner

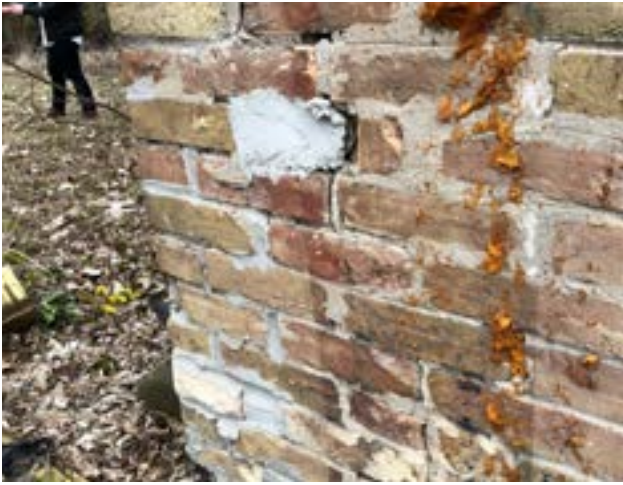
Figure. 2.10. Southwest corner brick in poor condition

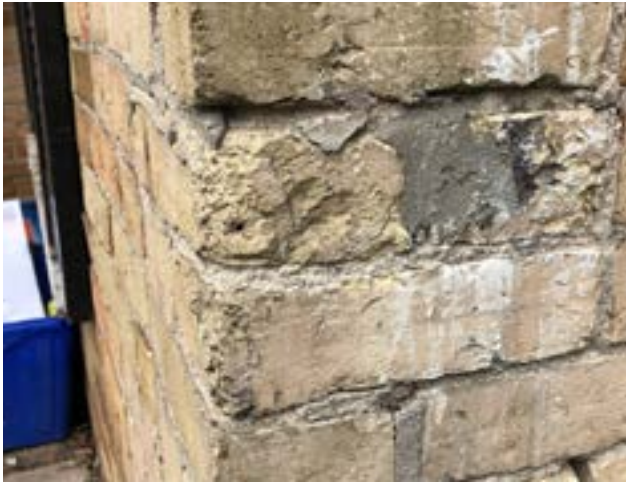
Figure. 2.14. Southeast corner: brick in poor condition

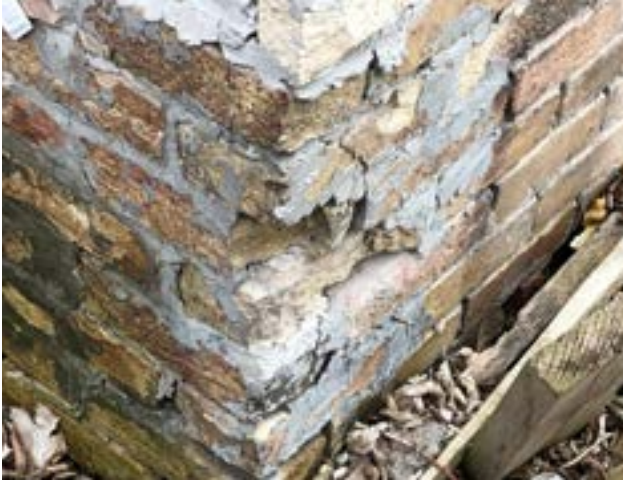
Figure. 2.11. Southwest quoining in poor condition

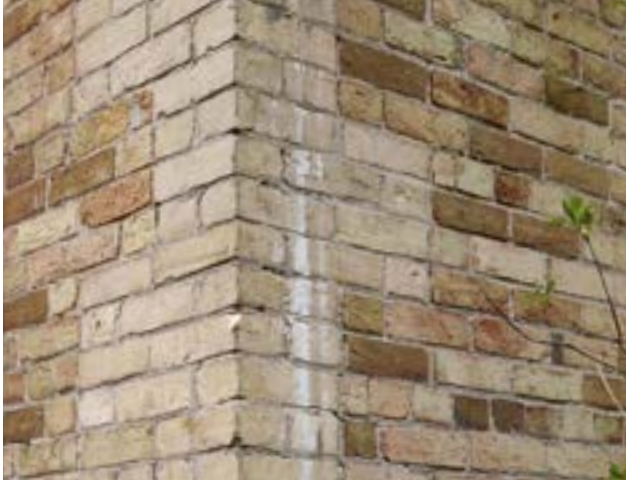
Figure. 2.15. Non-original quoining is in poor condition

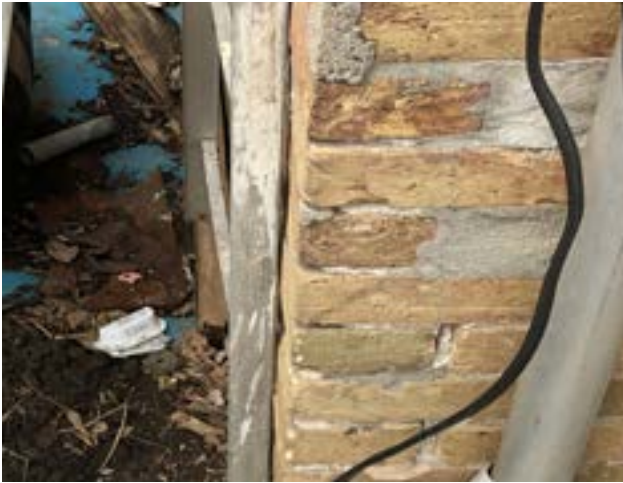
Figure. 2.12. Southeast corner brick & mortar in fair condition; missing brick

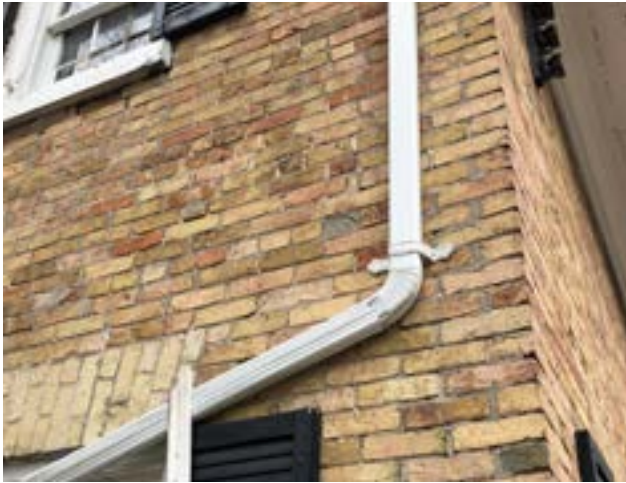
Figure. 2.13. South facade

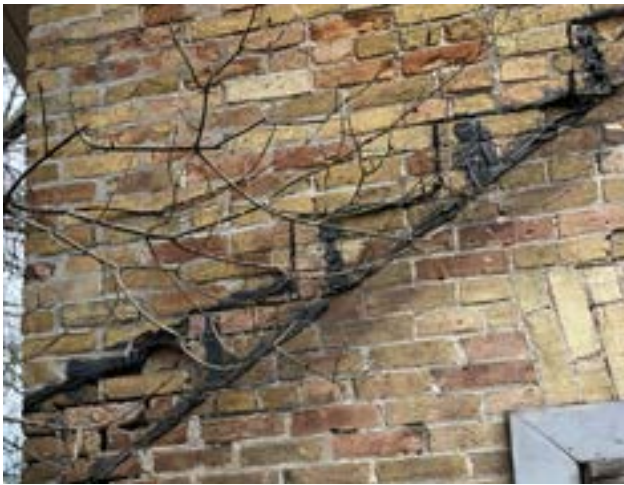
Figure. 2.16. South Facade: Staining & tar from a previously removed shed addition

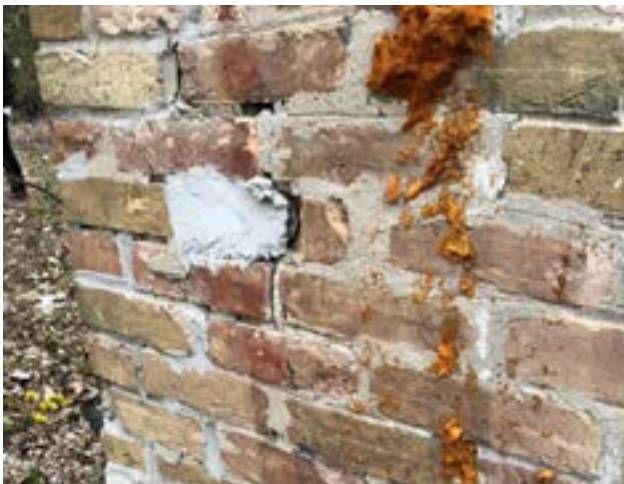
Figure. 2.17. Lower part of southwest corner in poor condition

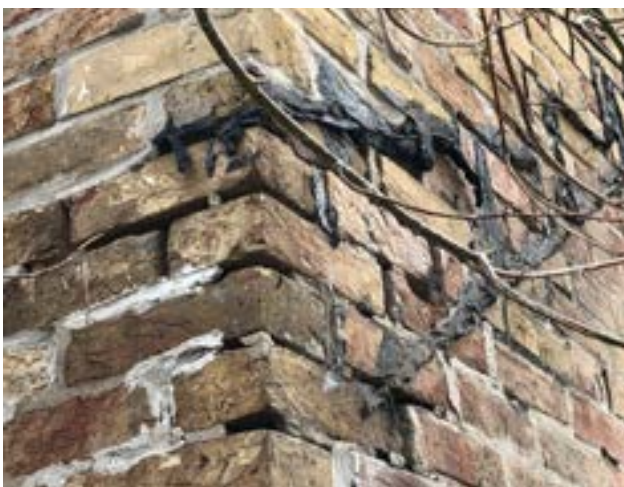
Figure. 2.18. South Facade: Open mortar joints at corner

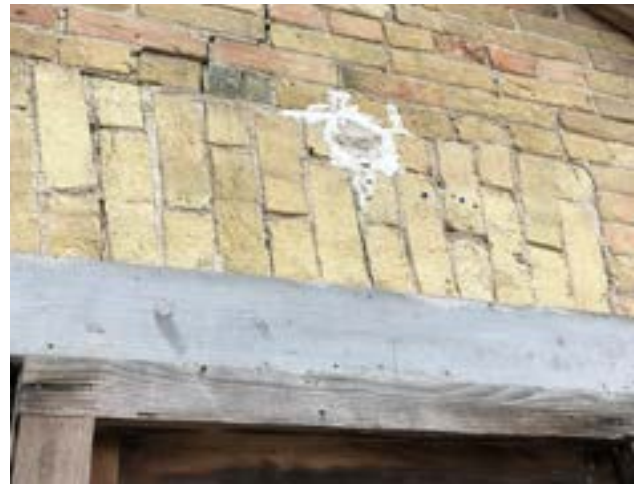
Figure. 2.19. South Facade : Missing bricks & cracks at soldier course above door

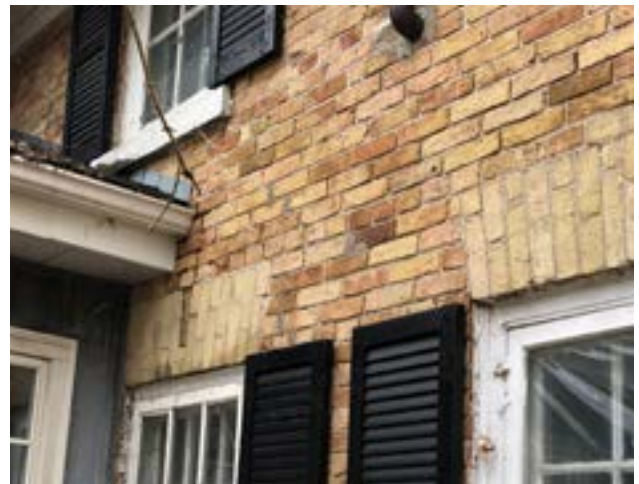
Figure. 2.20. West facade: Facade soiling & missing brick at soldier course

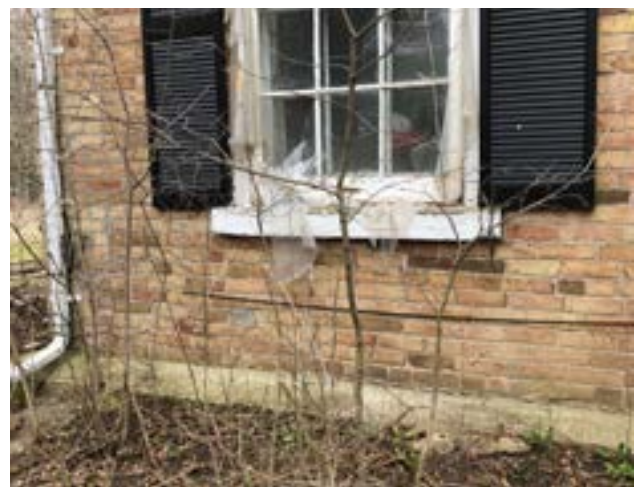
Figure. 2.21. West facade: Soiled & stained brick

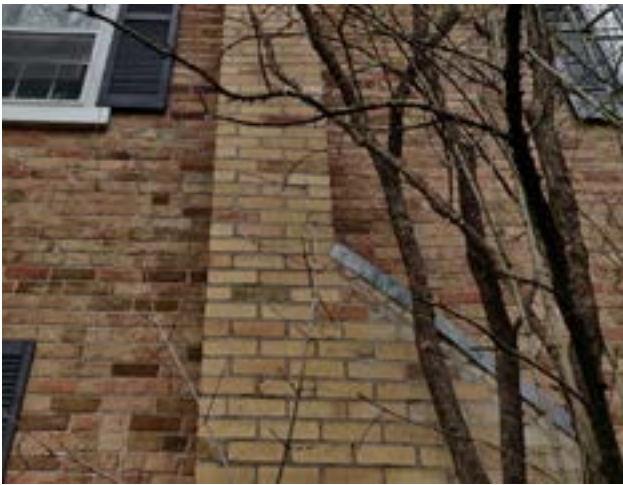
Figure. 2.24. West facade: Existing non-original chimney

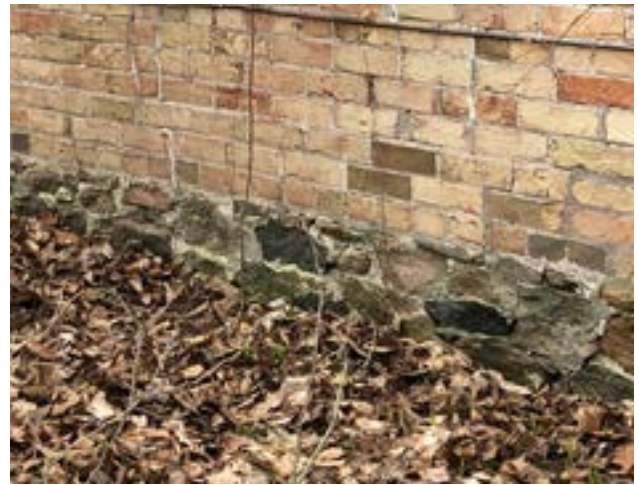
Figure. 2.22. North facade: Stone foundation in good condition

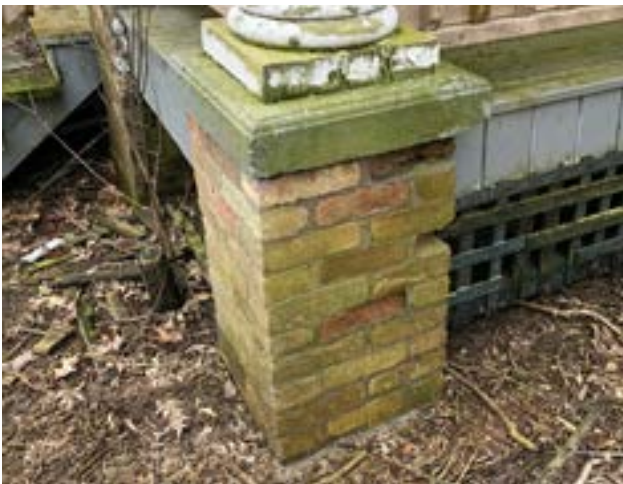
Figure. 2.25. North facade: Missing bricks

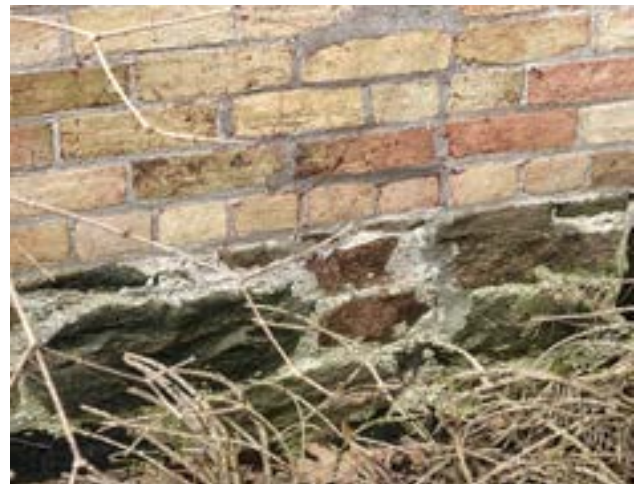
Figure. 2.23. North facade: Stone foundation in good condition

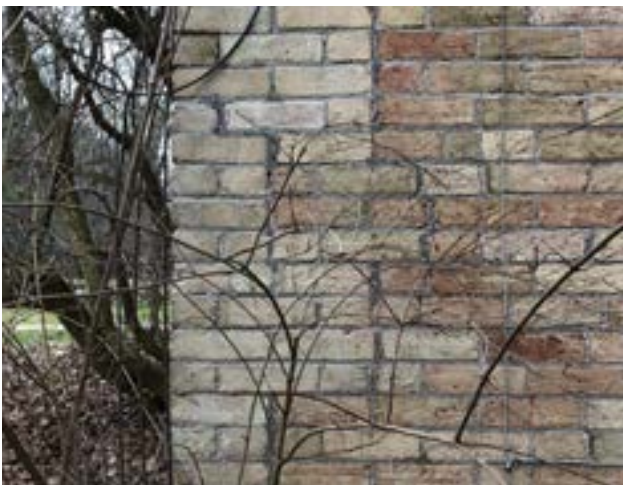
Figure. 2.26. North facade: Staining & environmental soiling

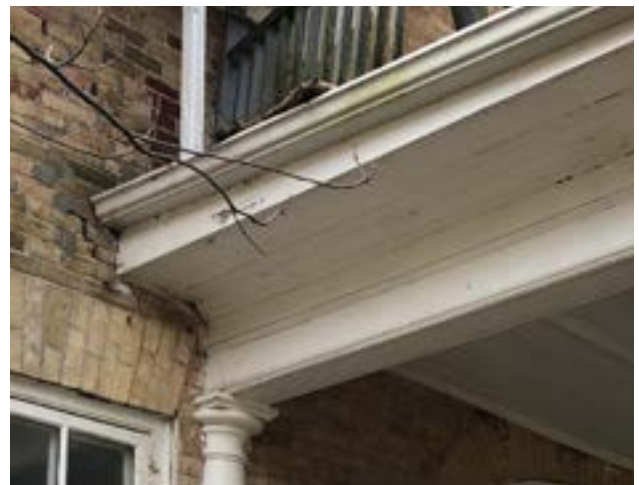
Figure. 2.27. North facade: Brick in poor condition where porch connects to the building, with partially missing bricks and signs of cracks

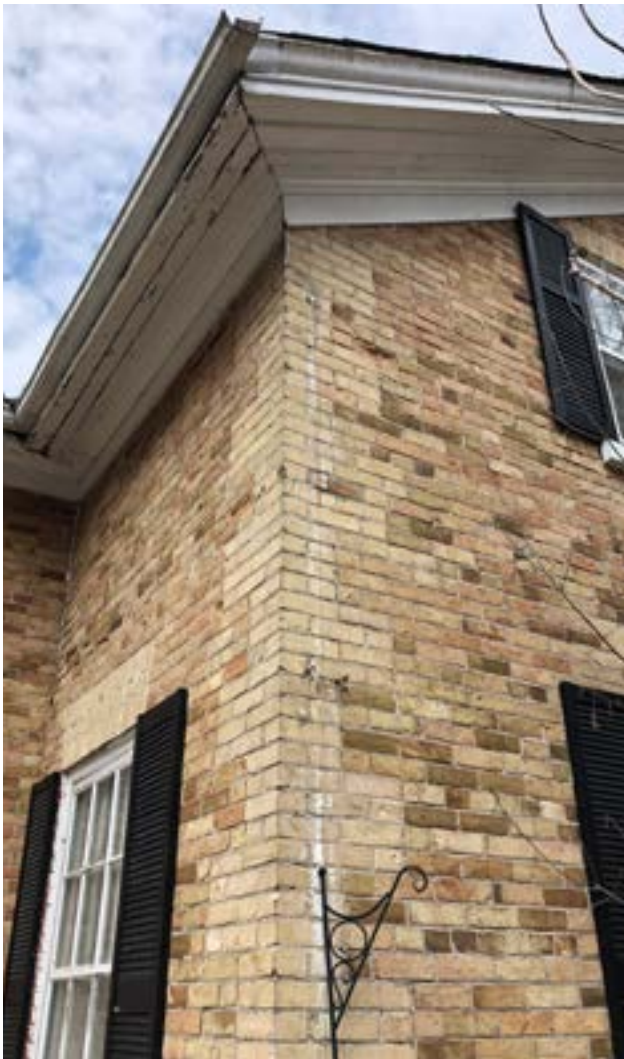
Figure. 2.28. East facade: Brick in generally good condition

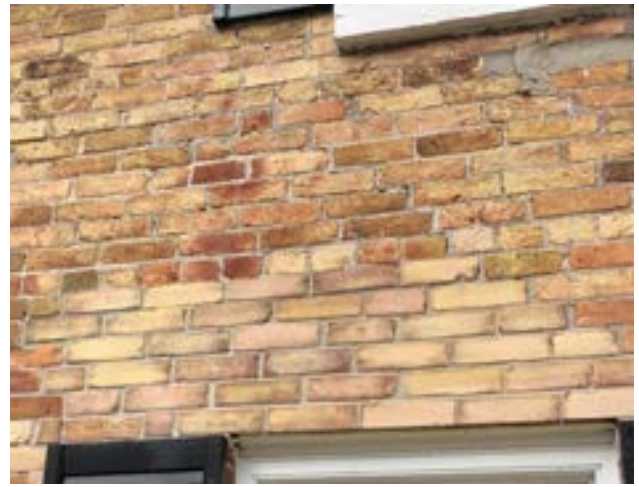
Figure. 2.29. East facade: Incompatible brick from previous repairs

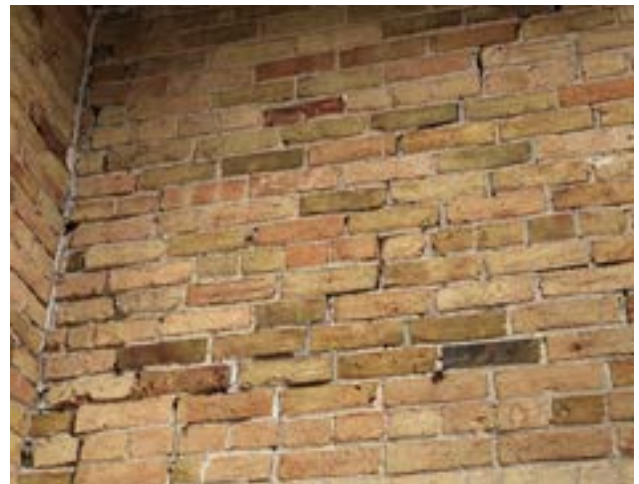
Figure. 2.30. Inner south east corner: brick in poor condition with signs of cracks and open mortar joints

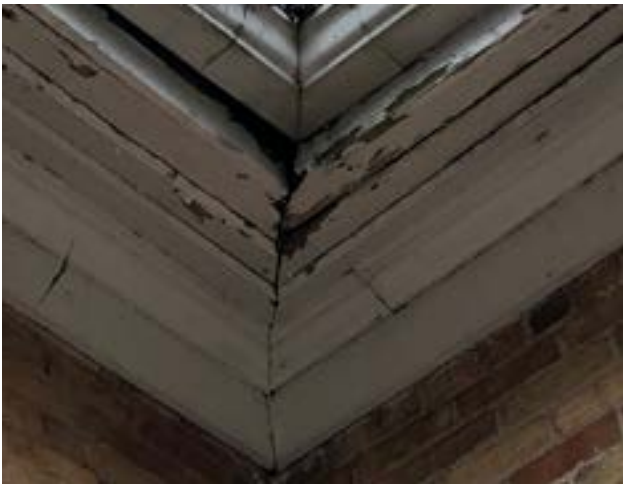
Figure. 2.31. Deteriorated original soffits and fascia

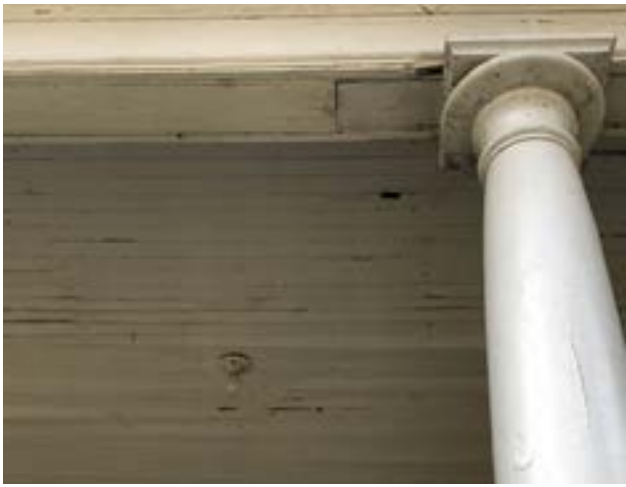
Figure. 2.34. Deteriorated original soffits and fascia

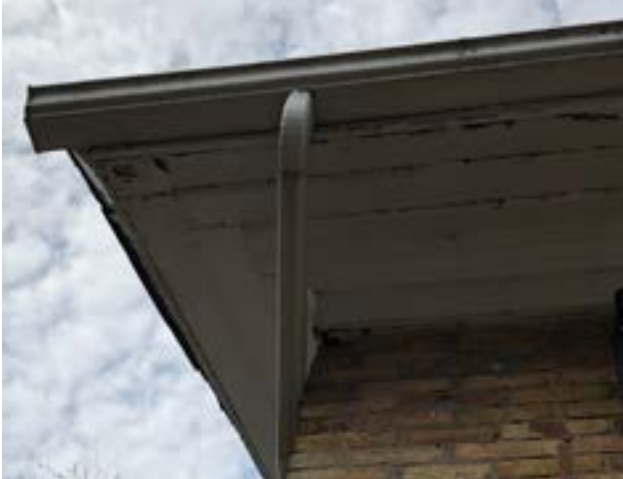
Figure. 2.32. Deteriorated original soffits and fascia

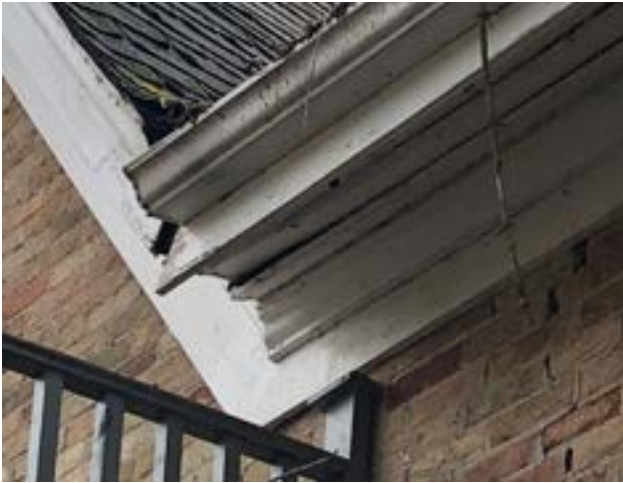
Figure. 2.33. Deteriorated original soffits and fascia

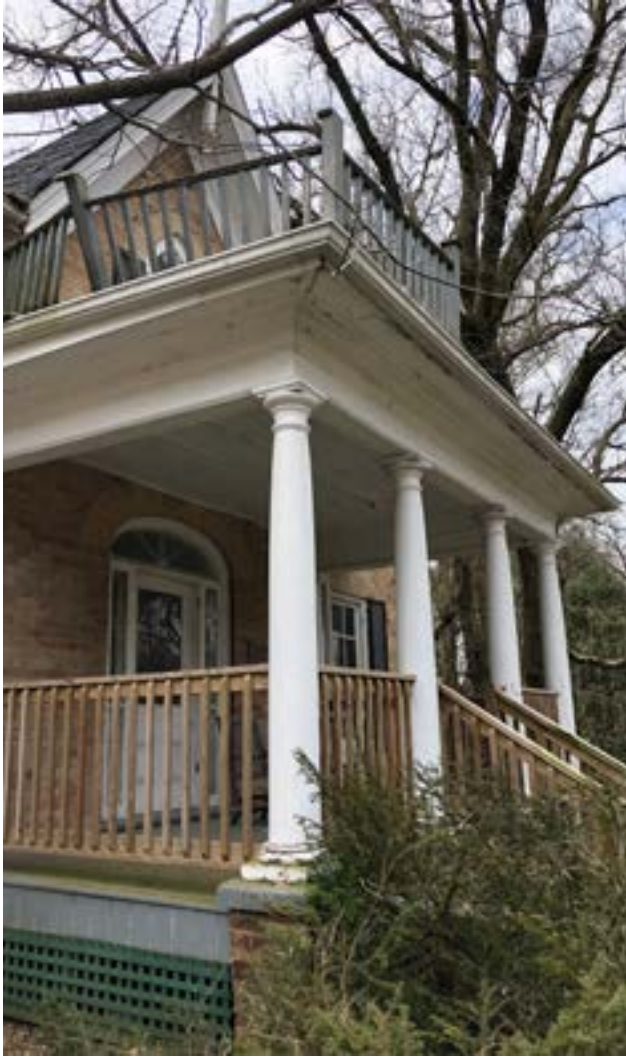
Figure. 2.35. Deteriorated porch railing, deck & skirting

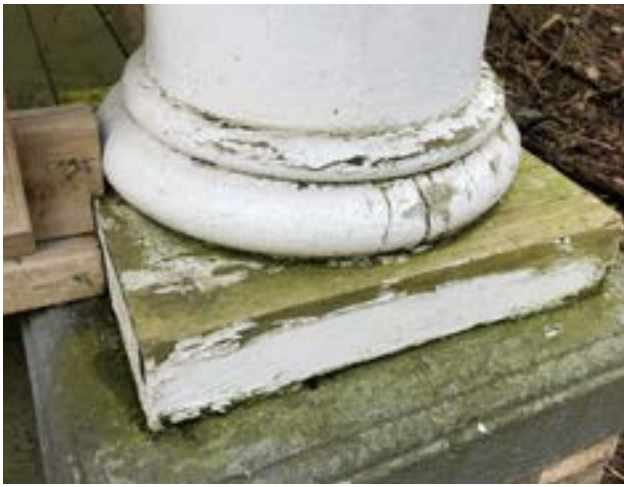
Figure. 2.36. Deteriorated original column bases at front porch

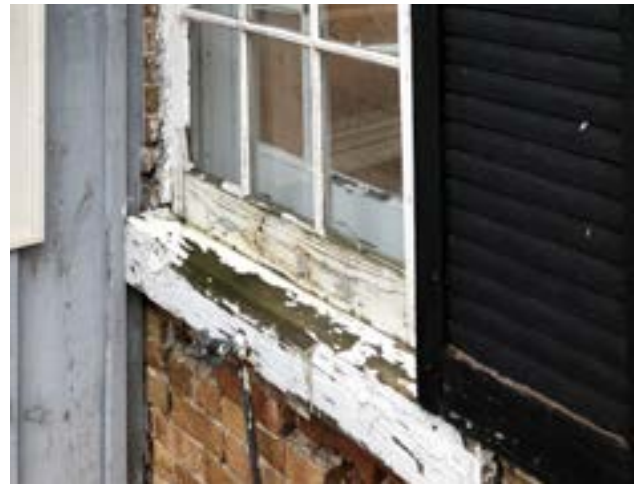
Figure. 2.39. Original lower sills in poor condition

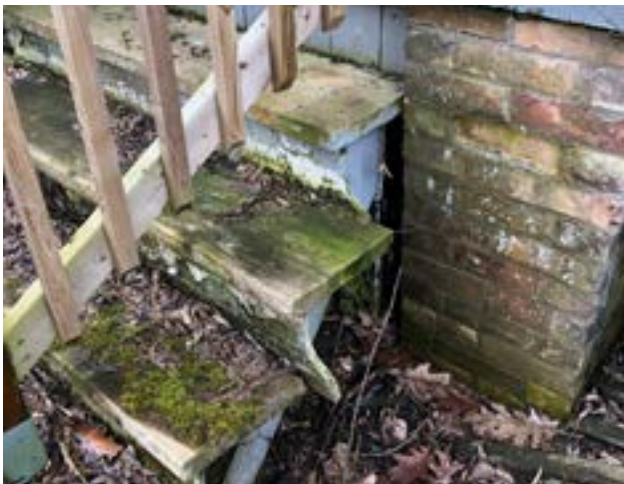
Figure. 2.37. Deteriorated front porch stairs

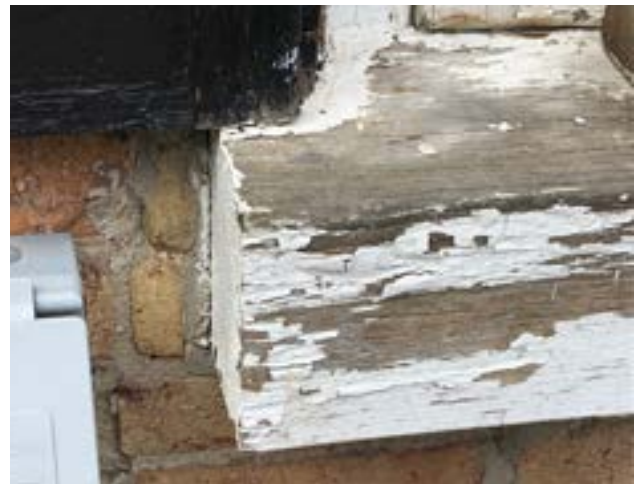
Figure. 2.40. Original lower sills in poor condition

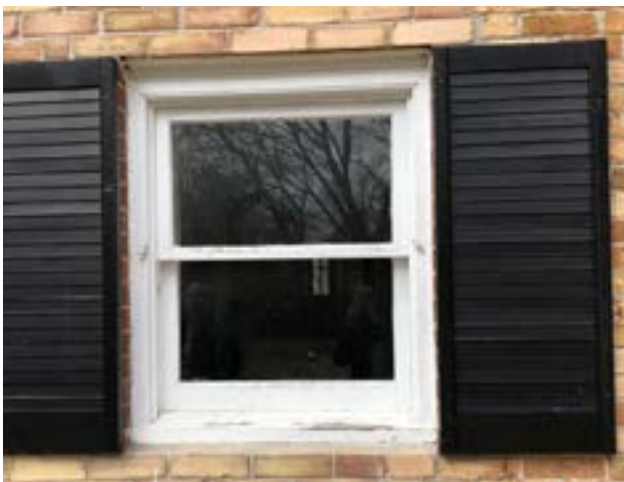
Figure. 2.38. Partially deteriorated original wooden windows with non-original shutters

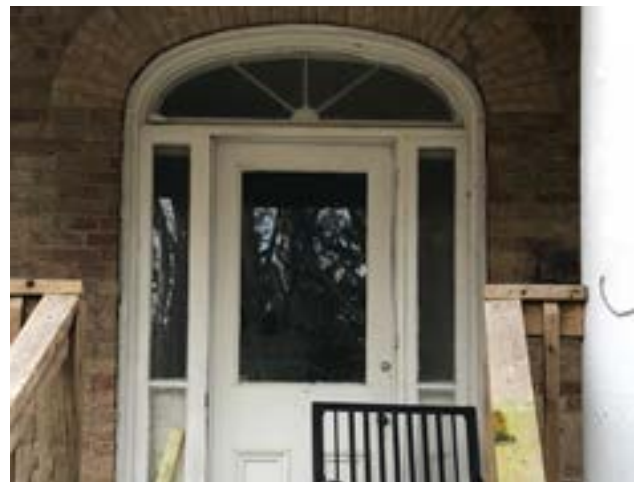
Figure. 2.41. Original front entrance in good condition

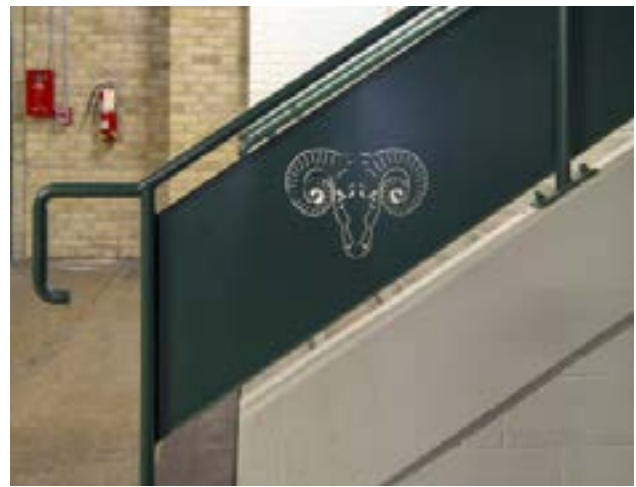
Figure. 3.1. Precedent image of commemoration metal panel. Joey Giaimo with ERA Architects.

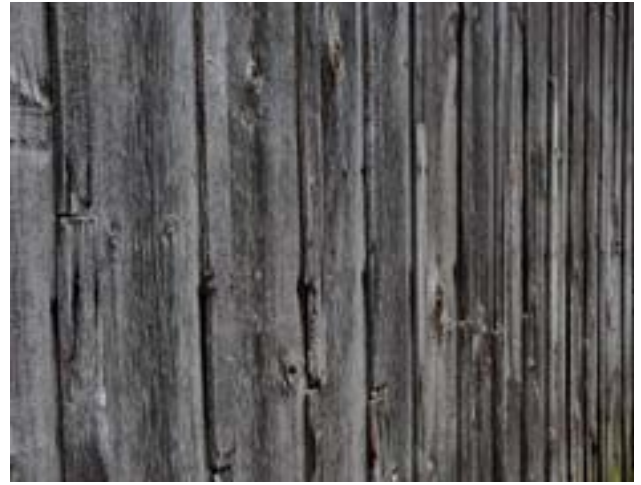
Figure. 3.4. Typical condition of wood at existing driveshed

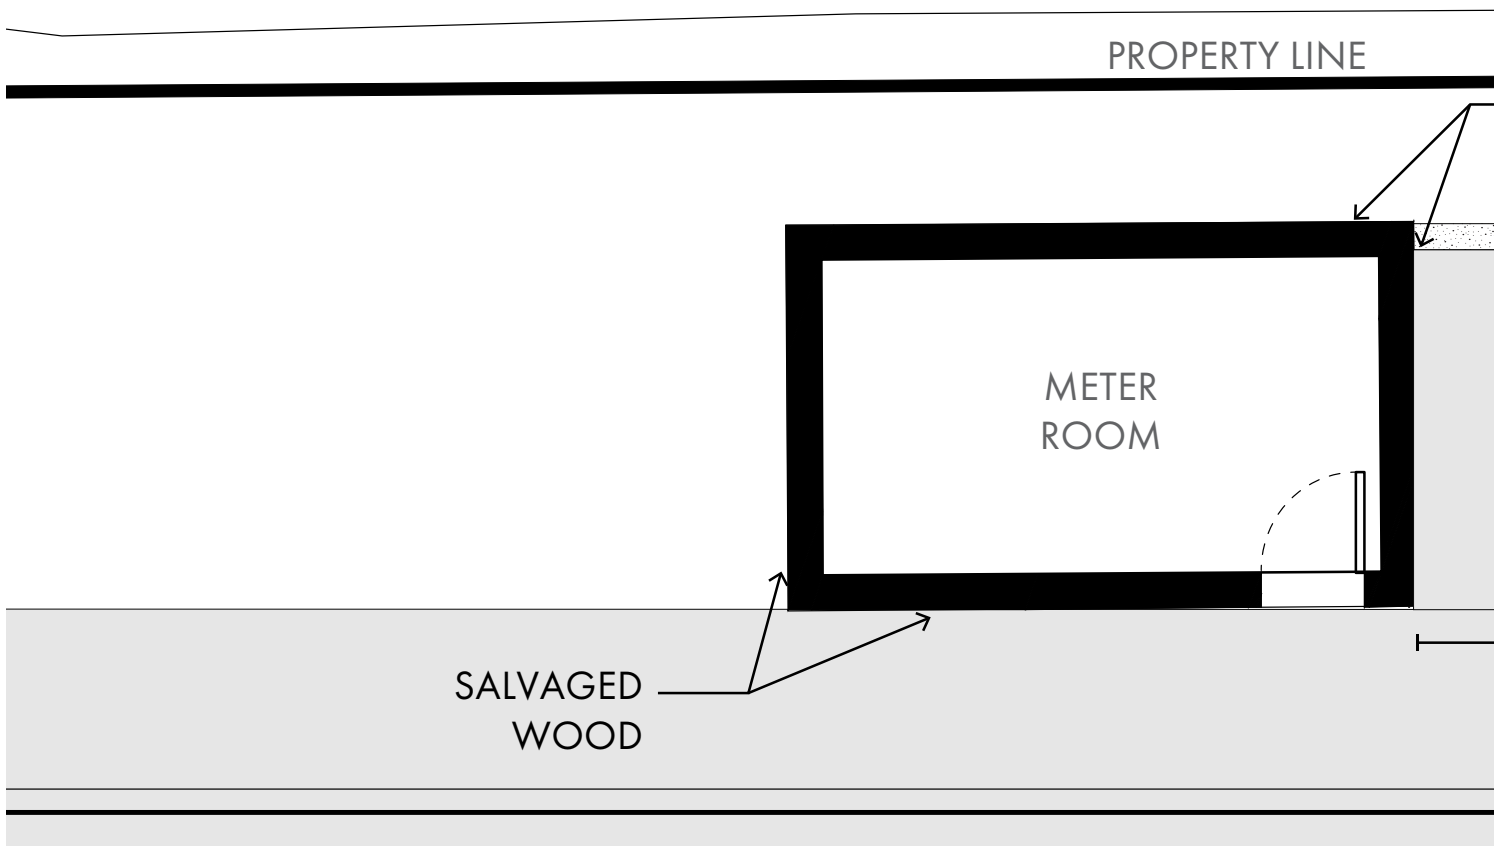
Figure. 3.5. Plan of commemoration installation, schematic design

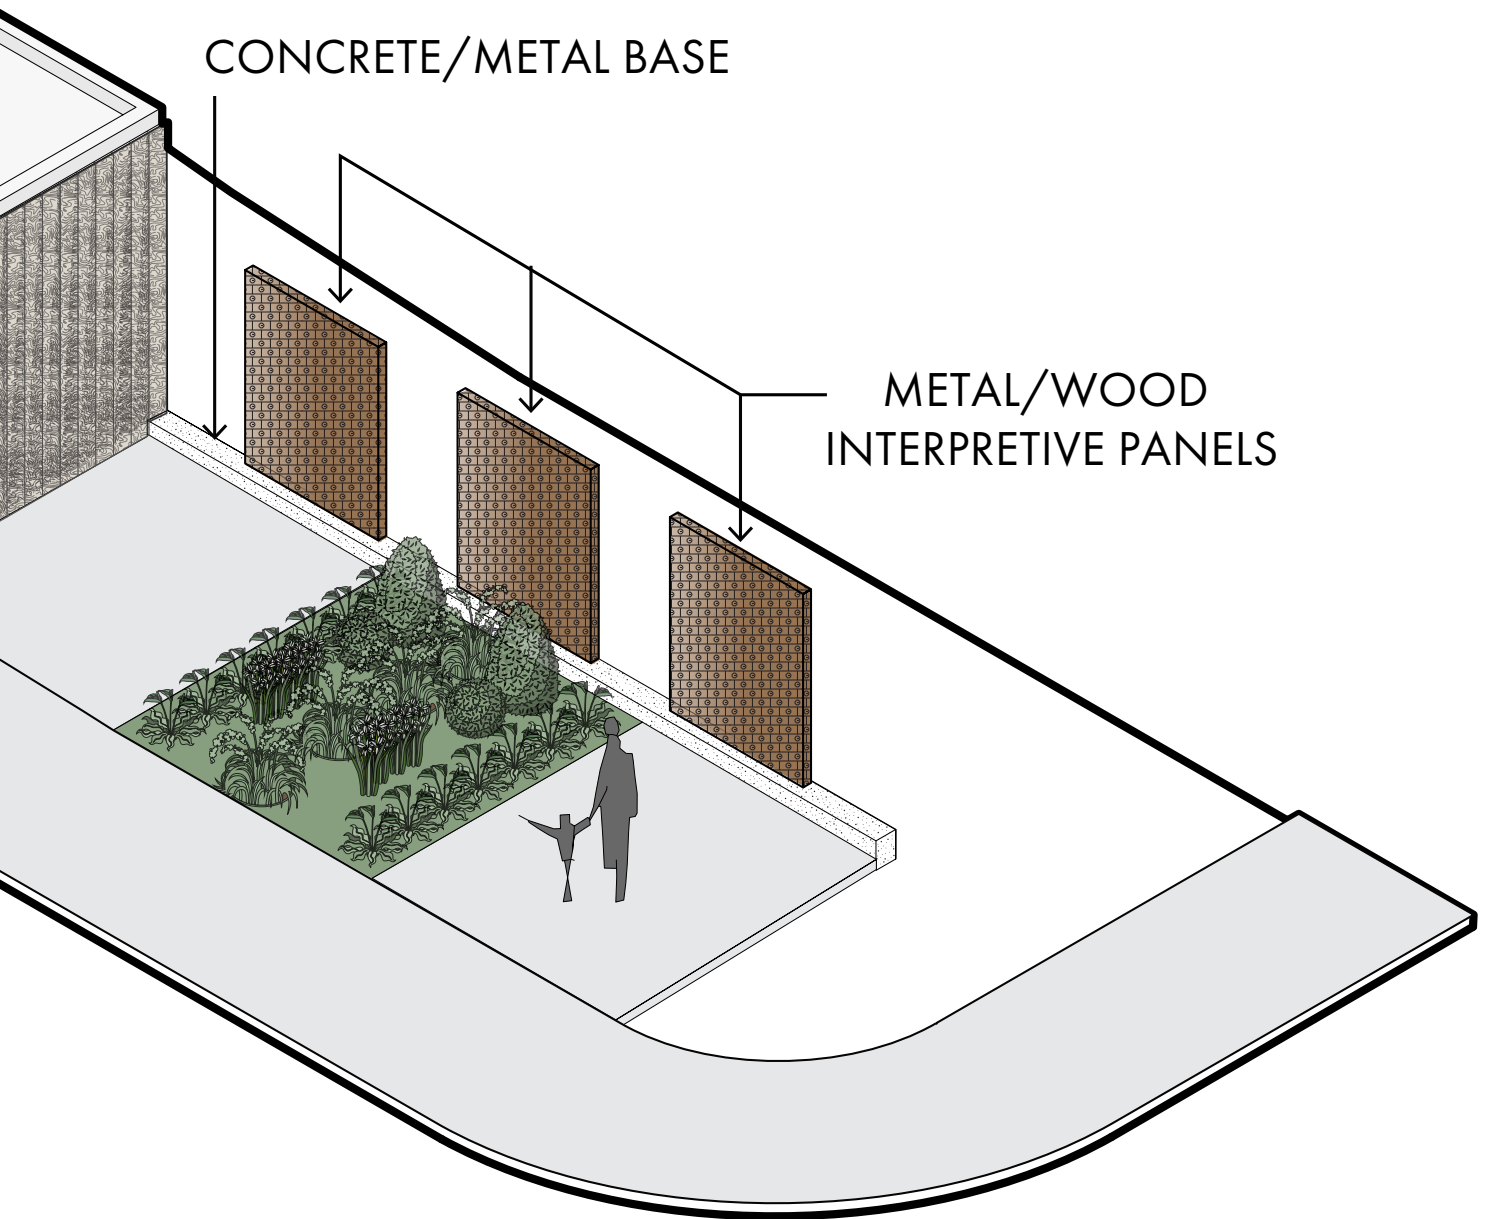
## 3.2 EXTERIOR RECOMMENDATIONS

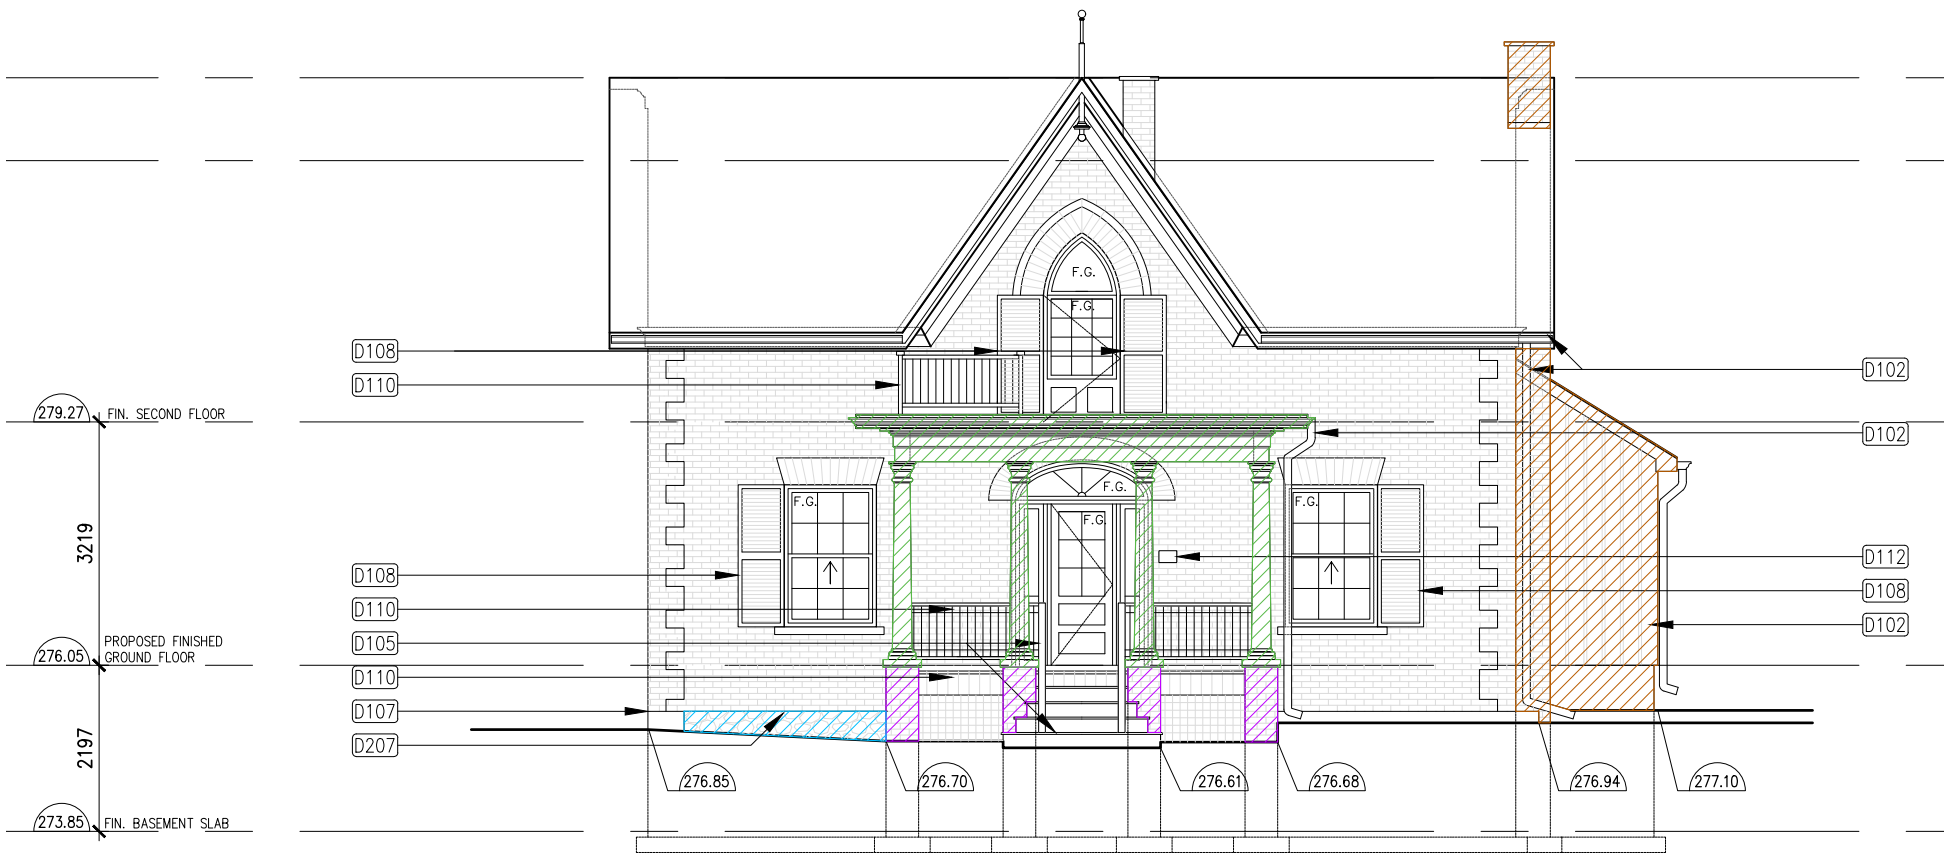
Figure 3.9. Conservation demolition, north elevation, 1:100

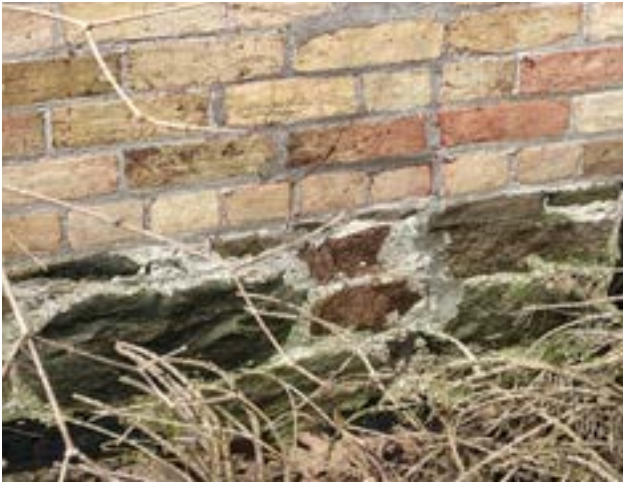
Figure. 3.17. Detail of fieldstone from existing foundation

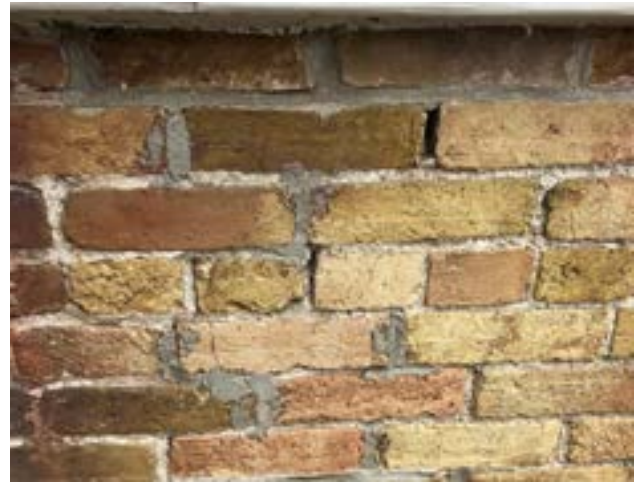
Figure. 3.20. Incompatible mortar to be removed

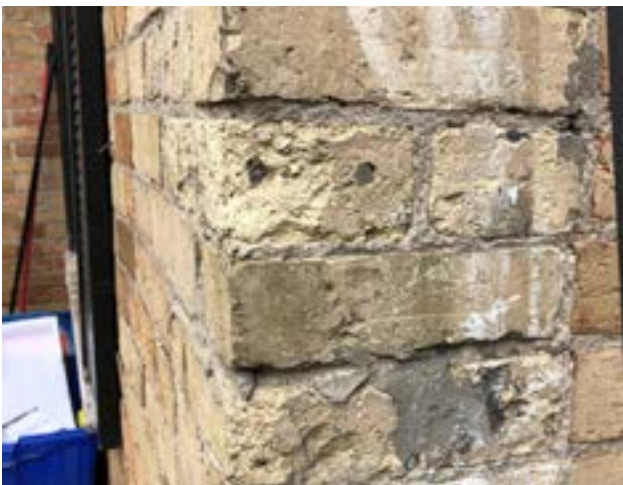
Figure. 3.19. Spalled & cracked brick to be removed & replaced

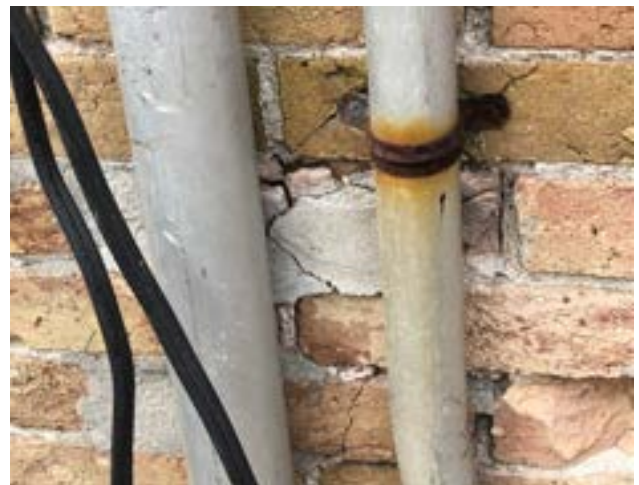
Figure. 3.22. Spalled & cracked brick to be removed & replaced

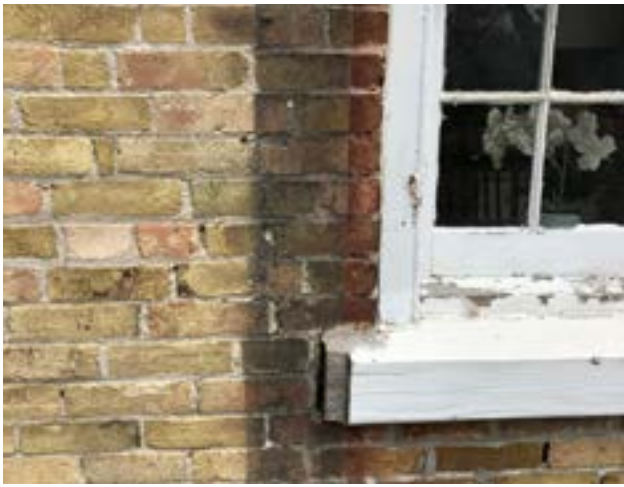
Figure. 3.23. All original masonry to be cleaned

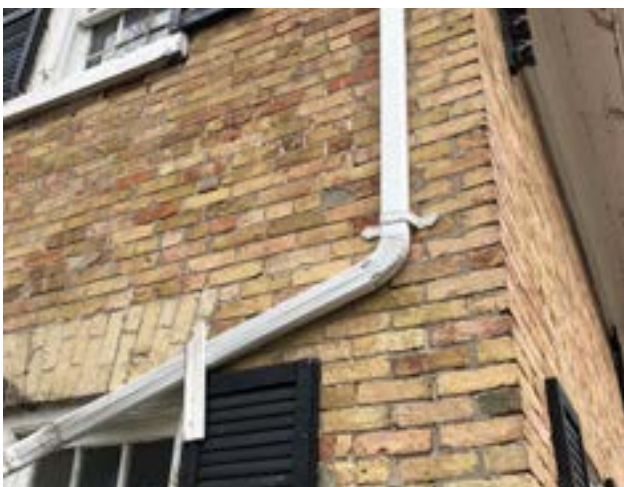
Figure. 3.25. Eavestroughs and downspouts to be replaced

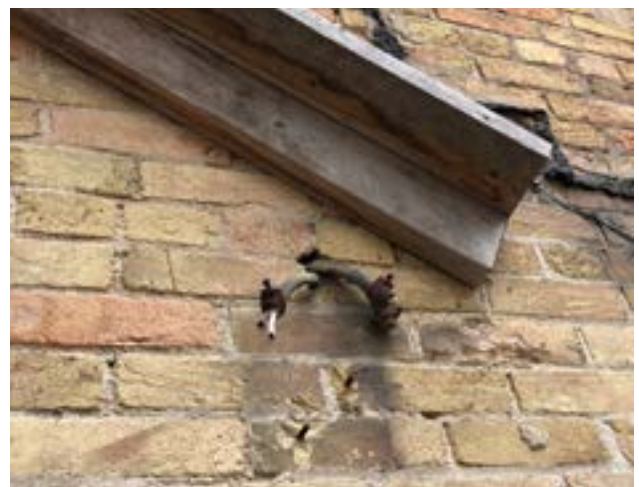
Figure. 3.28. Detail of extraneous items to be removed

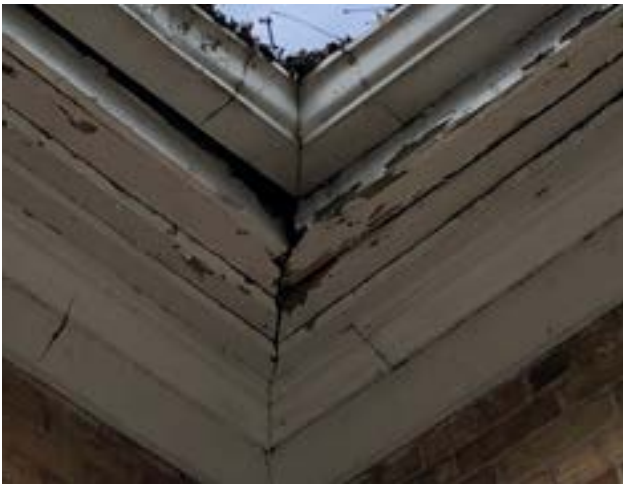
Figure. 3.29. Original wood fascia to be replaced or repaired & repainted
