## CONSERVATION PLAN

### **Gould Estate**

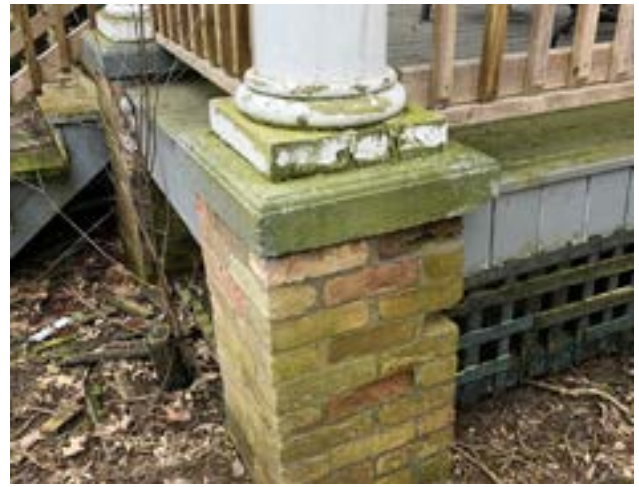
Figure. 3.32. Cracked original brick & wood column bases to be replaced

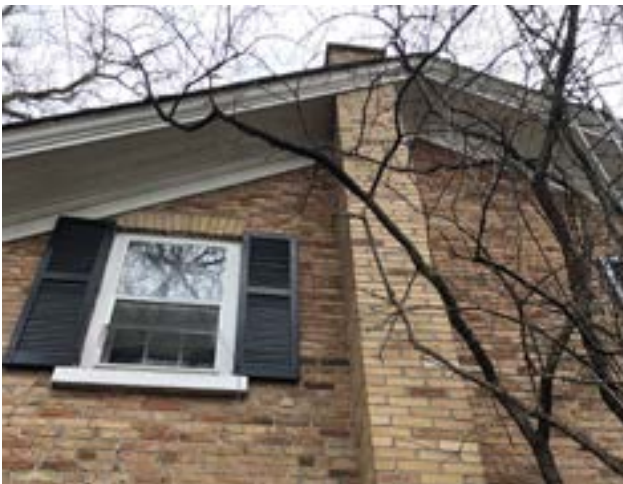
Figure. 3.30. Incompatible existing chimney is not original and is to be removed

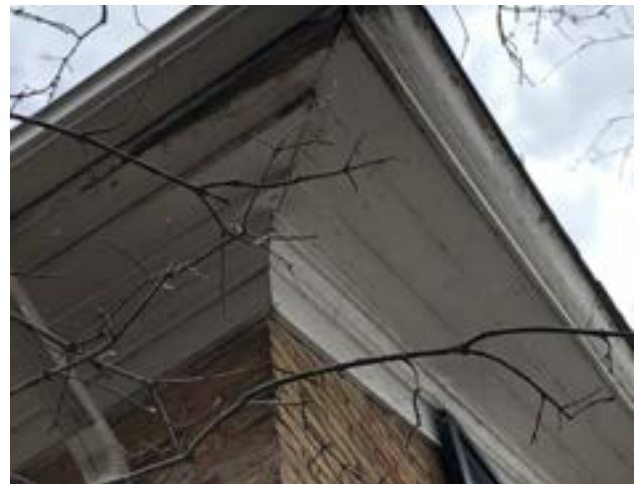
Figure. 3.33. Wood soffit and barge board to be repaired

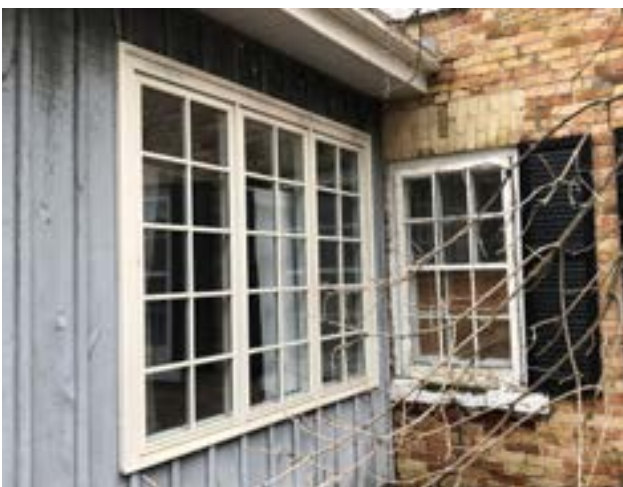
Figure. 3.31. One storey addition to be removed

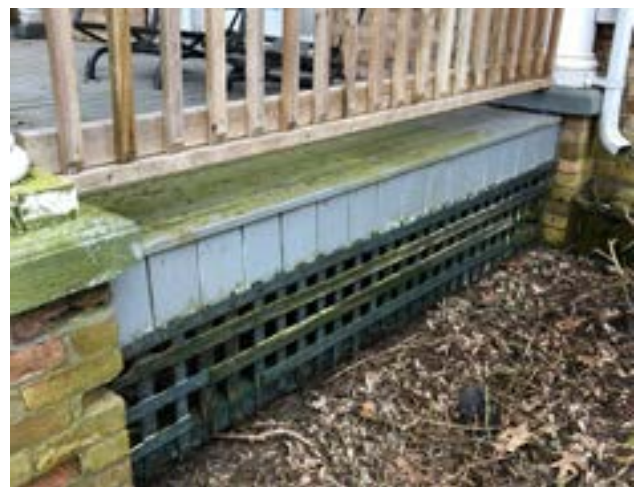
Figure. 3.34. Porch railing, deck & skirting to be removed & replaced

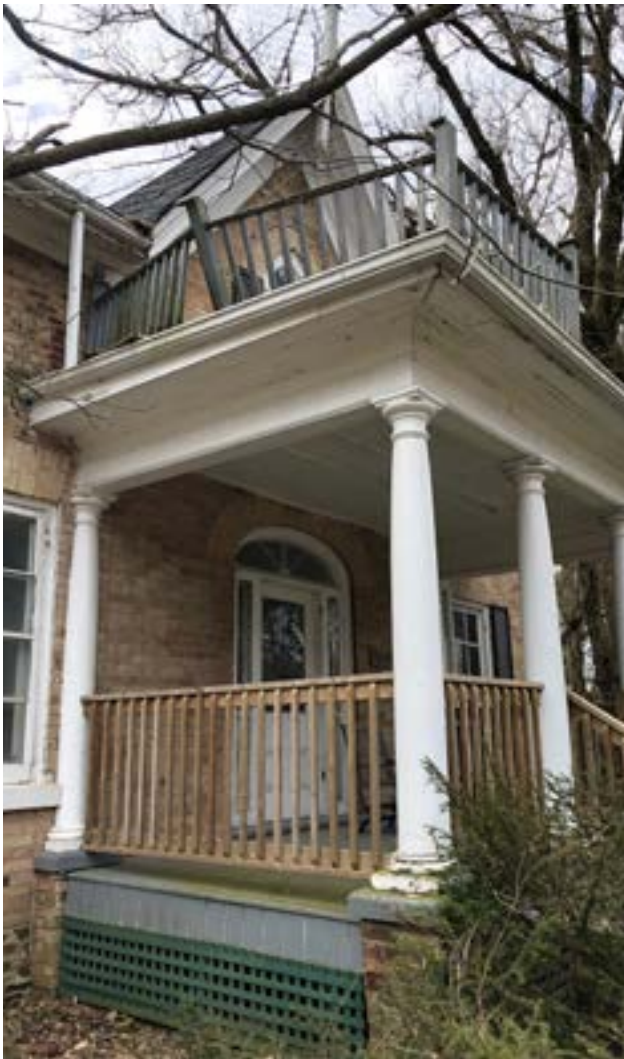
Figure. 3.35. Second floor deck rail to be removed & replaced

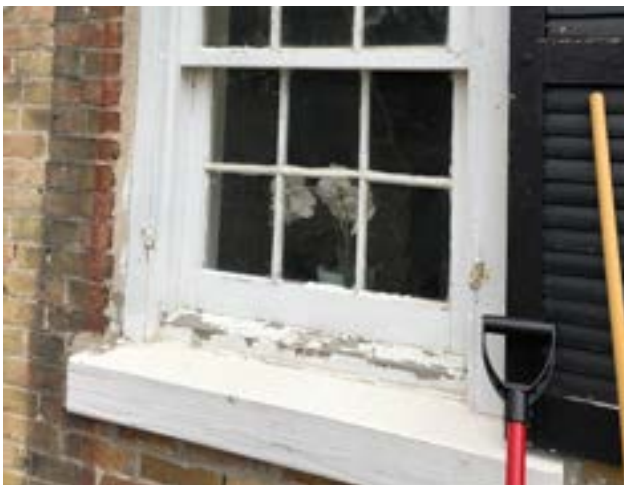
Figure. 3.36. All original windows to be fully restored & sills to be replaced

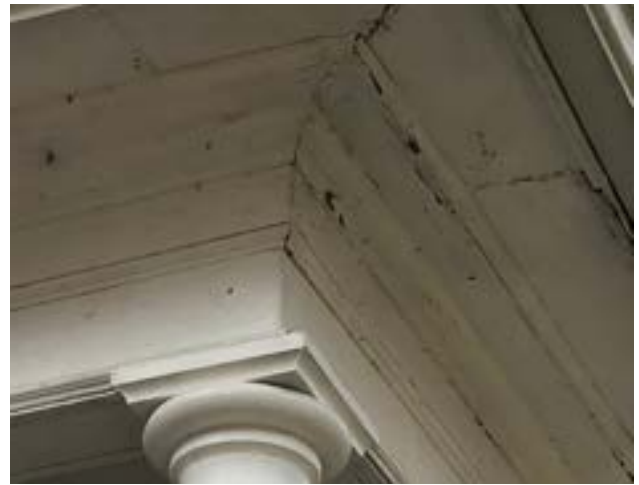
Figure. 3.37. All original wood elements at porch to be repaired and repainted

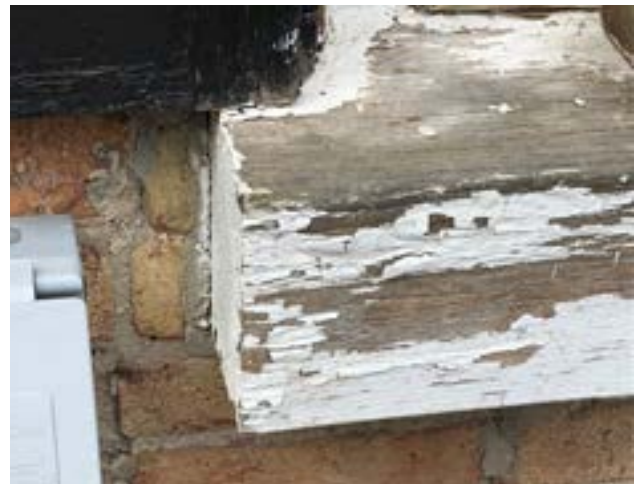
Figure. 3.38. All original windows to be fully restored & sills to be replaced

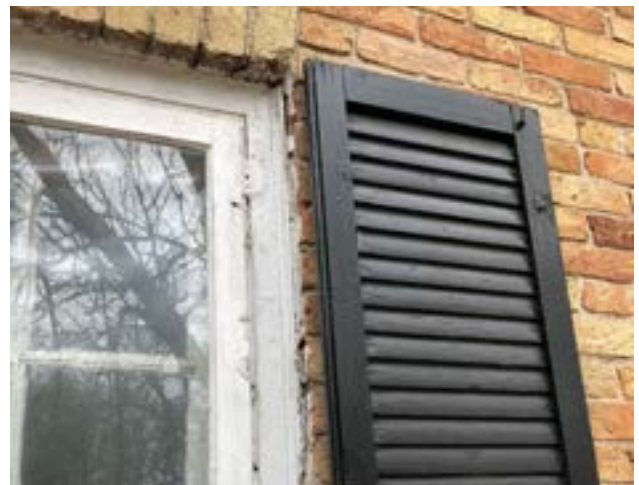
Figure. 3.39. Shutters are not original and are to be removed; brick replaced; mortar repointed

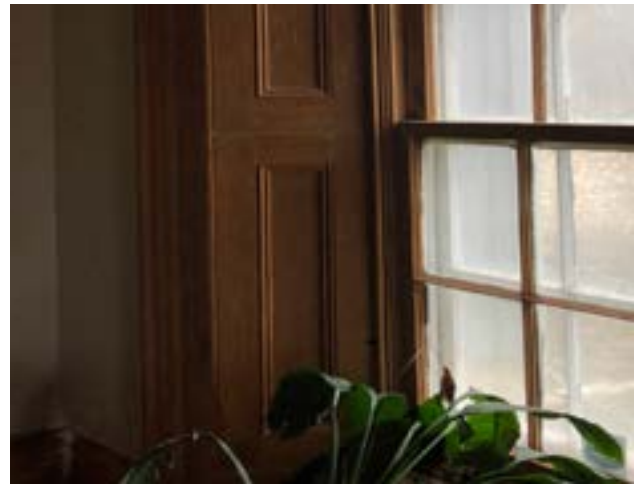
Figure. 3.42. Original window reveals & sills to be preserved, repaired & repainted

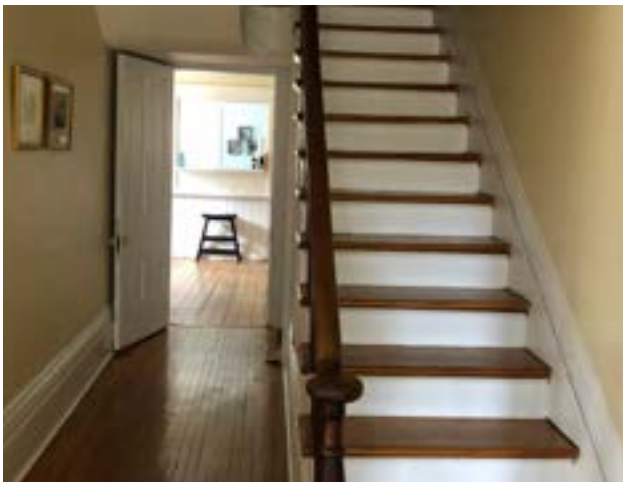
Figure. 3.40. Original stairs to be retained, stabilized, resealed & repainted

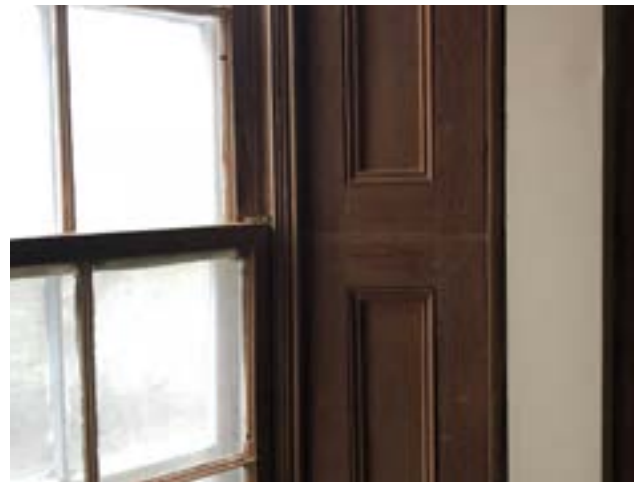
Figure. 3.43. Original window reveals & sills to be preserved, repaired & repainted

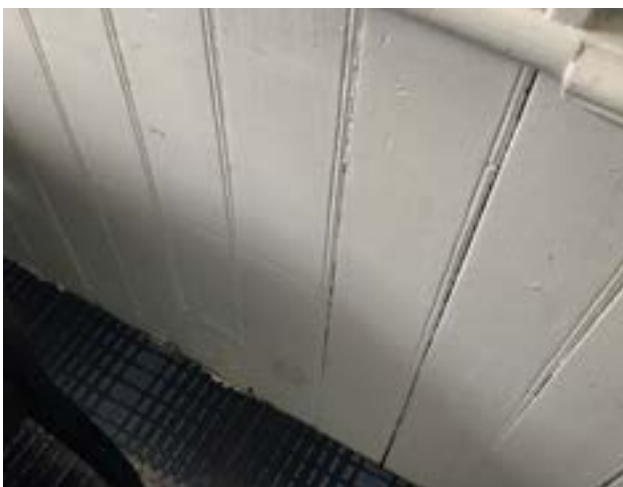
Figure. 3.41. Original wainscoting to be preserved, repaired & repainted

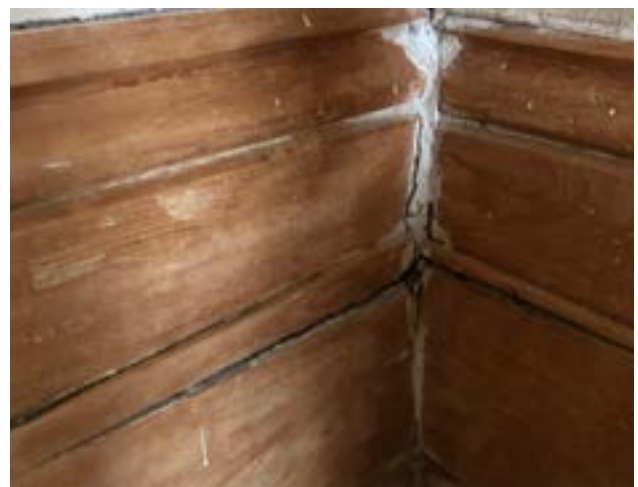
Figure. 3.44. Original baseboards to be preserved, repaired & repainted

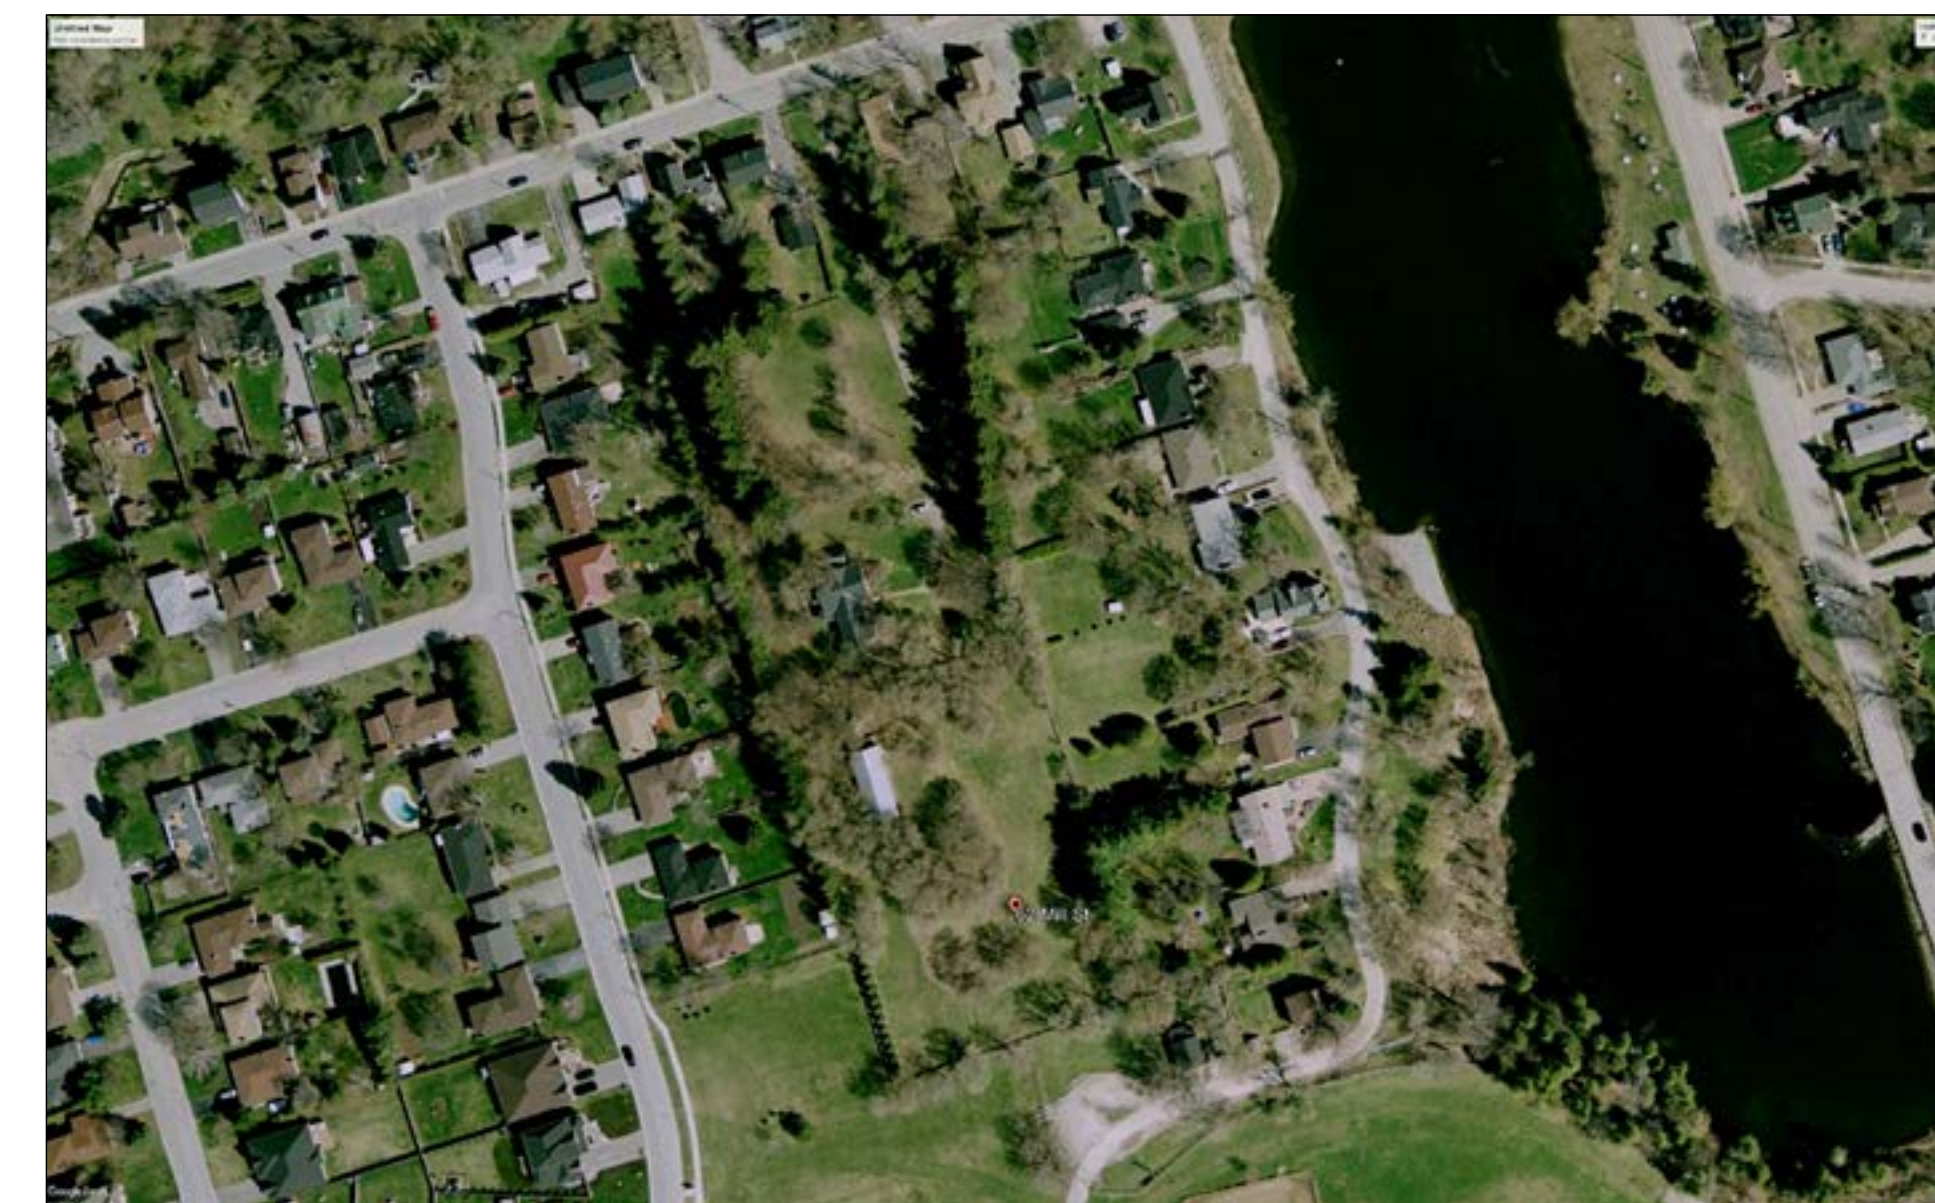
KEYPLAN  
SCALE: N.T.S.

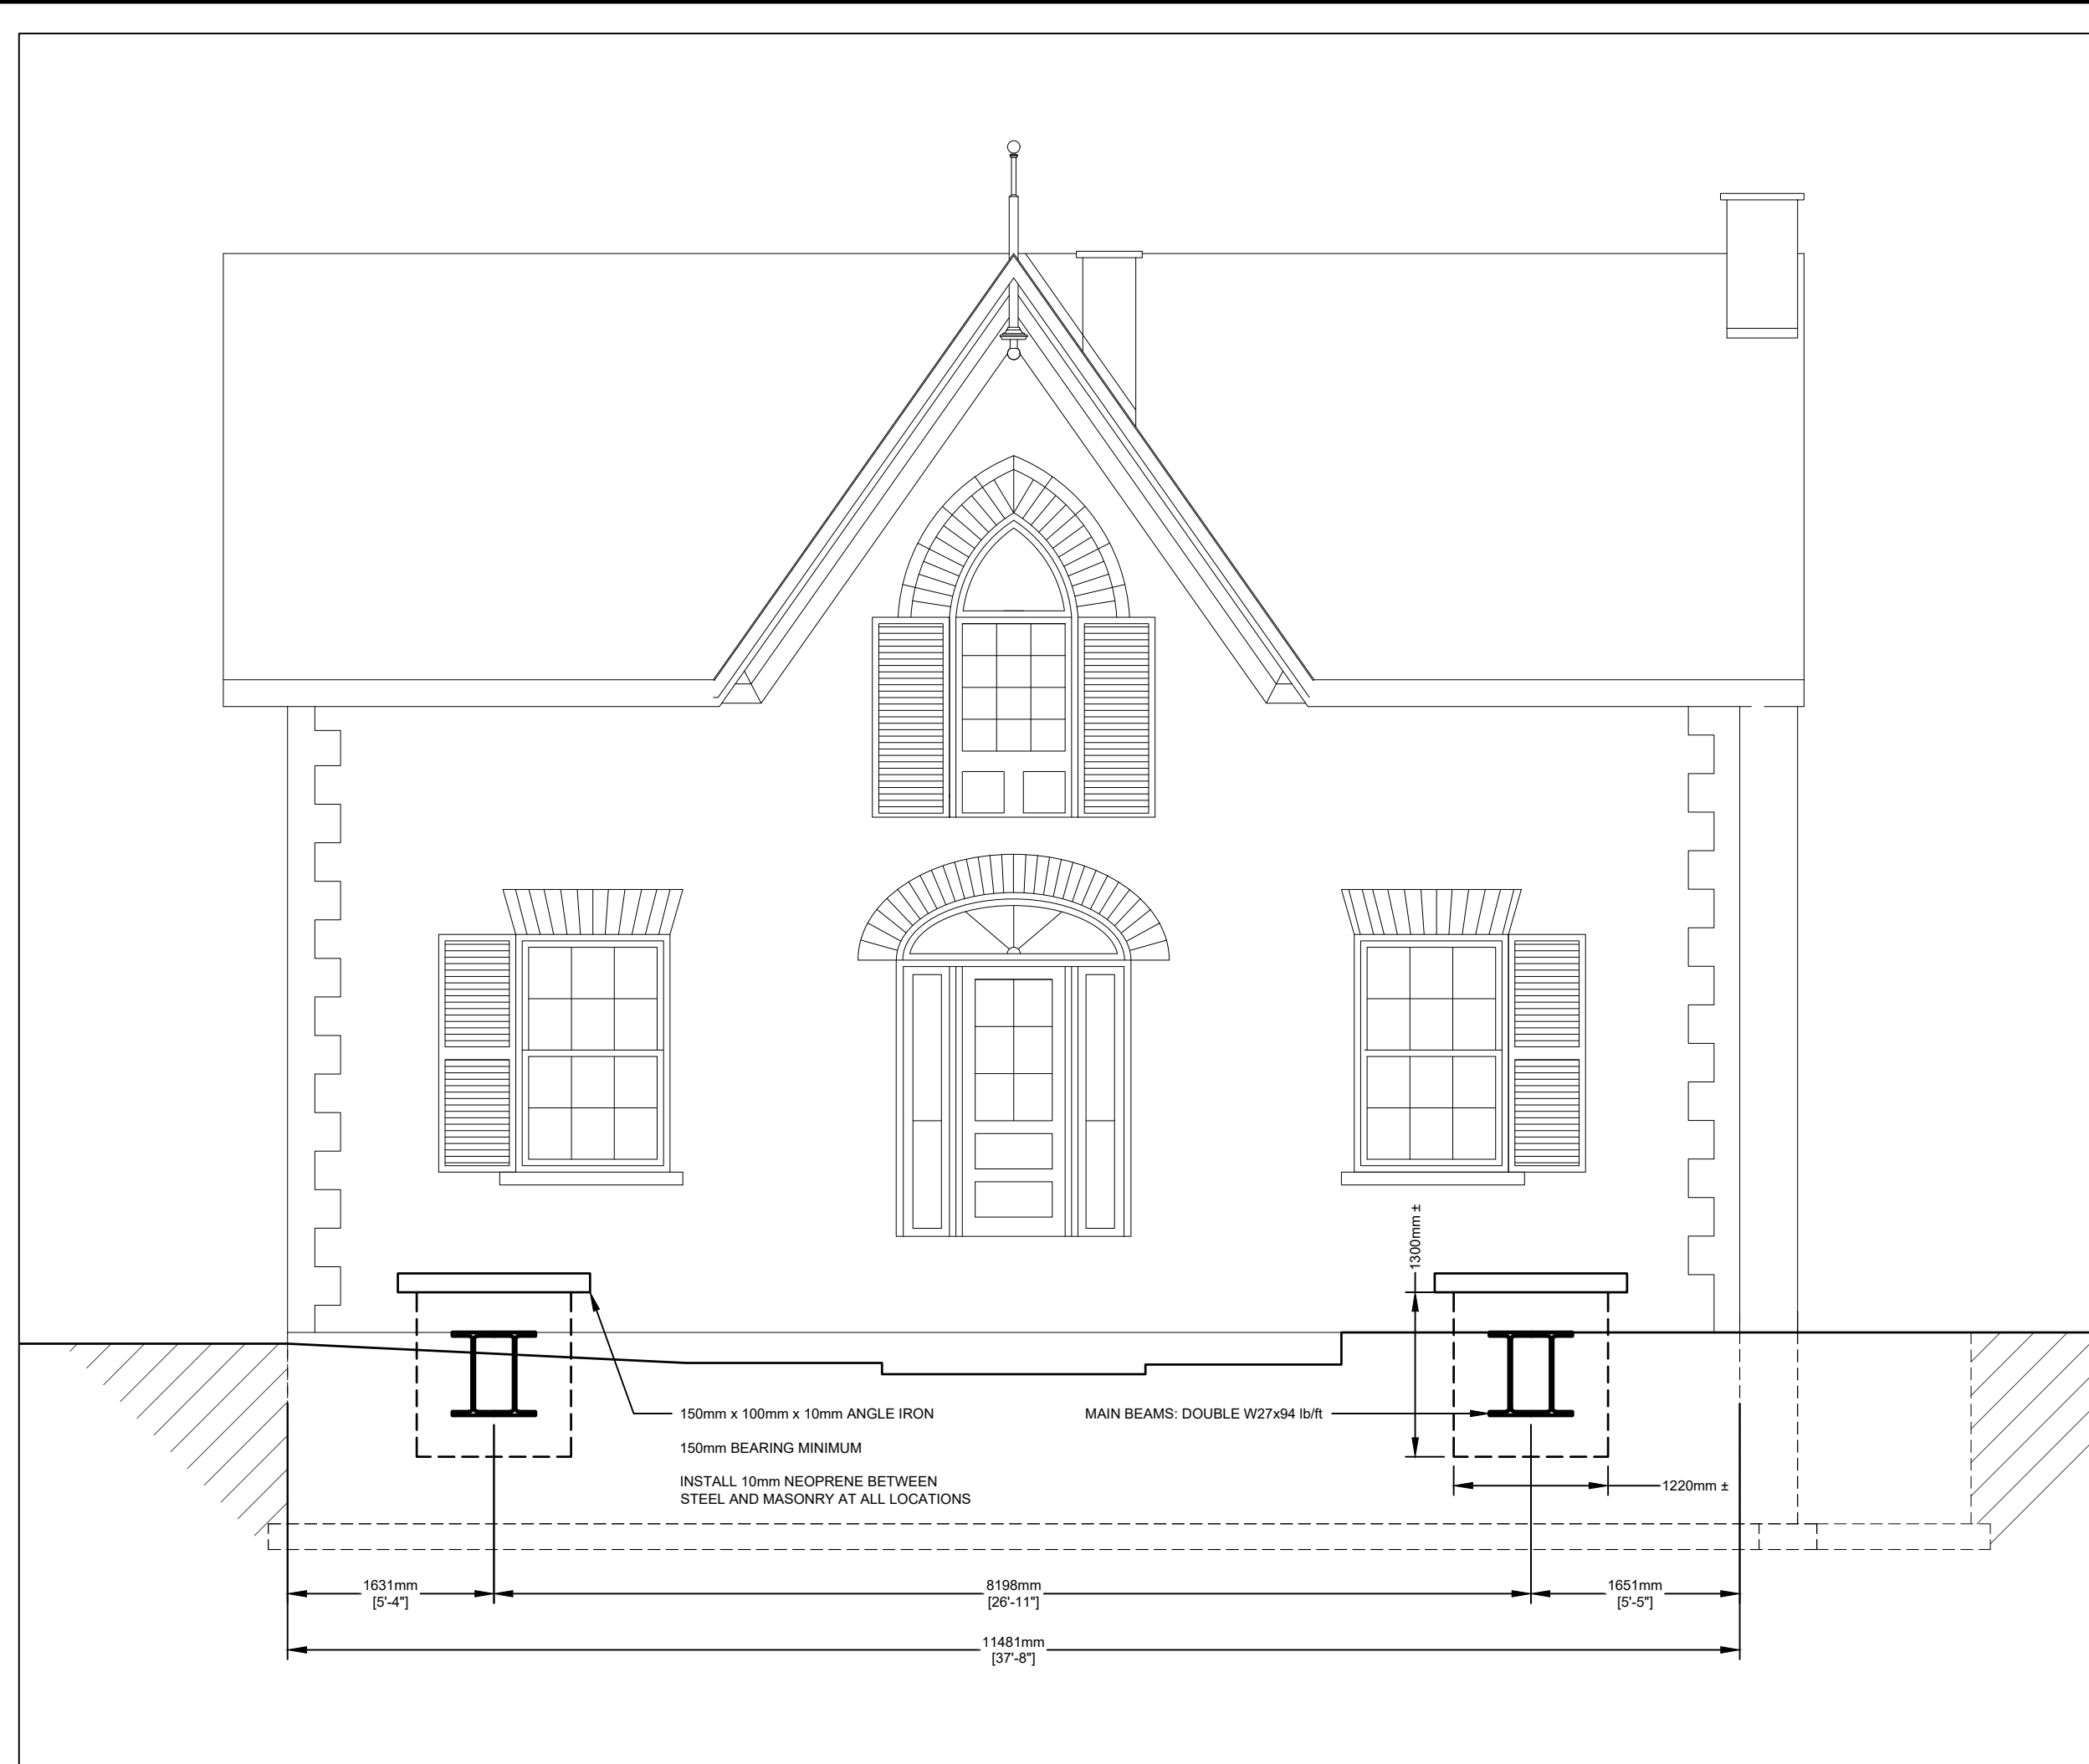
BEAM POCKETS THROUGH FOUNDATION: NORTH ELEVATION

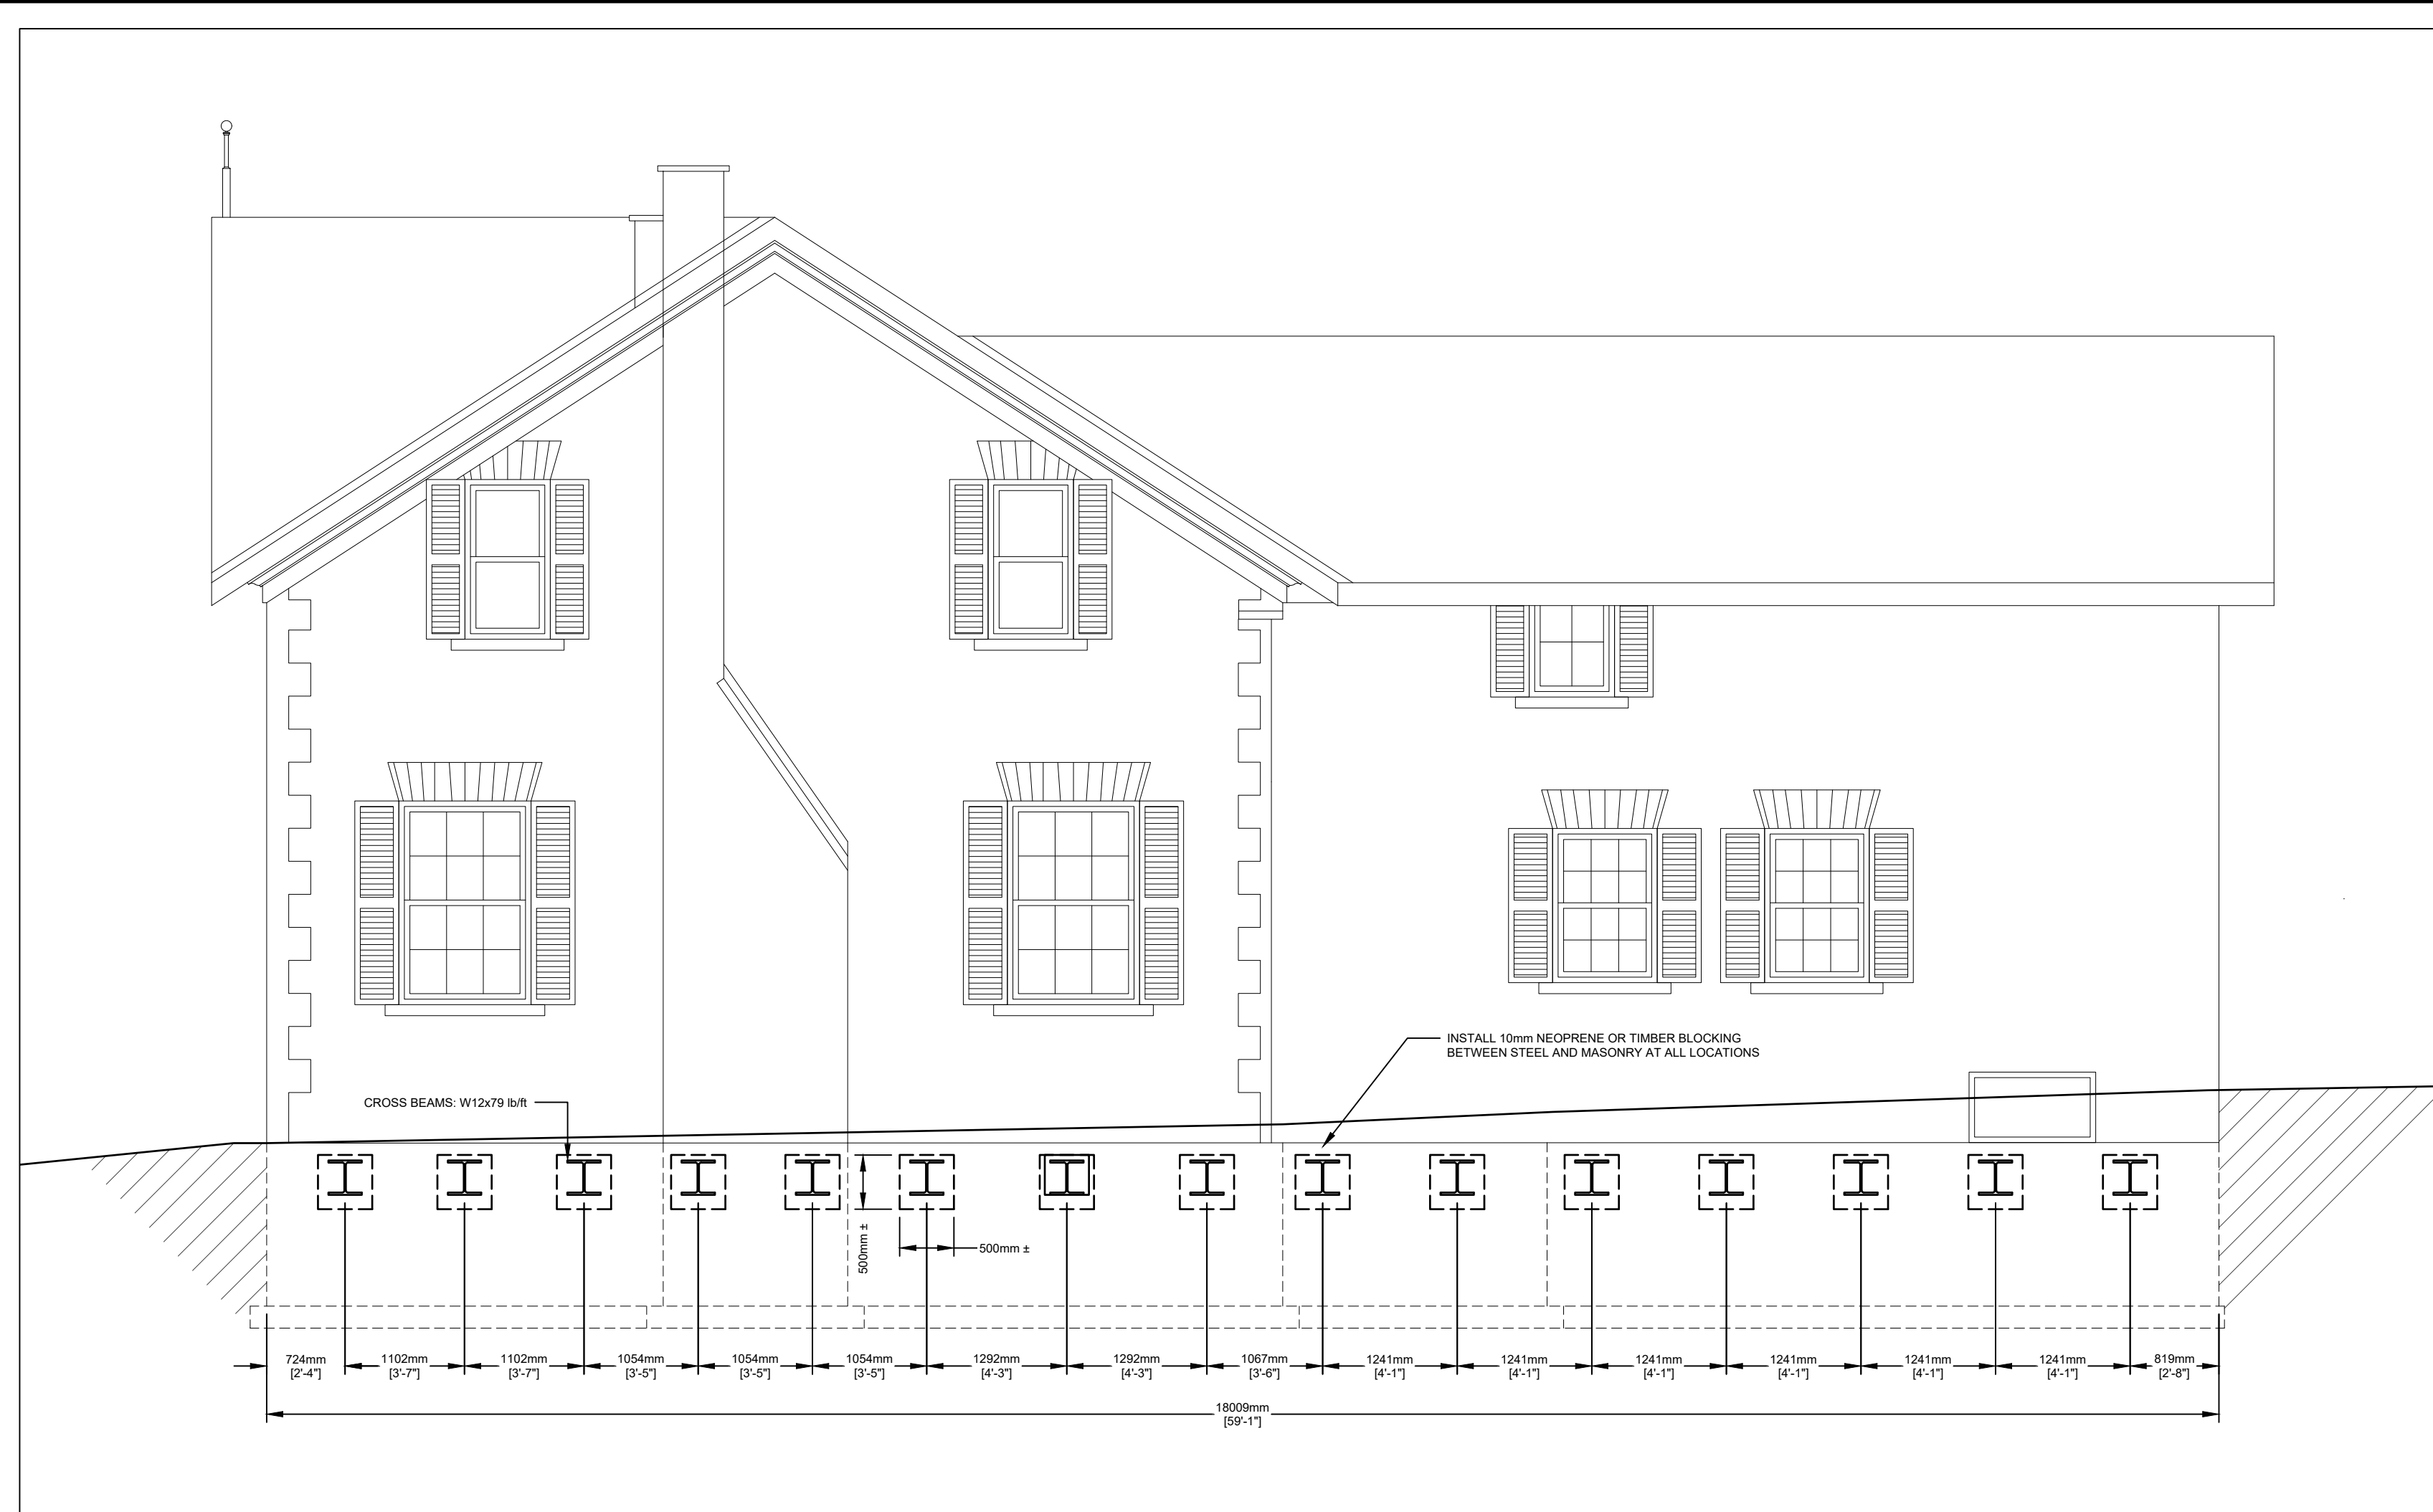
BEAM POCKETS THROUGH FOUNDATION: WEST ELEVATION

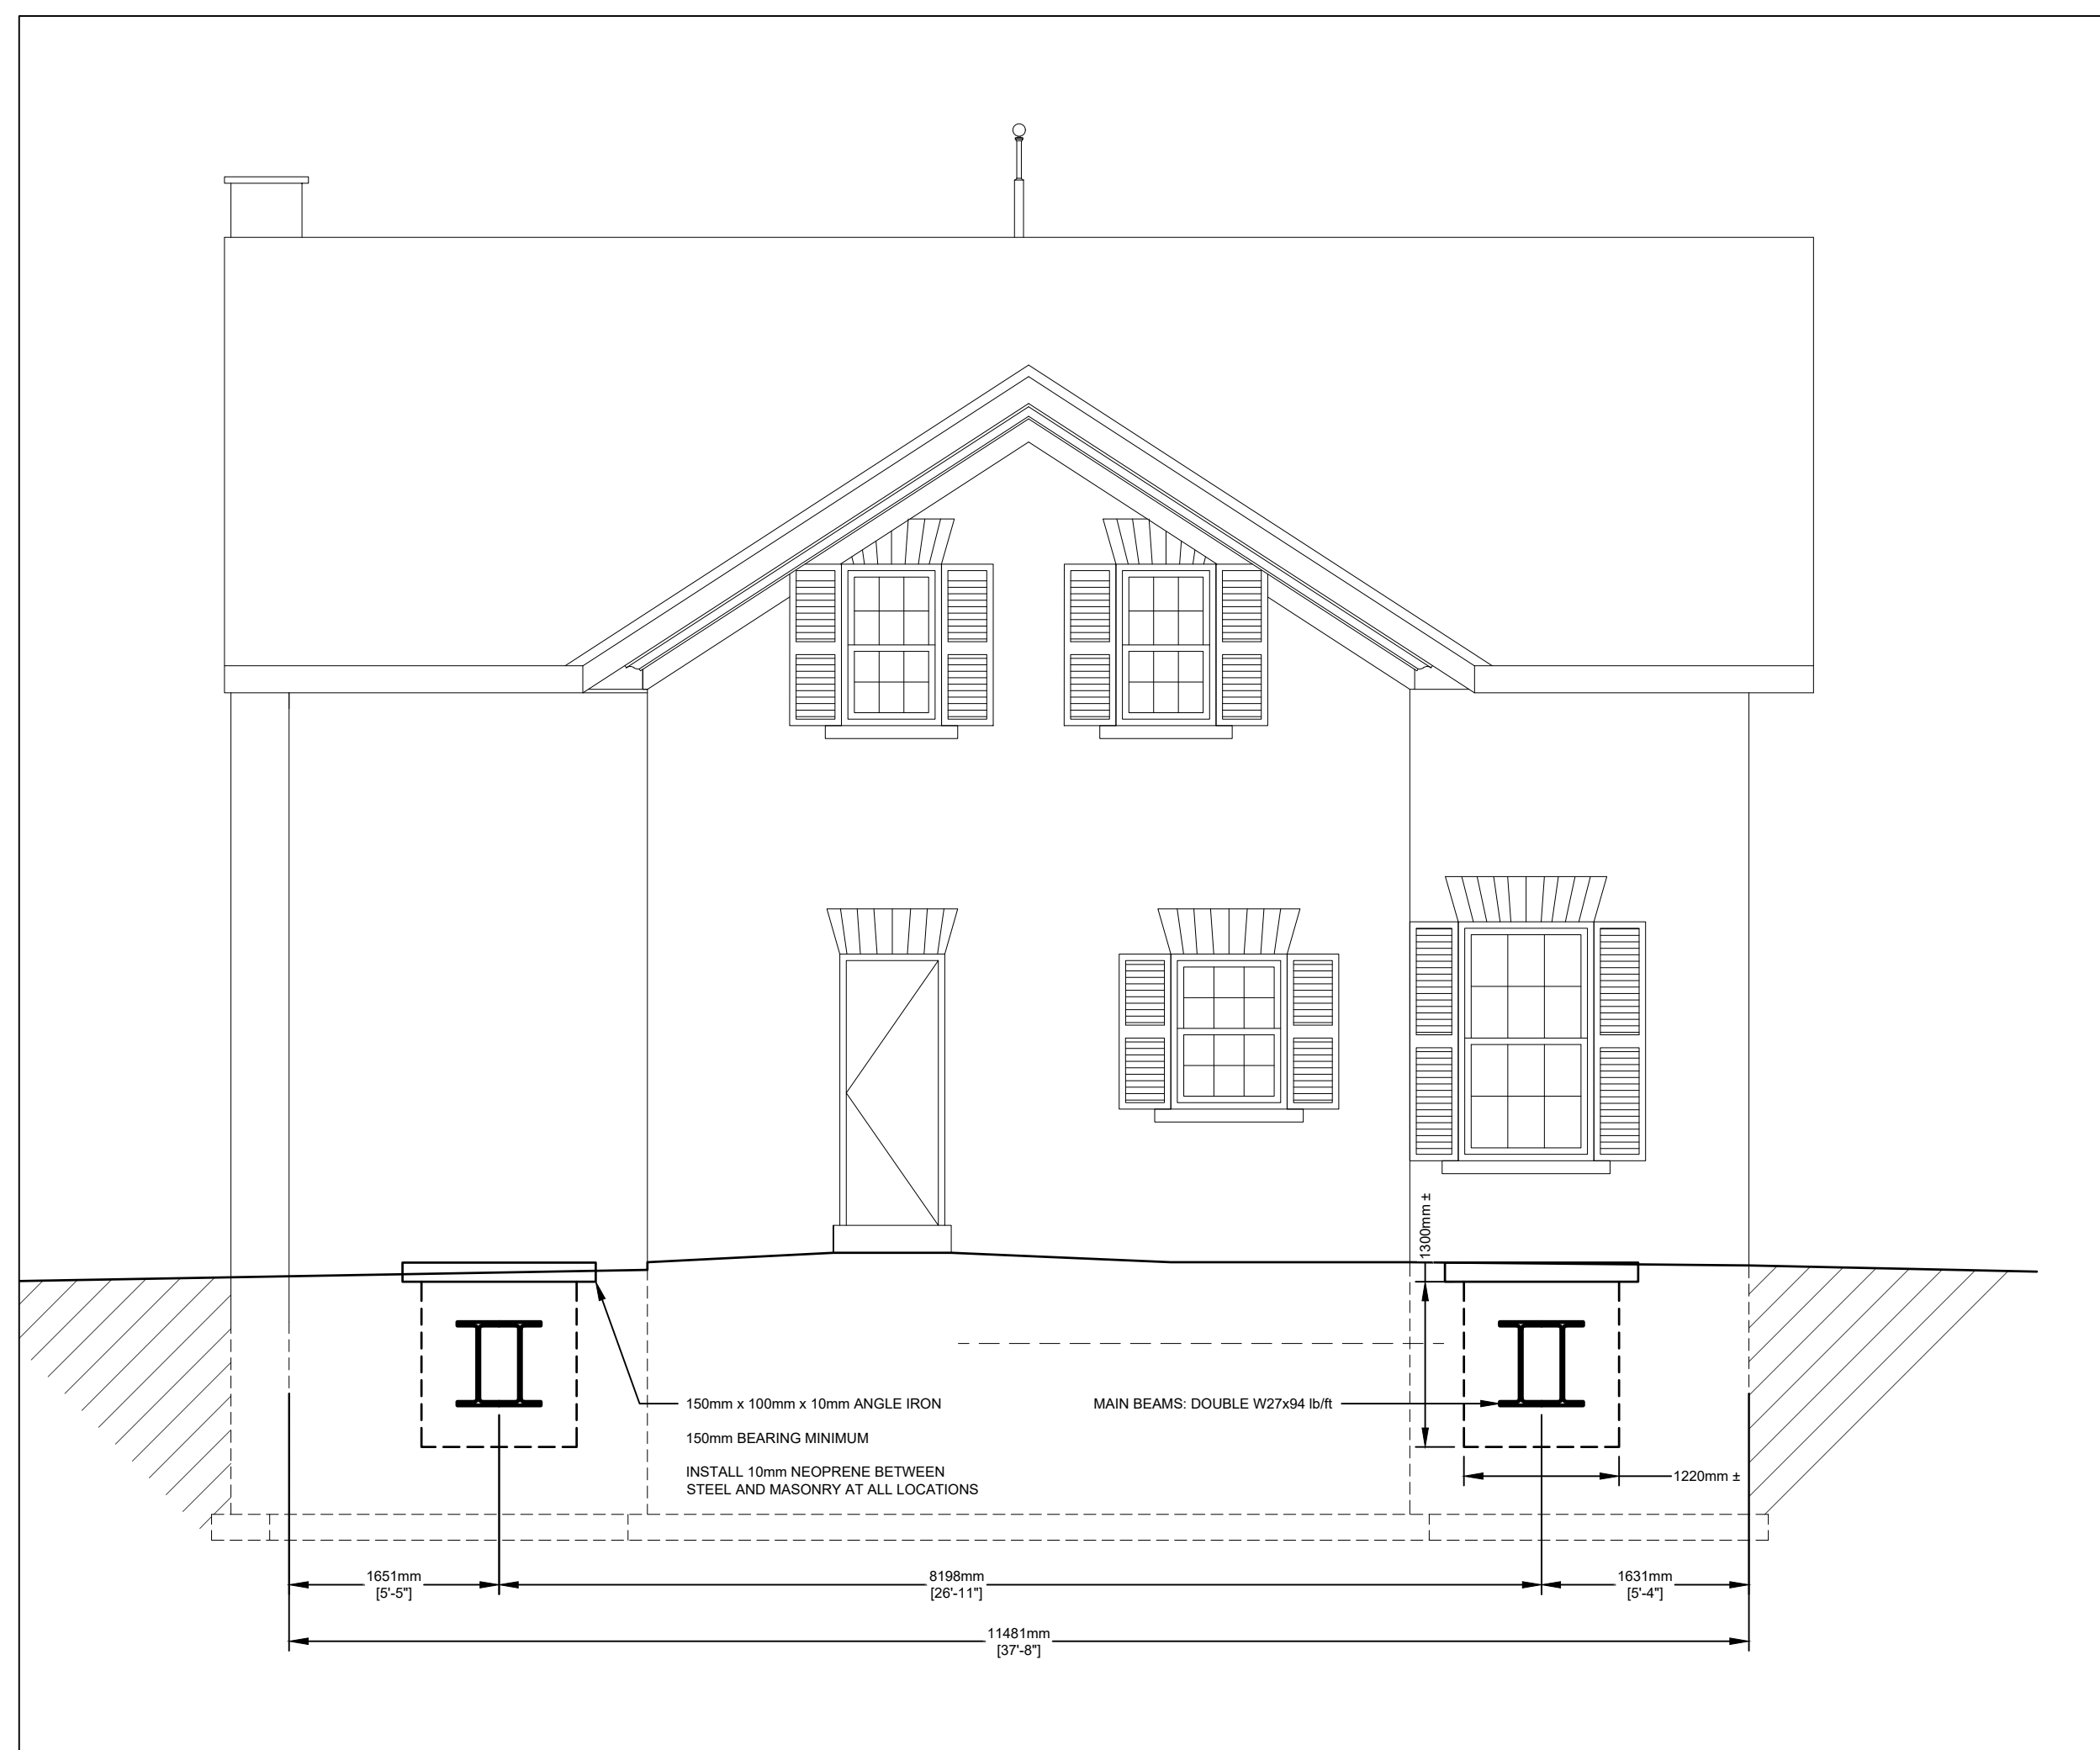
BEAM POCKETS THROUGH FOUNDATION: SOUTH ELEVATION

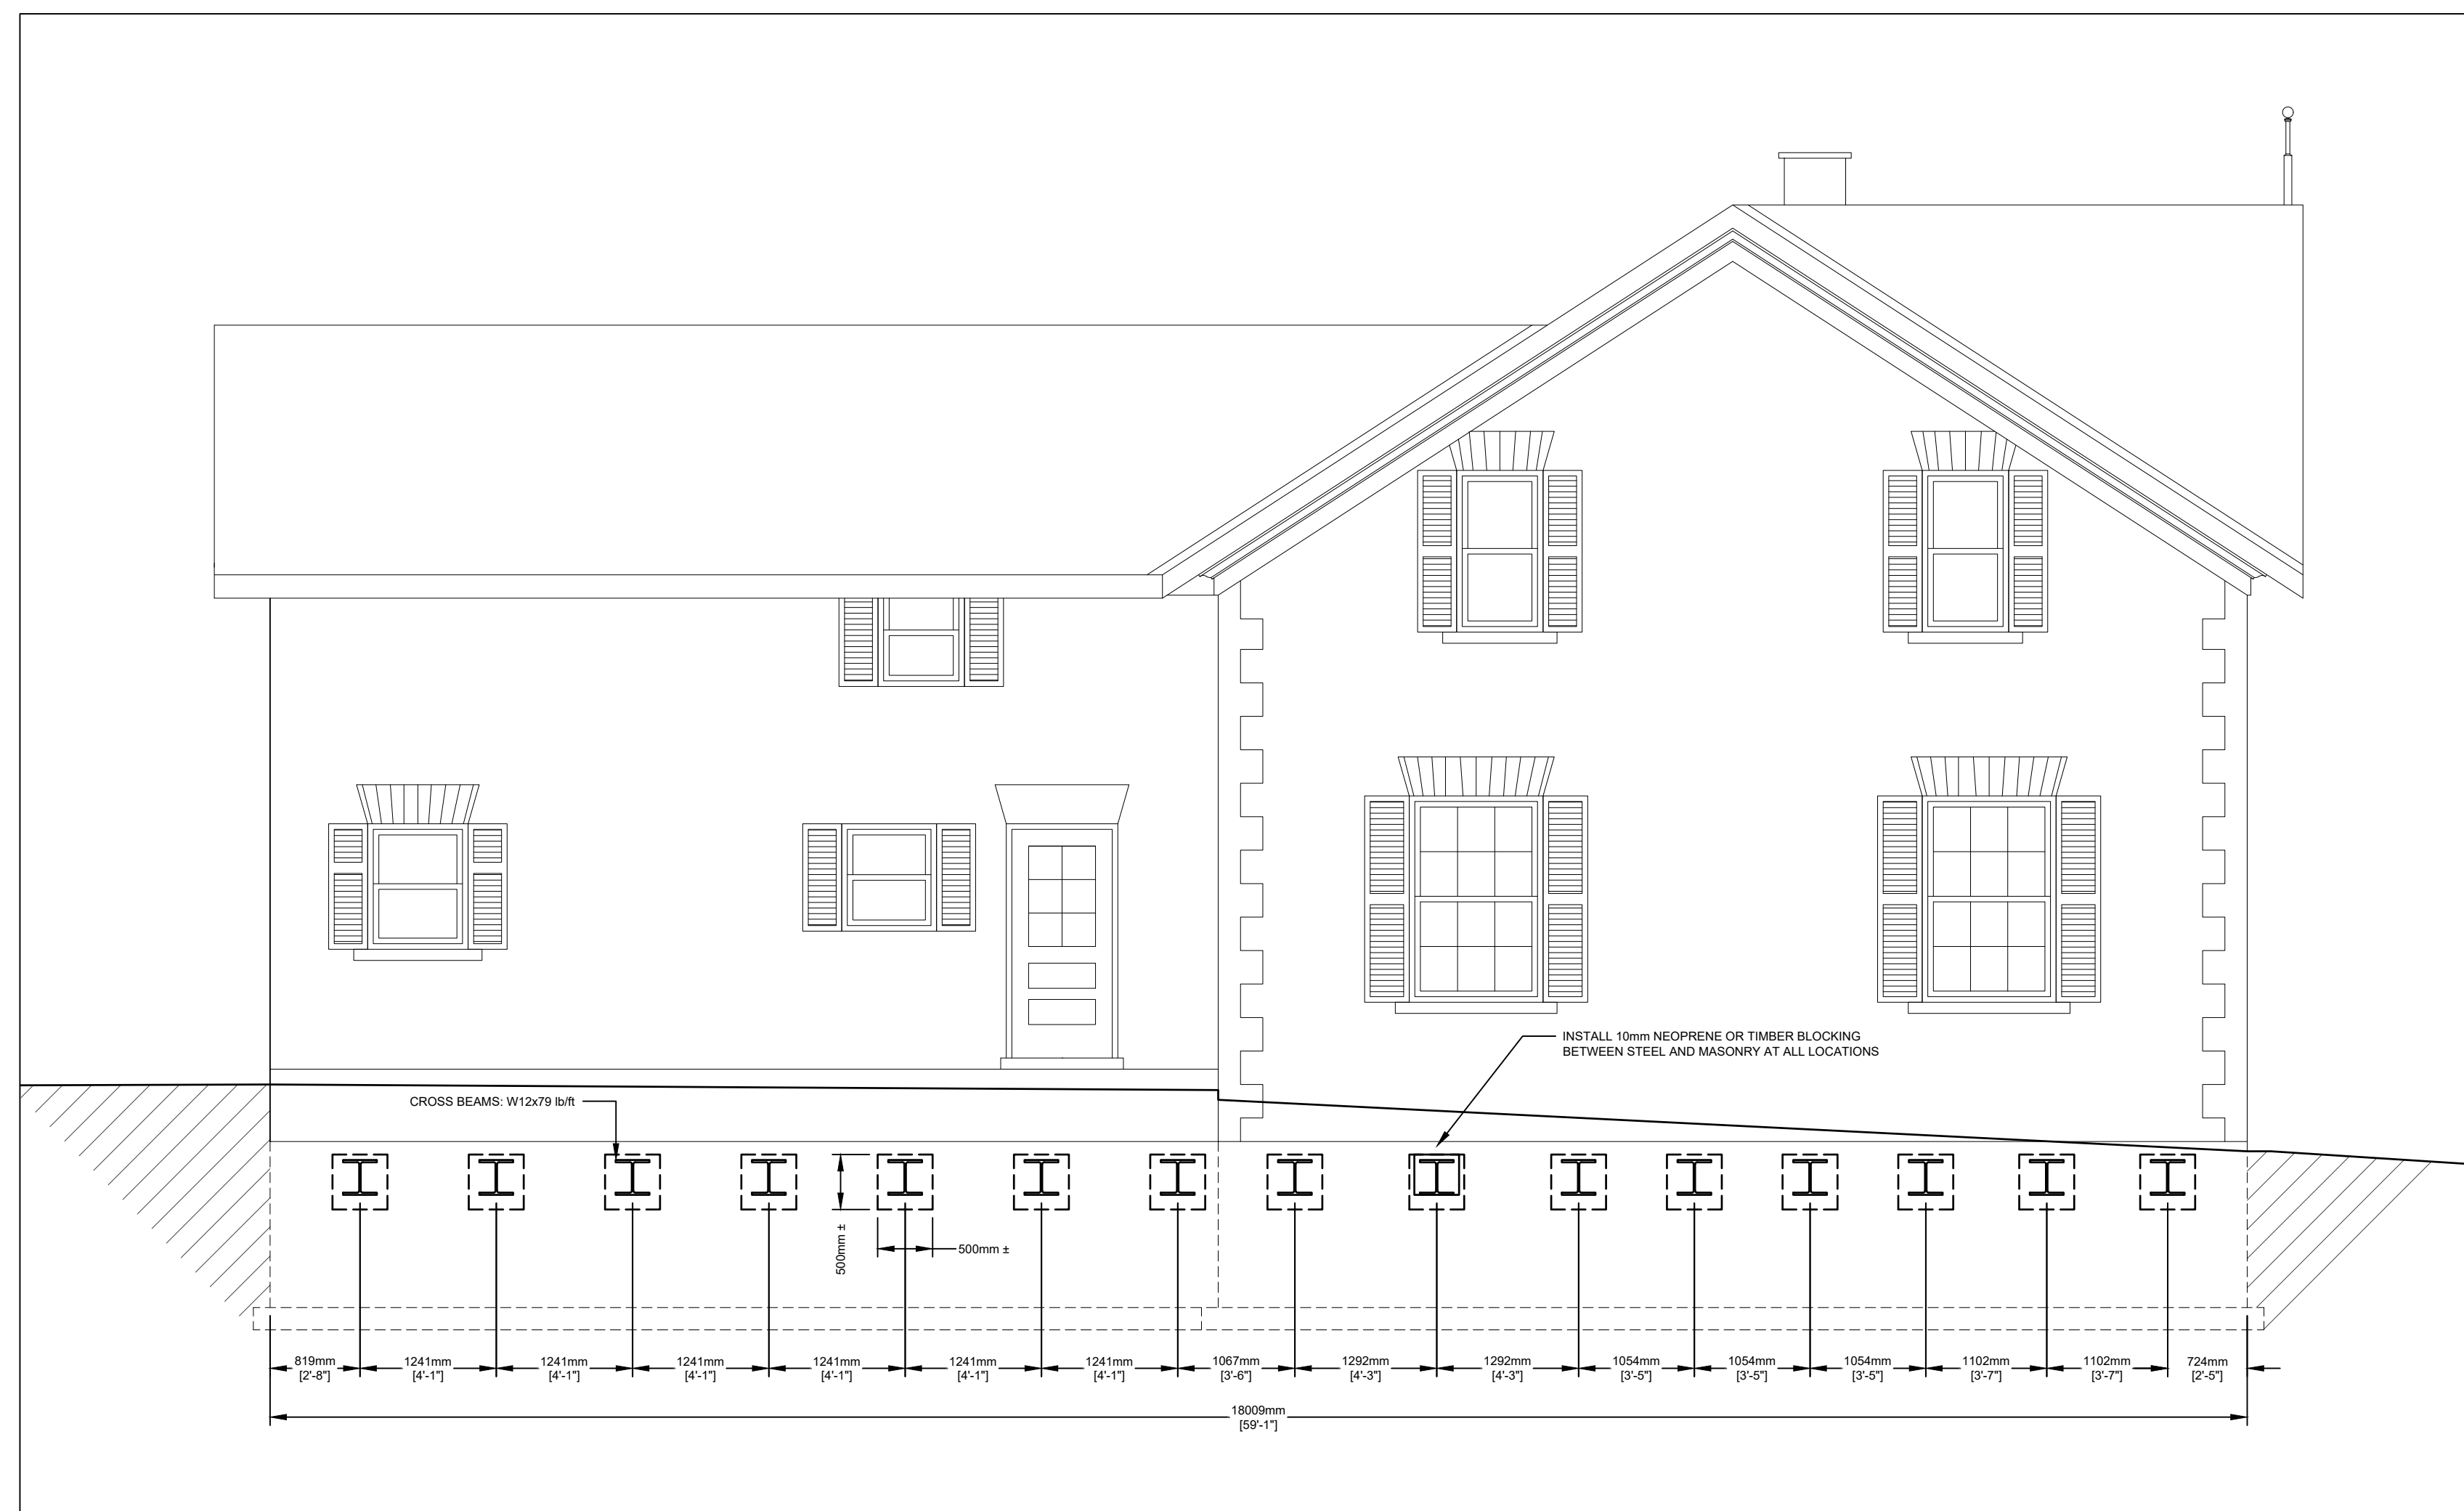
BEAM POCKETS THROUGH FOUNDATION: EAST ELEVATION
