## CONSERVATION PLAN

### **Gould Estate**

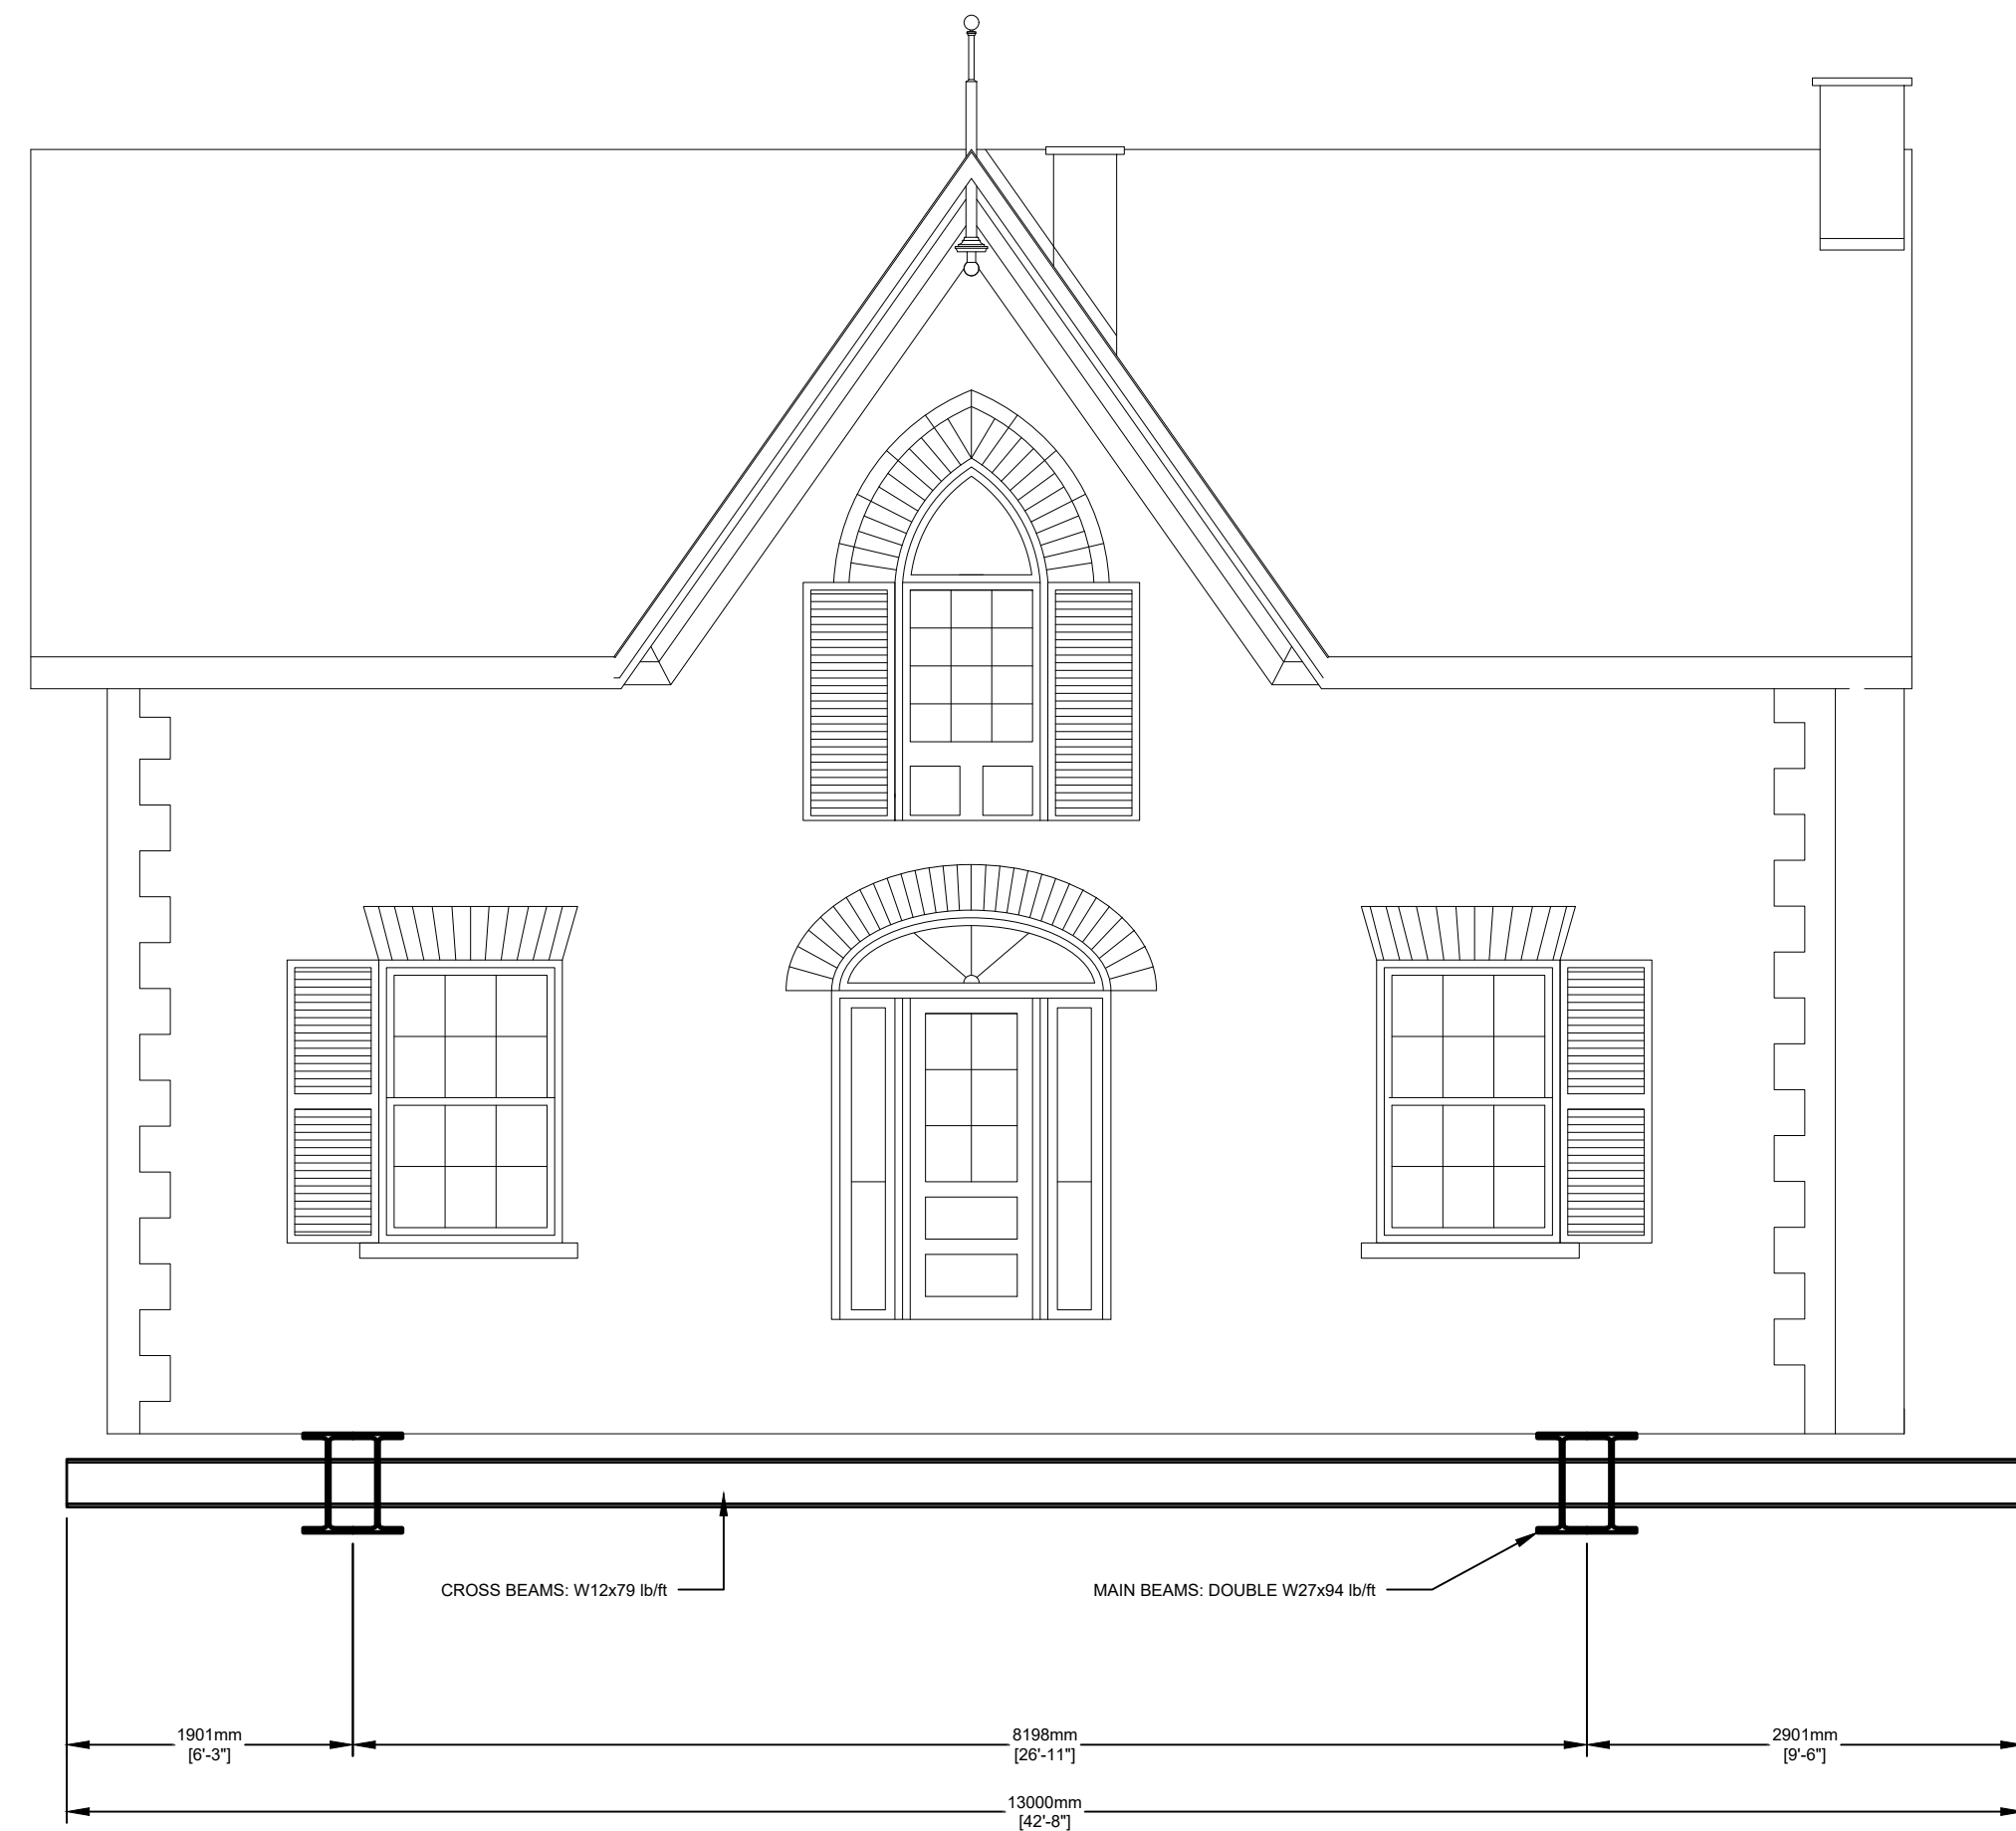
RELOCATION STEEL LAYOUT: NORTH ELEVATION
