**REPORT ON
GEOTECHNICAL INVESTIGATION
150 CEMETERY ROAD
UXBRIDGE, ONTARIO**

**REPORT NO.: 5431W-20-GA
REPORT DATE: JANUARY 12, 2021**

**PREPARED BY
TORONTO INSPECTION LIMITED**

**PREPARED FOR
CORAL CREEK HOMES
1 BROWNSCOMBE CRESCENT
UXBRIDGE, ONTARIO
L9P 1X9**

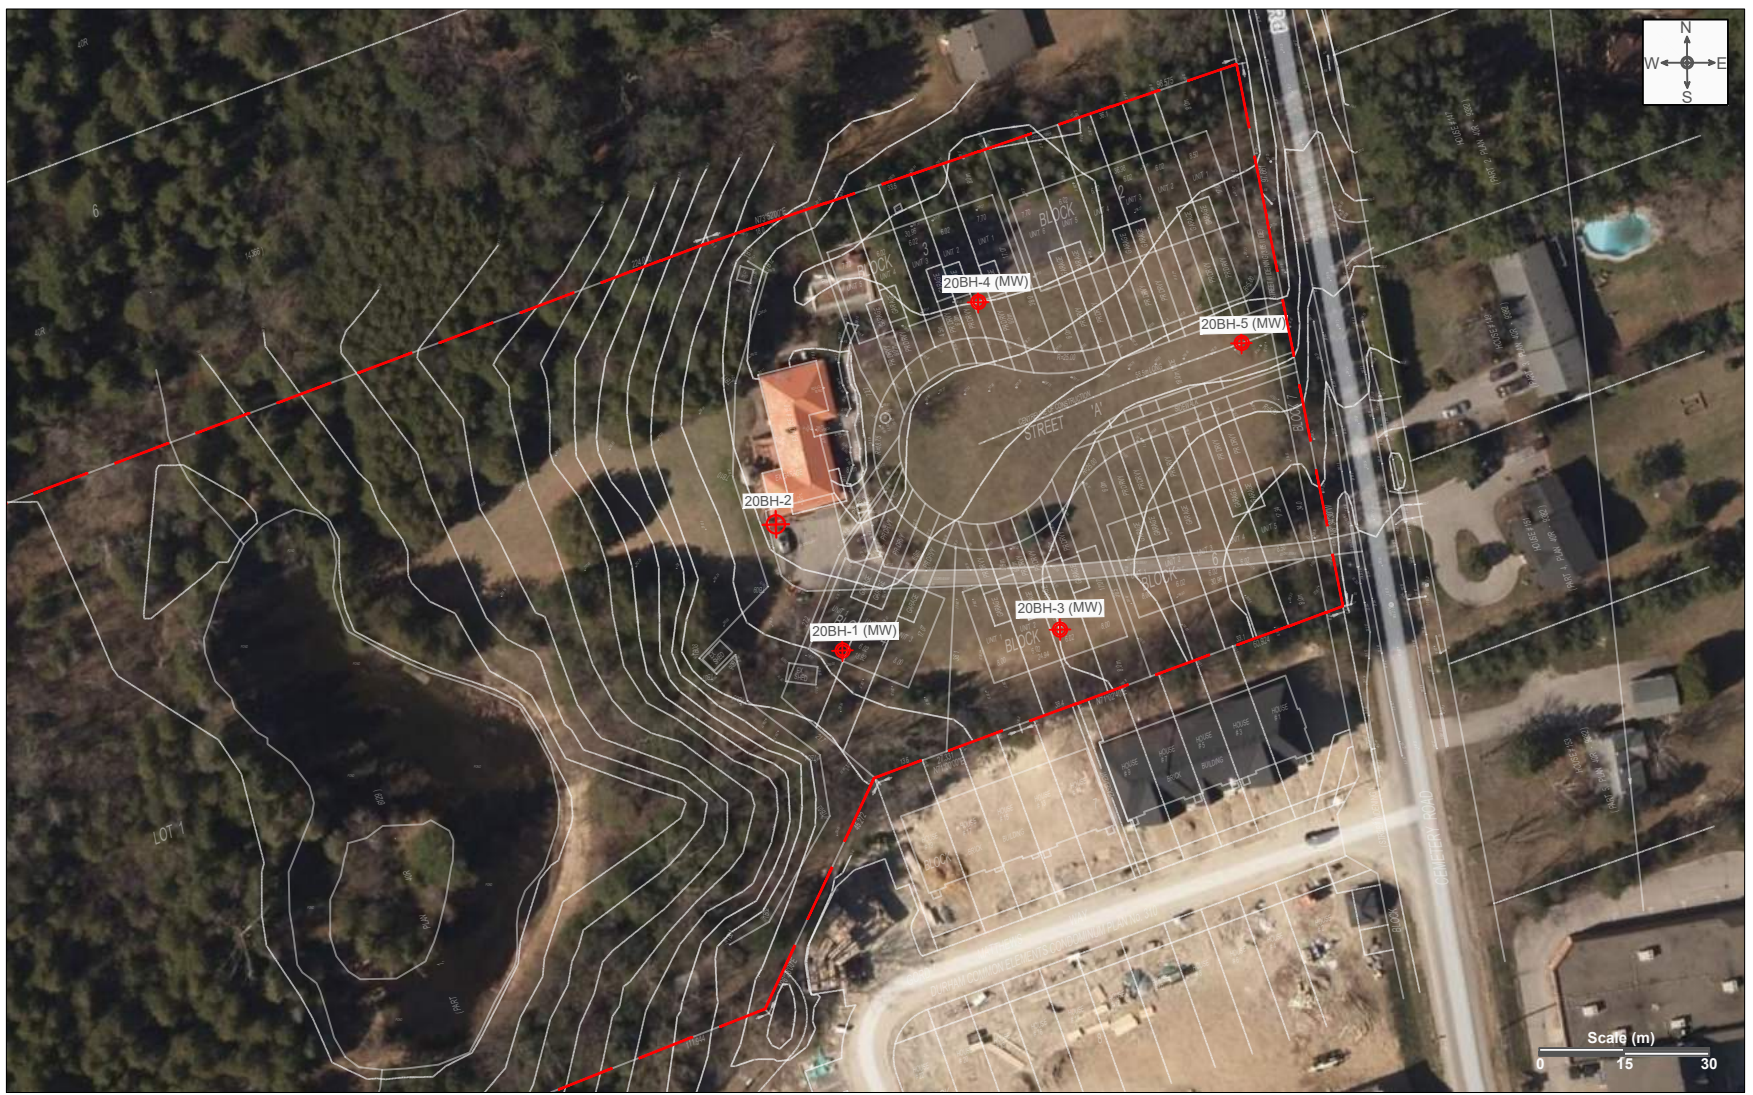
Location of Cross Sections

Long Term Stable Top of Slope

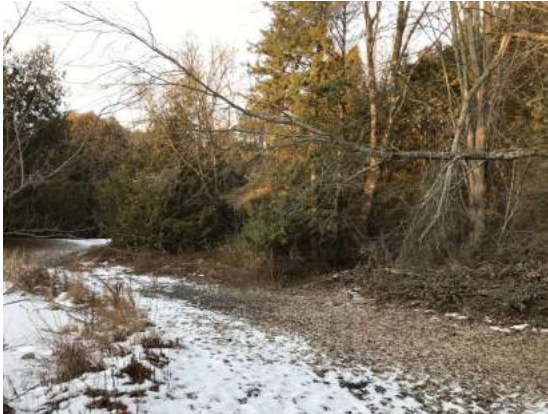
P1 - View of bottom of slope at south side

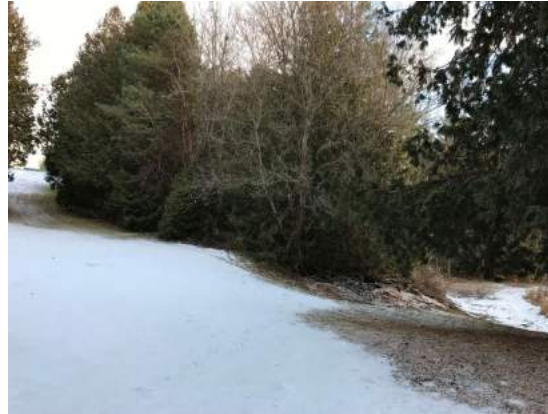
P2 - View of dense trees on slope

The vegetation aids in improving slope stability against shallow failures by increasing the effective cohesion within the surficial soils. The vegetation on the

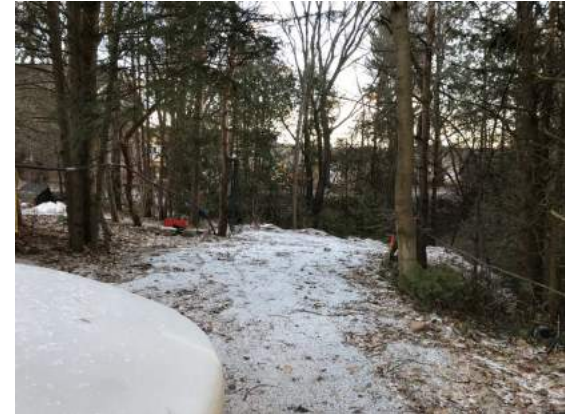
P3 - The trees extend to top of slope on south side

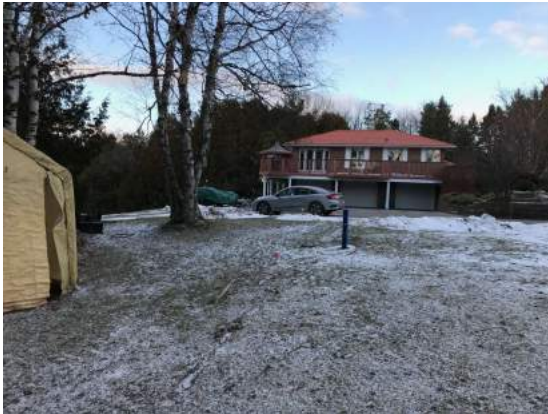
P4 - Monitoring well at Borehole
20BH-1(MW)

Groundwater observations were made in the boreholes during and upon the completion of drilling. Boreholes 20BH-1, 20BH-3, 20BH-4 and 20BH-5 were completed as monitoring wells to determine the current static groundwater conditions and as part of a concurrent hydrogeological investigation. The symbol (MW) besides the borehole identification number, indicates a monitoring well. The groundwater records are presented in the borehole logs.

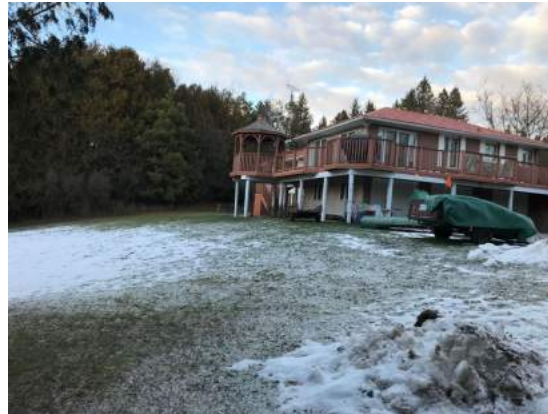
P5 - View of slope and house at top of
slope on north side

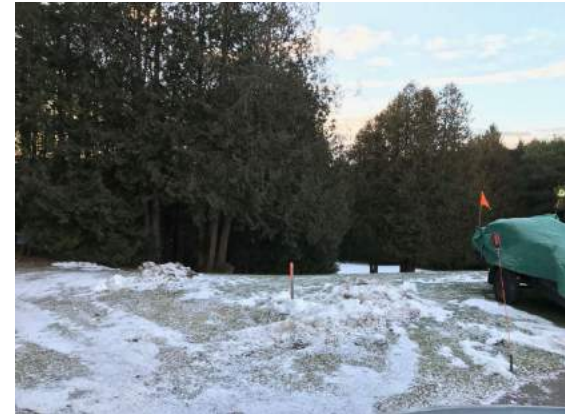
P6 - View of top of slope

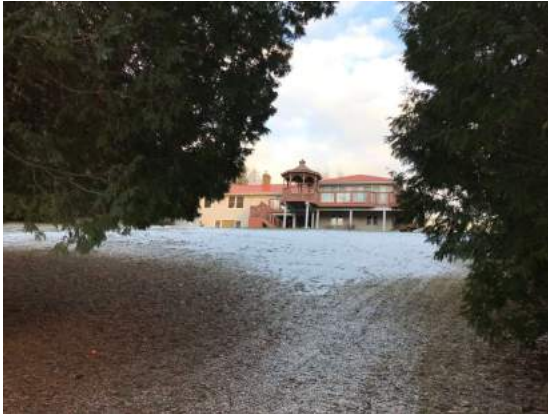
P7 - View of the slope below the existing house

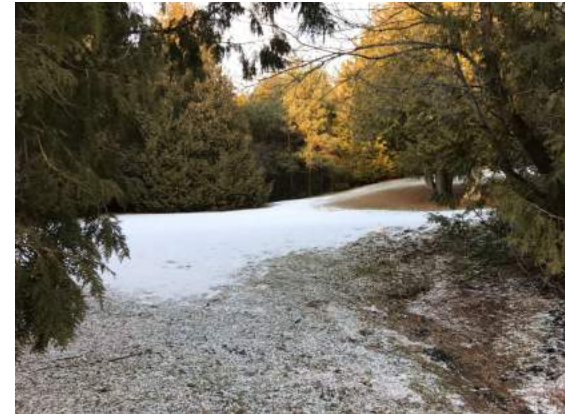
P12 - Bottom of the slope on the north side of the site
