CCTV Investigation  
181 Toronto Street South  
Uxbridge, Ontario  
Larkin+

23-WH-12

**Mainline Survey List** 181 Toronto Street South, Uxbridge**Number of surveys in this** 7 **as of** Monday, August 14, 2023**Unit of Measure:** m

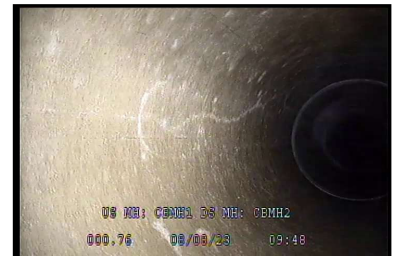
| Miscellaneous | | | | | | Structural | | | O&M | Constructional |
|---|---|---|---|---|---|---|---|---|---|---|
| 0.76 | | CL - Crack Longitudinal | | | | | 12 | | | |

0.8 Crack Longitudinal

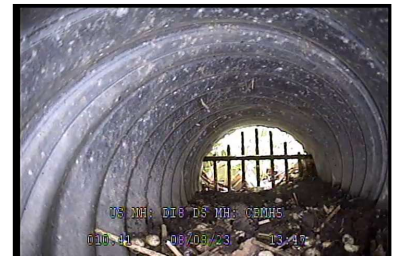
| Miscellaneous | | | | | | Structural | | | O&M | Constructional |
|---|---|---|---|---|---|---|---|---|---|---|
| 10.41 | | OBZ - Obstruction Other | | | 010 | | 05 | 07 | sticks/brush | |

#### 10.4 Obstruction Other

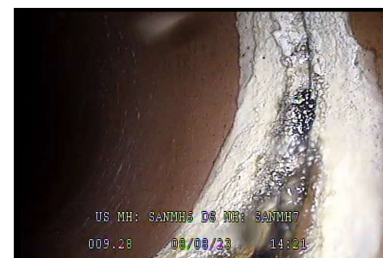
| Miscellaneous | | | | | | Structural | | | O&M | Constructional |
|---|---|---|---|---|---|---|---|---|---|---|
| 9.28 | | IR - Infil Runner | | | | X | 02 | | | |

9.3 Infil Runner

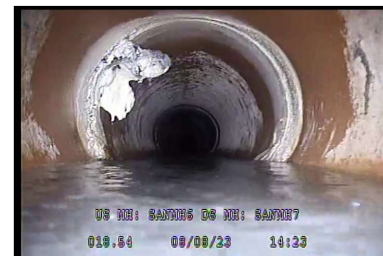
| Miscellaneous | | | | | | Structural | | | O&M | Constructional |
|---|---|---|---|---|---|---|---|---|---|---|
| 19.36 | | DAE - Deposits Attached Encrustation | | | 005 | | 10 | | | |

19.4 Deposits Attached Encrustation

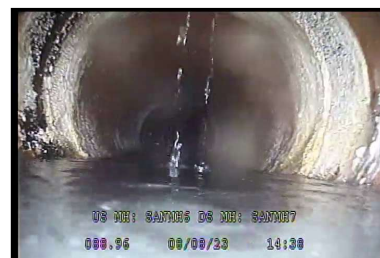
74.0 Infil Gusher
