Hydrogeological Assessment, 309 Zephyr Road, Zephyr, Township of Uxbridge

Cambium Reference No.: 6199-001

2018-11-16

Prepared for: China Canada Jing Bei Xin Min Intl.
c/o EcoVue Consulting Services Inc.

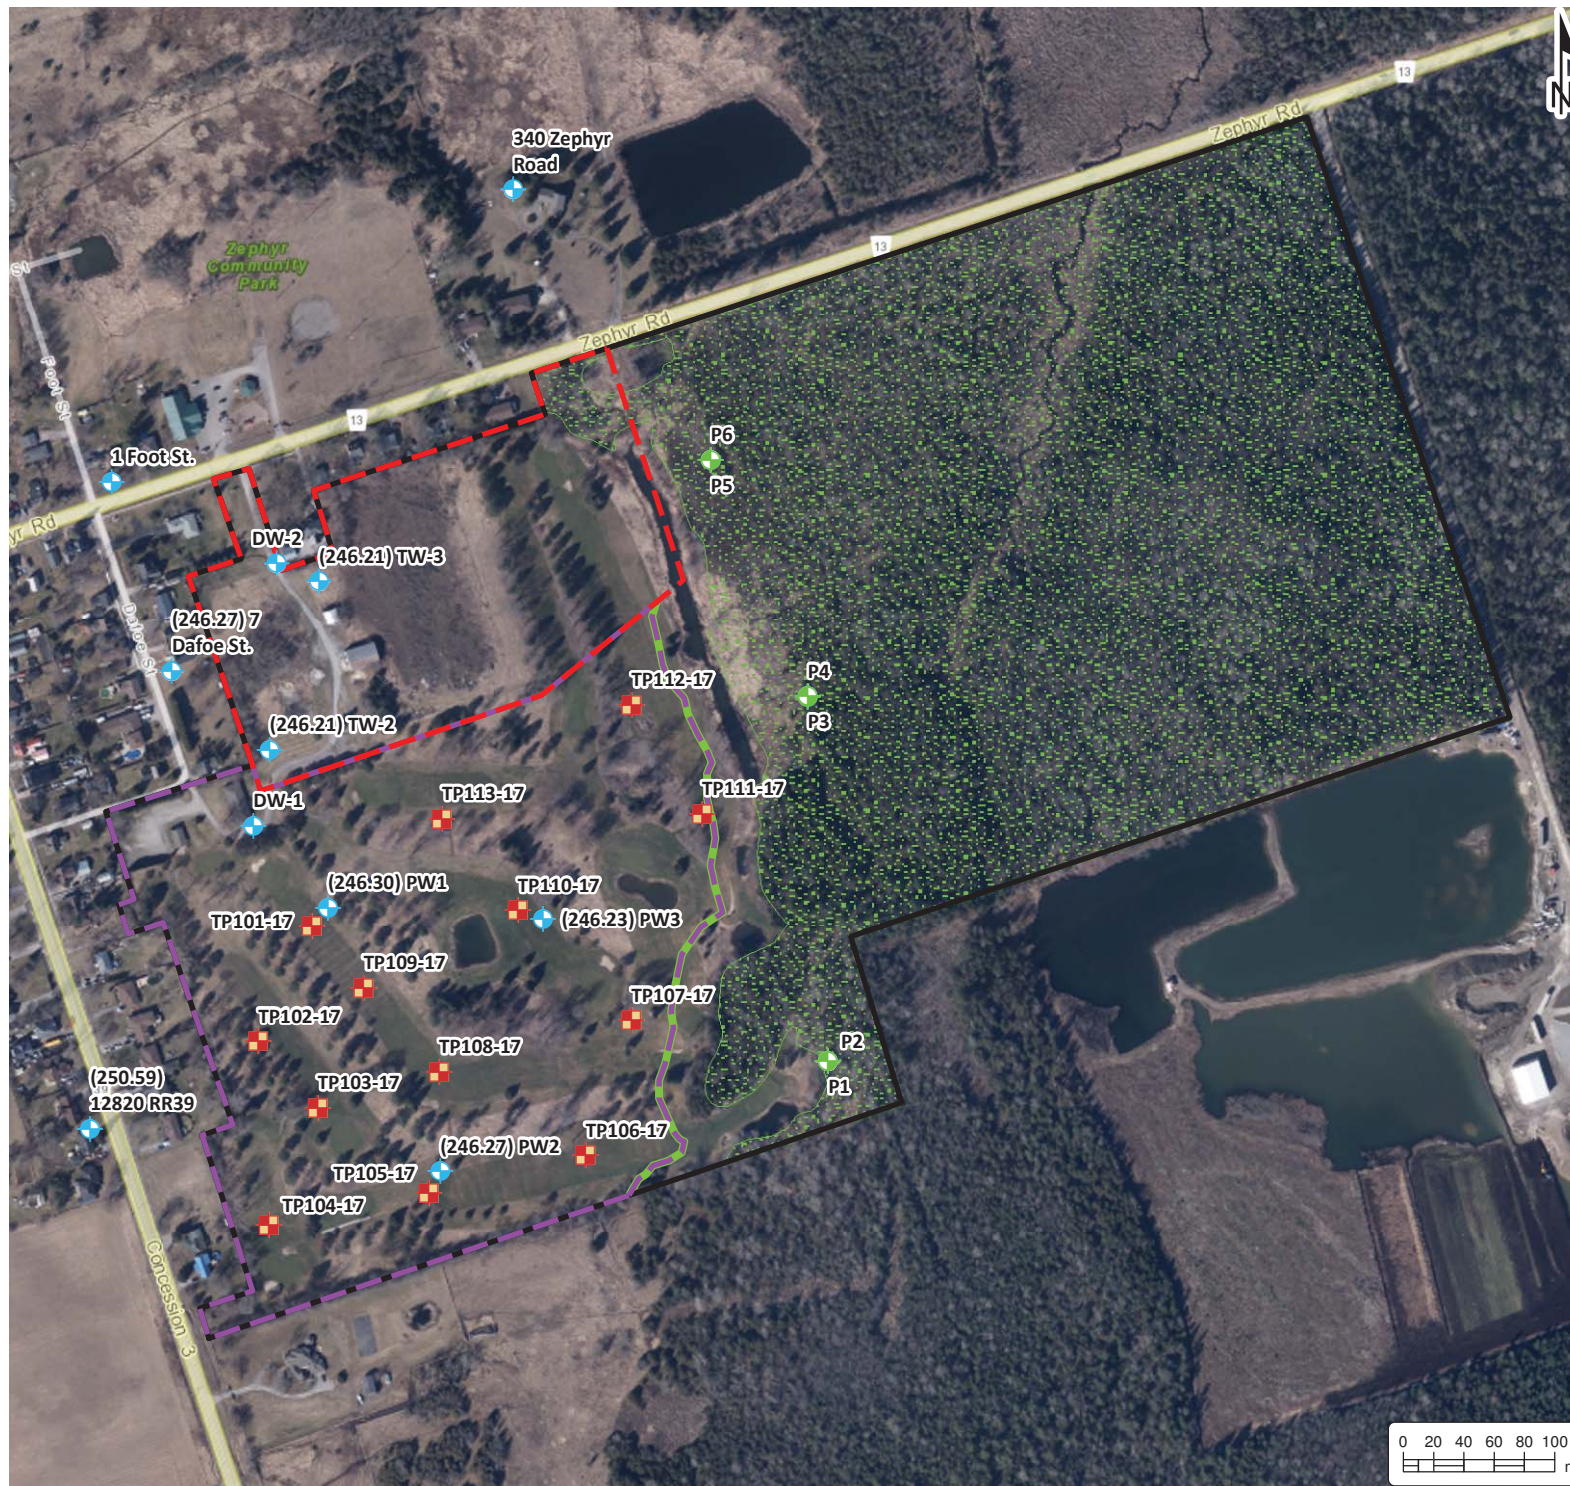
ORIENTATION PLAN		
Project No.: 6199-001	Date: August 2018	Rev.: 1
Scale: 1:5,000	Projection: NAD 1983 UTM Zone 17N	
Created by: TLC	Checked by: CM	Figure: 2

- Phase 1 and 2 Subject Property is approximate and was obtained from Ecovue, Draft, Concept Sketch A, Project No:17-1672 Dated November 17, 2017.
- Wetlands and Wetland Setback were obtained from Ecovue, Draft, Concept Sketch A, Project No:17-1672 Dated November 17, 2017.
- Base mapping features were obtained from the Durham County online GIS.
- Distances on this plan are in metres and can be converted to feet by dividing by 0.3048.
- Cambium Inc. makes every effort to ensure this map is free from errors but cannot be held responsible for any damages due to error or omissions. This map should not be used for navigation or legal purposes. It is intended for general reference use only.

On August 3, 2017 a test-pit investigation was completed by Cambium to determine the shallow subsurface conditions across the property. The test-pits were excavated using a tracked excavator under the supervision of a Cambium technologist. A total of 13 test-pits, designated as TP101-17 through TP113-17, were advanced throughout the Site in the western portion of the property where the development is proposed to occur. Each soil sample was handled only by the technologist using dedicated nitrile gloves. Soil samples were logged for soil colour, texture, structure, moisture content, and consistency/compactness. Open test-pits were backfilled with the excavated soils and compacted with the backhoe bucket. The test-pit logs are provided in Appendix B. Test-pit locations have been outlined on Figure 2.

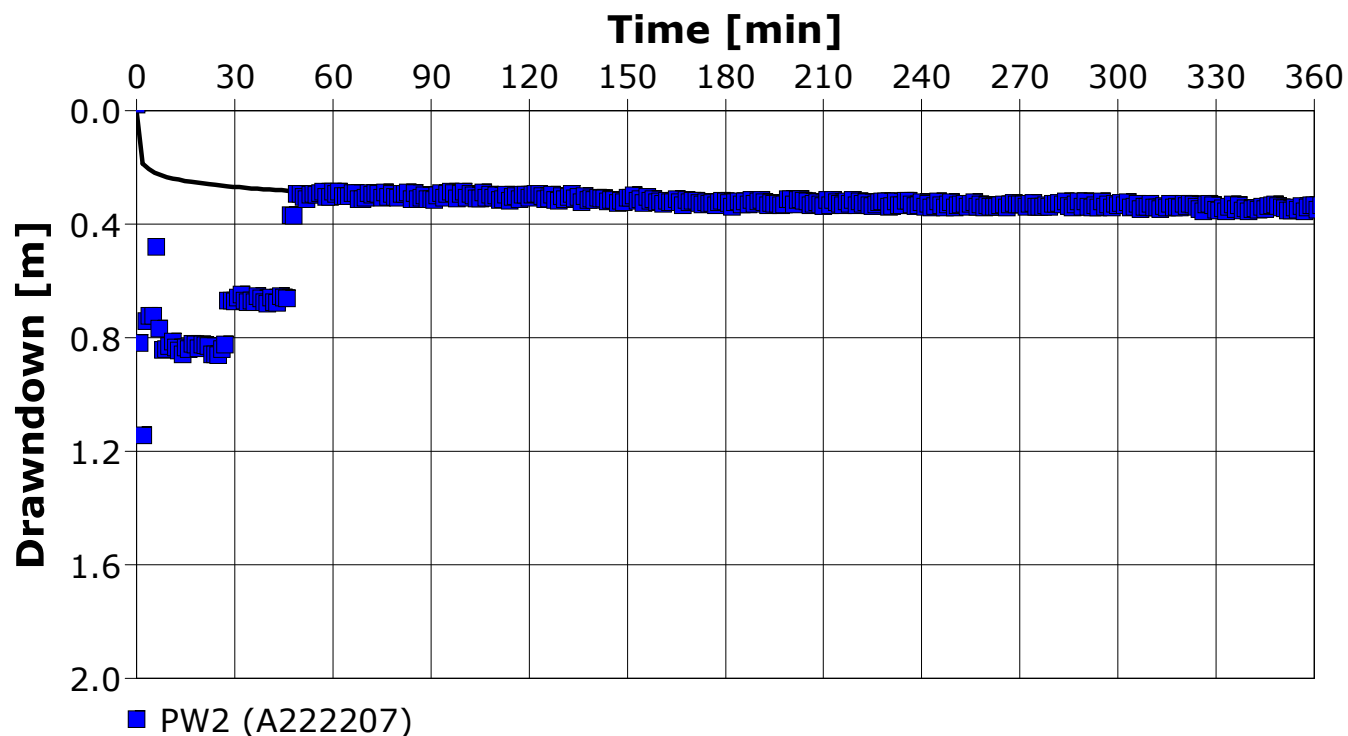
Calculation using Theis

Observation Well	Transmissivity [m²/s]	Hydraulic Conductivity [m/s]	Radial Distance to PW [m]
PW2 (A222207)	2.00×10^{-2}	1.33×10^{-2}	0.08

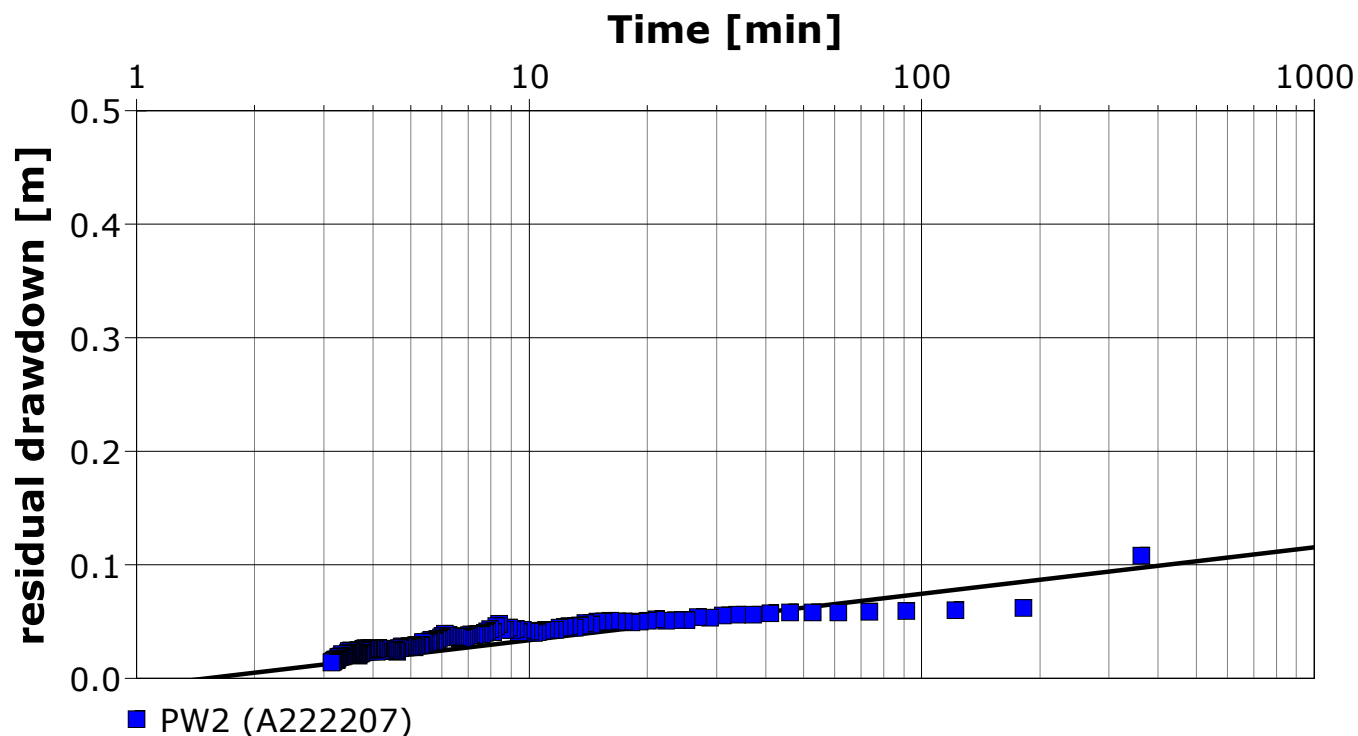
Calculation using THEIS & JACOB

Observation Well	Transmissivity [m²/s]	Hydraulic Conductivity [m/s]	Radial Distance to PW [m]
PW2 (A222207)	1.12×10^{-1}	7.48×10^{-2}	0.08

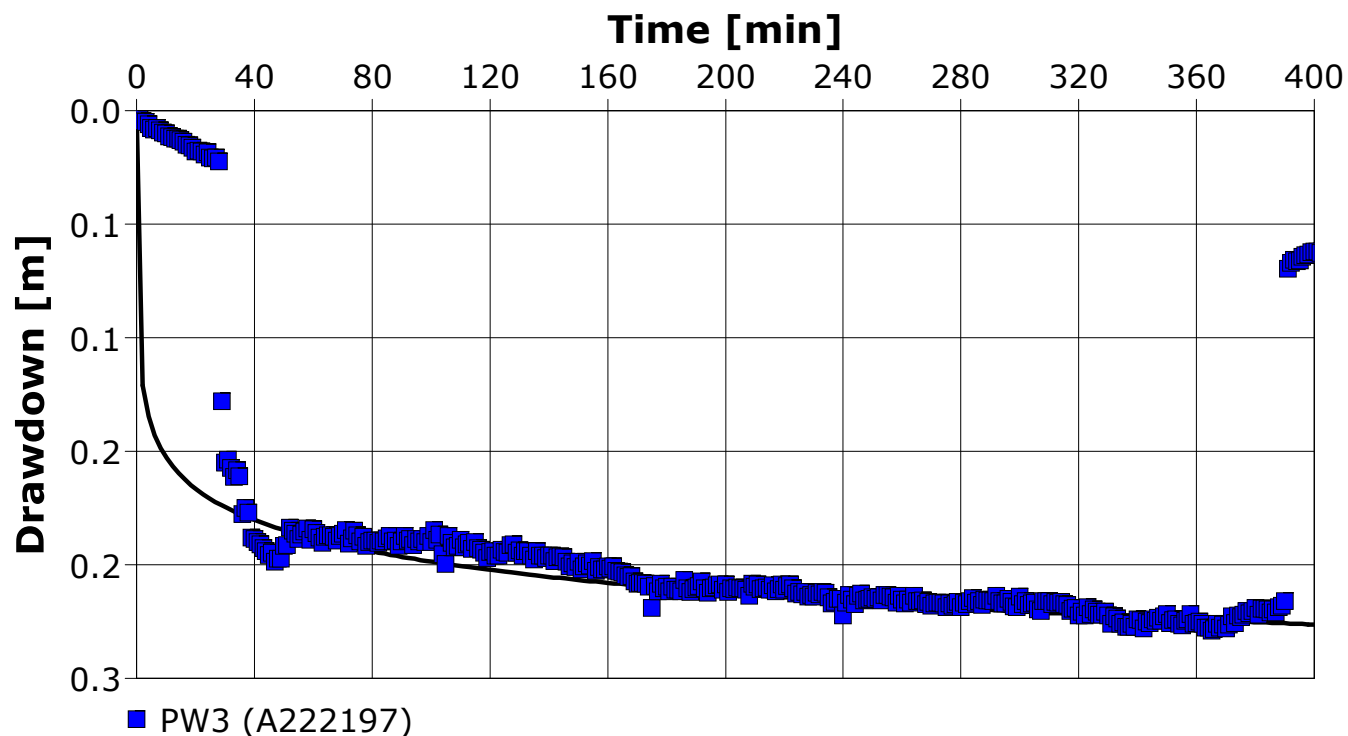
Calculation using Theis

Observation Well	Transmissivity [m ² /s]	Hydraulic Conductivity [m/s]	Radial Distance to PW [m]
PW3 (A222197)	1.50×10^{-2}	1.00×10^{-2}	0.08
