Conceptual Technical Design Brief: Tributary of Uxbridge Creek

Town of Uxbridge, Ontario

Report Title: Conceptual Technical Design Brief:
Tributary of Uxbridge Creek
Town of Uxbridge, Ontario

Project Number: PN18072
Status: Final
Version: 1.0
First Submission Date: August 10, 2018
Revision Date: --

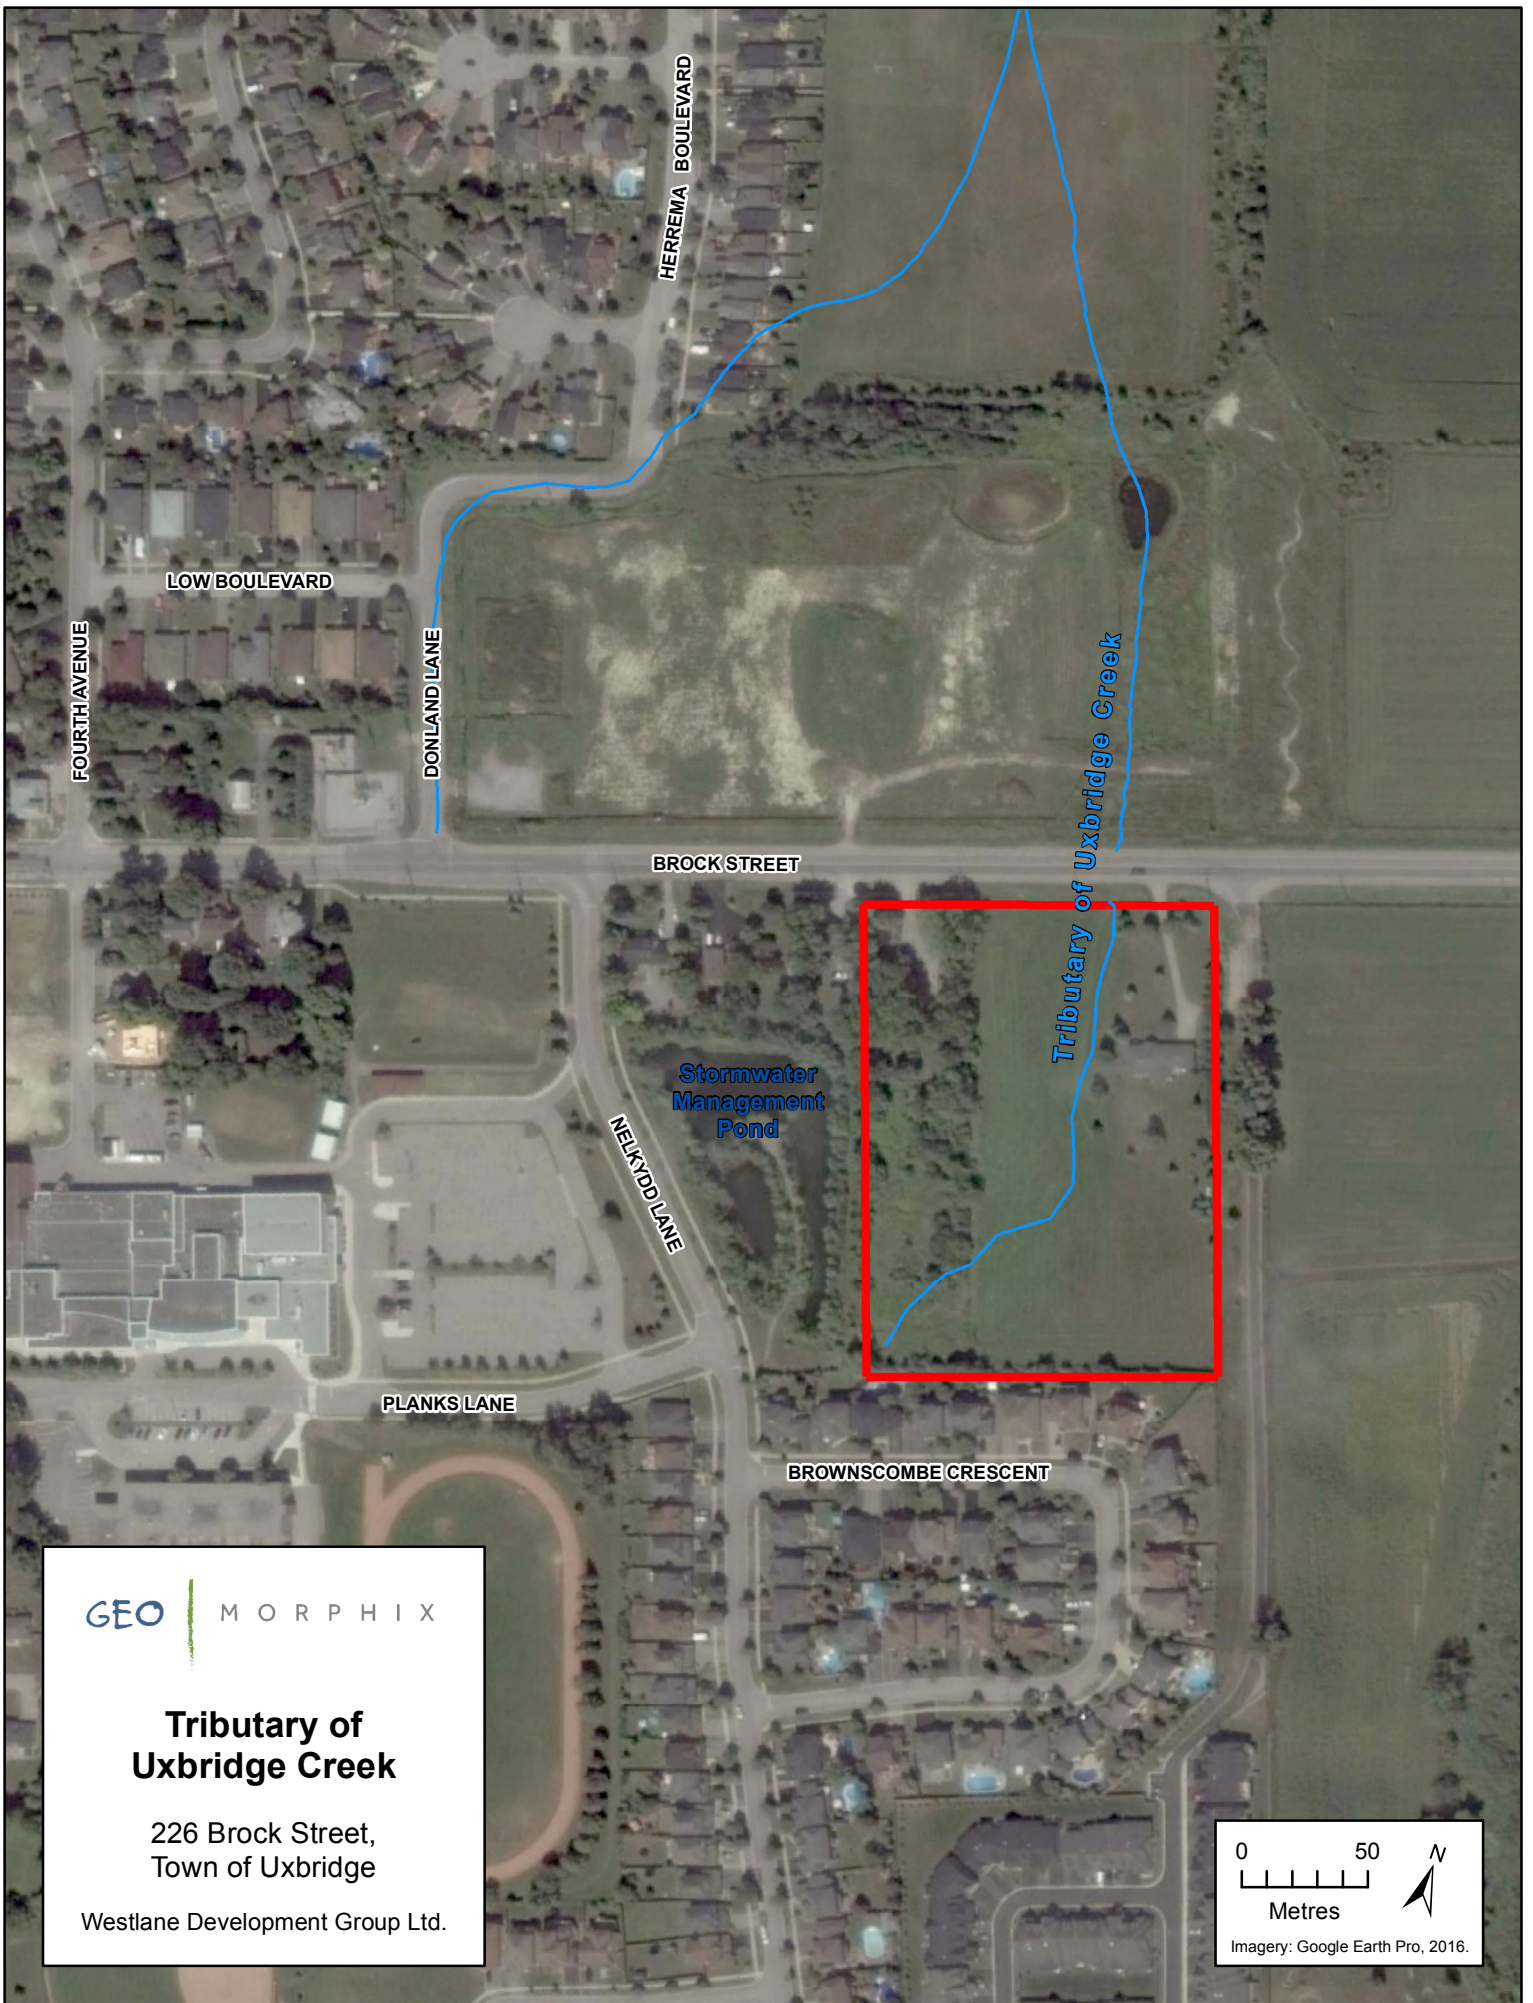
Appendix A Site Map

Stormwater Management Pond

Tributary of Uxbridge Creek

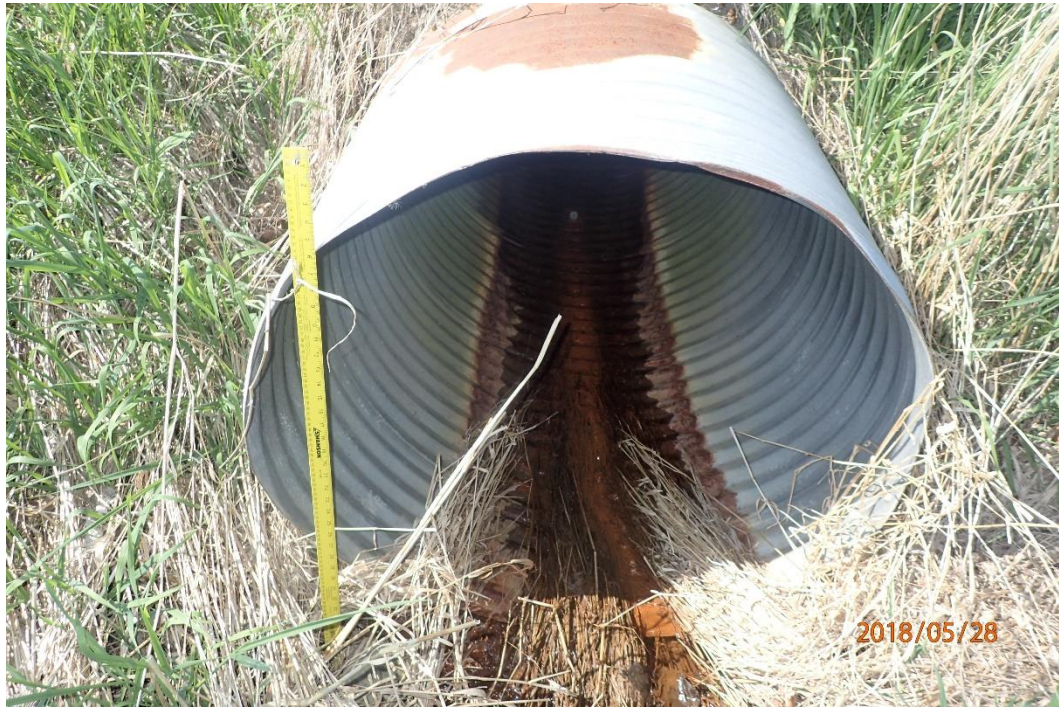
Photo
1

Reach UCT1 flows into a CSP at Brock Street at the downstream extent of the property. Iron staining was noted at the downstream extent, but no where else in the reach.

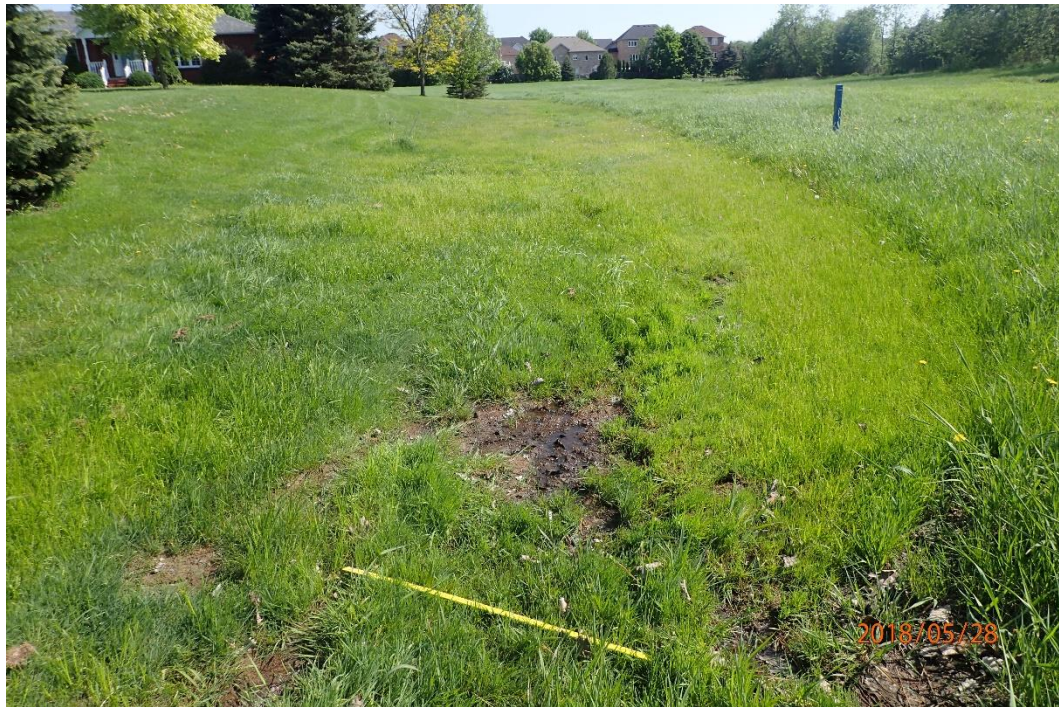
Photo
2

Photograph taken facing upstream from the CSP at Brock Street. The swale feature has no defined channel banks.

Reach UCT1 consists of a swale feature with no defined channel banks or riffle-pool formation. A swale feature is a shallow trough-like depression that conveys water during snow melt or storms. Riparian vegetation consists mainly of grasses that fully encroach the reach. Bed materials are comprised of clay and silt. A stormwater management pond feeds the reach at the upstream extent adjacent to the subject property.

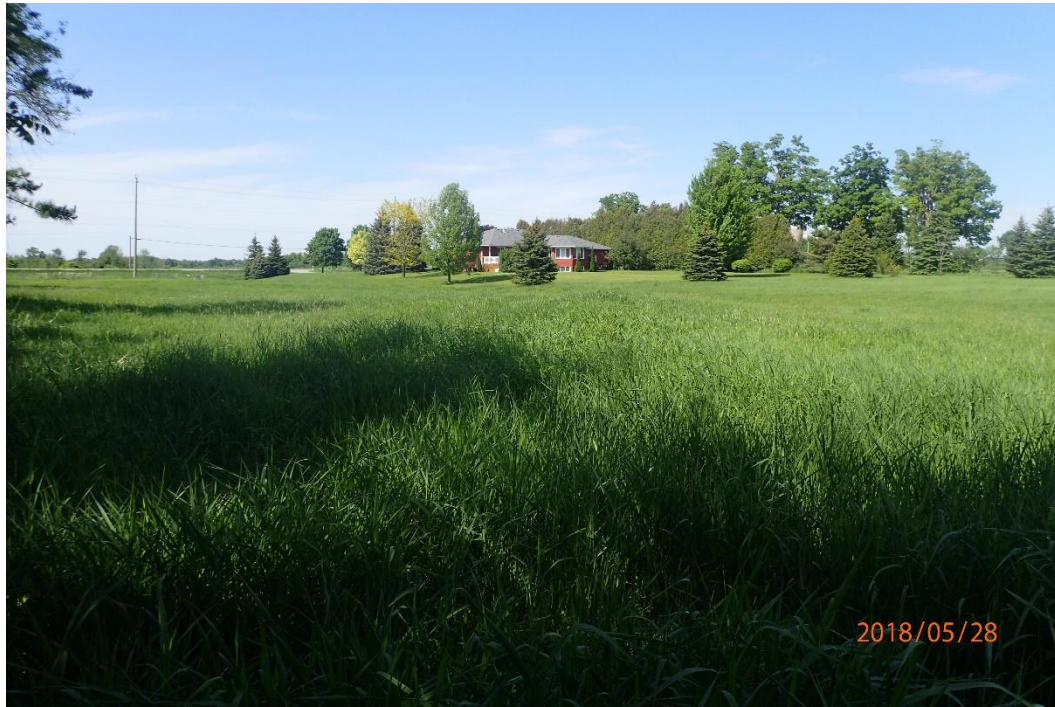
Photo
3

Photograph taken facing downstream at the fence line between 266 and 212 Brock Street East. The reach is fully encroached with riparian grasses.

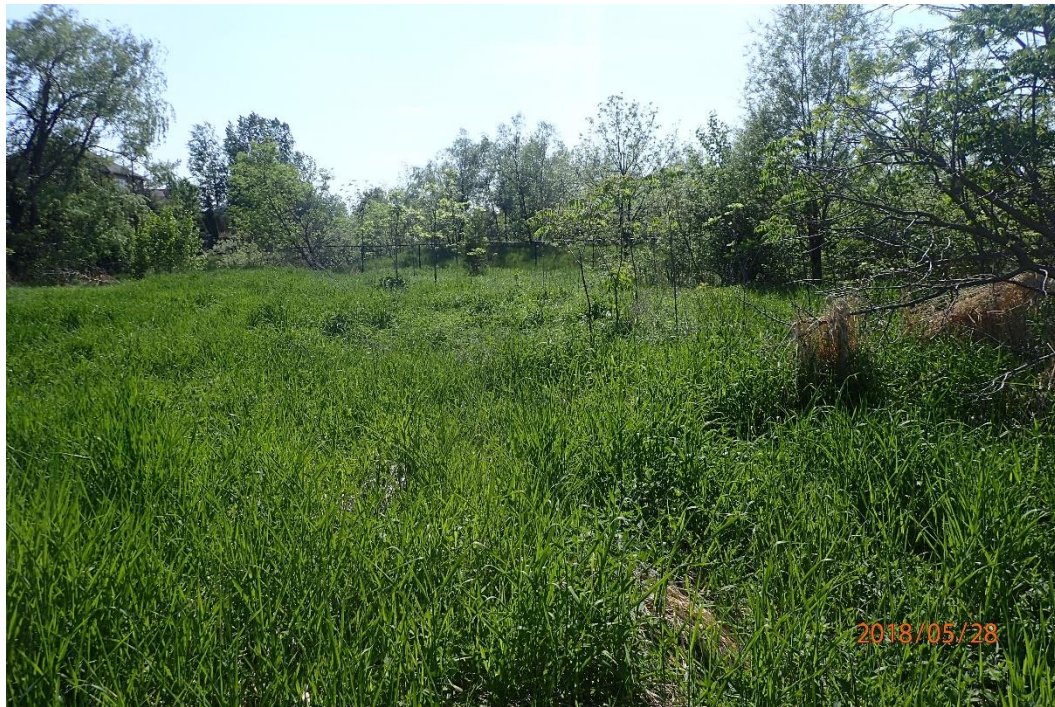
Photo
4

Photograph taken facing upstream at the same fence line as Photo 3 towards the stormwater management pond.
